MODEL
**2015MY
Sorento (XMa)
2014-2015MY
Optima (TF, QF)
Sportage (SL)**

NUMBER
1802 (Rev 1, 08/28/2018)

SUBJECT: **PRODUCT IMPROVEMENT CAMPAIGN**

**KNOCK SENSOR DETECTION SYSTEM - ECU
LOGIC IMPROVEMENT (PI1802)**

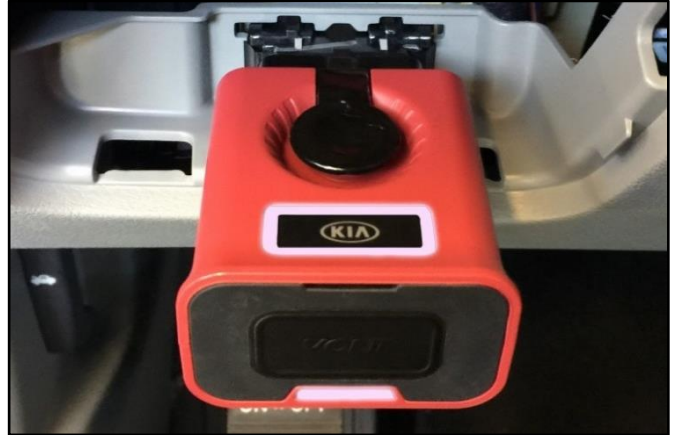
The ECU upgrade function on KDS operates wirelessly. It is not necessary to perform the upgrade via USB cable.

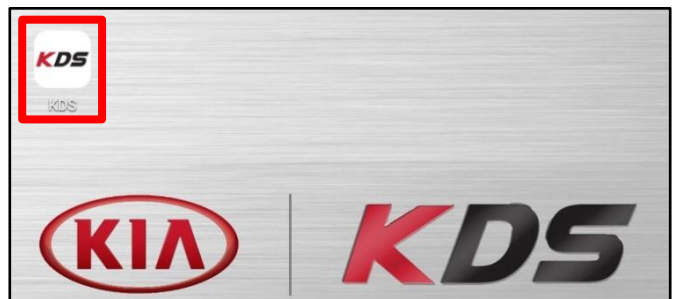
2. With the ignition ON, turn ON the KDS tablet. Select **KDS** from the home screen.

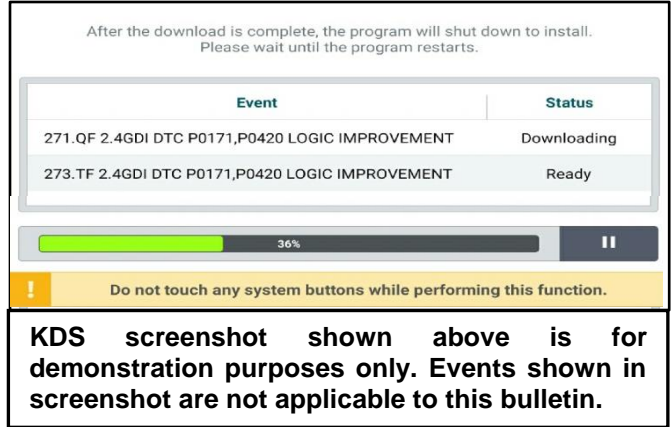
- The KDS will check the server for recently uploaded Events and then automatically download **Upgrade Event #374 (XMa), #375 (TF), #376 (SL), or #377 (QF)**.

The vehicle must be identified in Vehicle Selection to download an Event for that vehicle.

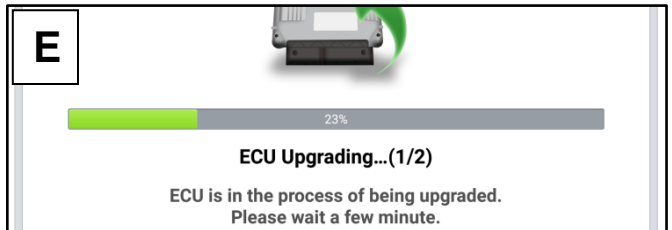
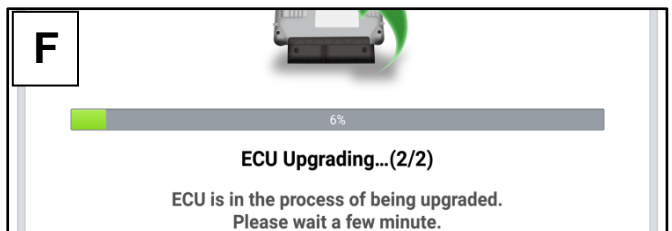
- The ECU upgrade will begin and the progress of the upgrade will appear on the bar graph. Upgrade part (1/2) (E) will download the upgrade event to the VCI-II. Upgrade part (2/2) (F) will upgrade the ECU.

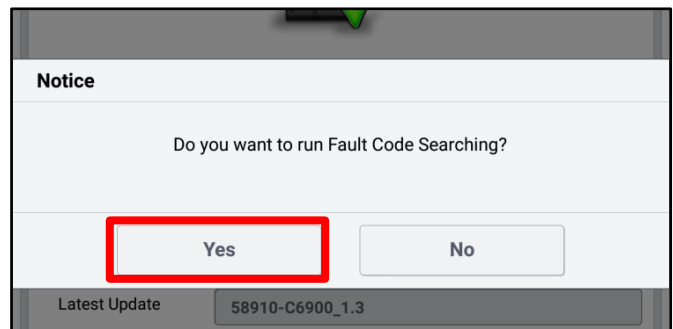
12. When prompted, select **YES** to check for Diagnostic Trouble Codes (DTC) and erase any DTCs stored such as EPS, ESC, and TPMS that may have been set during the upgrade.
