## **EMISSIONS RECALL**

**CAB OVER ENGINE (COE) ECU, DCU AND VCS  
SOFTWARE UPDATE**

**CAMPAIGN NO: AA920  
DATE: 8-2-2018  
REFERENCE: QA-180730-N3**

**SUBJECT VEHICLES:** 18MY-19MY COE Trucks equipped with a J05 engine

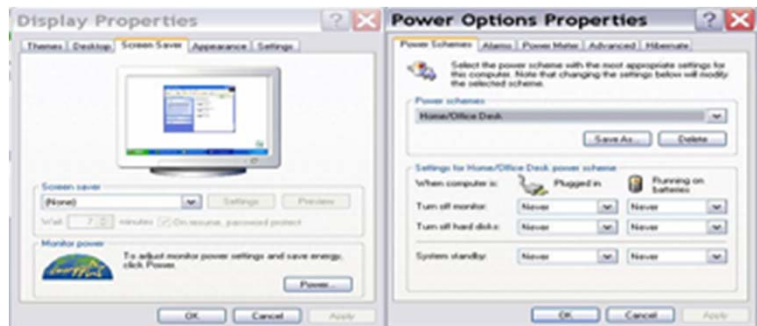
1. Screen saver
2. Energy saving features
  - a. Monitor
  - b. Hard disks
  - c. System standby

**NOTICE:** The illustrations above depict what you will see on your computer screen with regard to the features which must be disabled. The location on the screen of the features to be disabled will vary, however, based upon the operating software. Consult your IT (Information Technology) department as required.

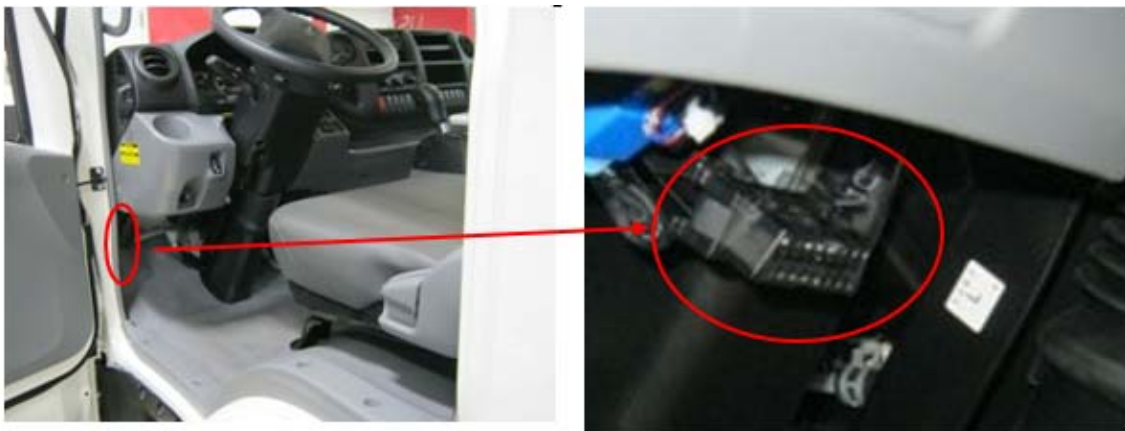
2. Connect the DLC cable to the vehicle's DLC connector. The DLC connector is found under the dash on the left side of the steering column.

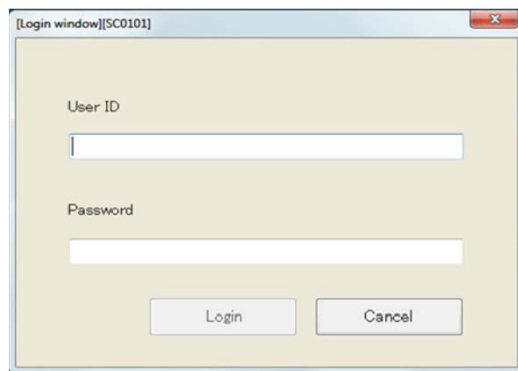
**4.** Hino DX2 will prompt you for a “User ID” and “Password”. Enter your User ID-, and password and then select the “Login” icon. Verify that the DX2 has software version 1.1.18.12 or later.

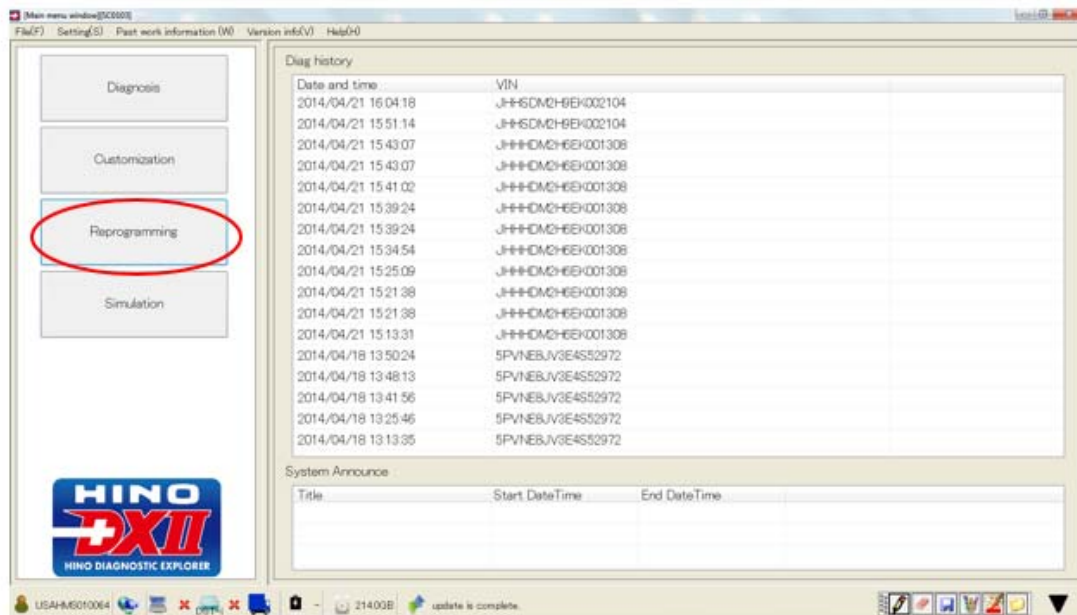
6. Select the “Reprogramming” icon.

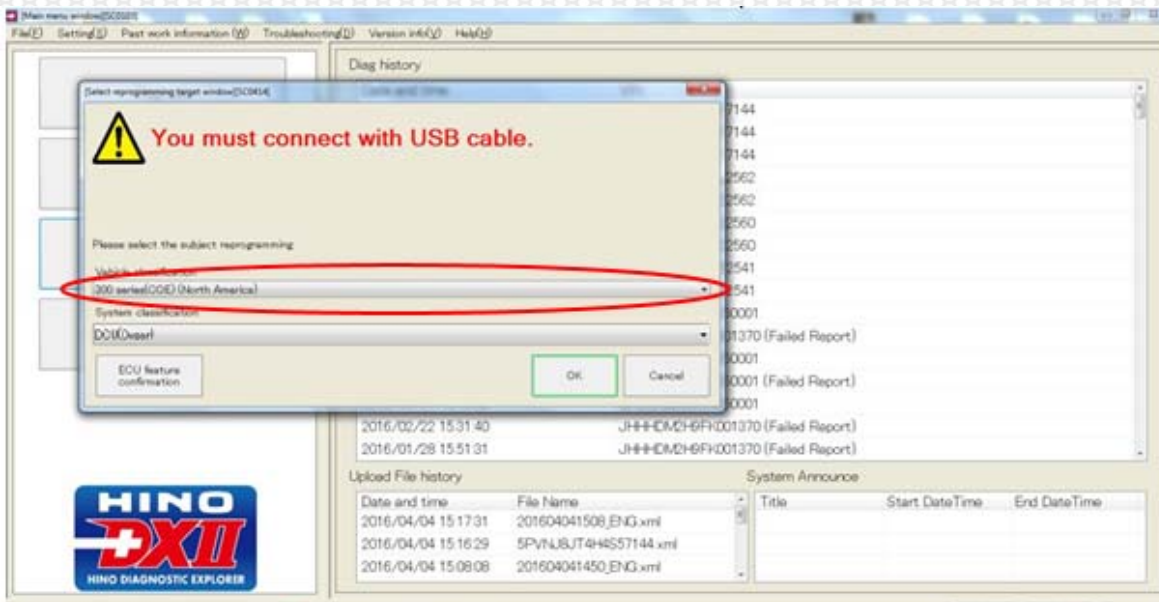
11. Select “300 Series” under the “Vehicle Classification” drop down menu.

12. Select “DCU (Doser)” under the “System Classification” drop down menu and then select the “OK” icon.

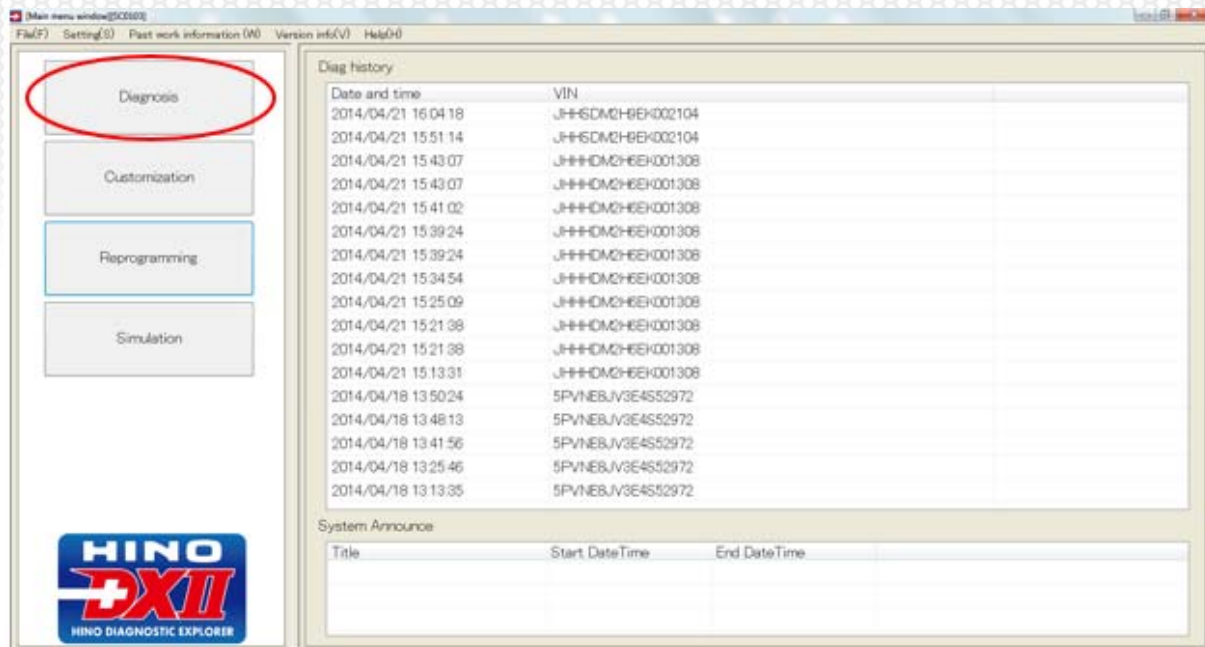
**22.** During ECU software reprogramming, other DTC's may have been set. These DTC's will need to be cleared prior to completing this Emission Recall. Select the "Diagnosis" icon.

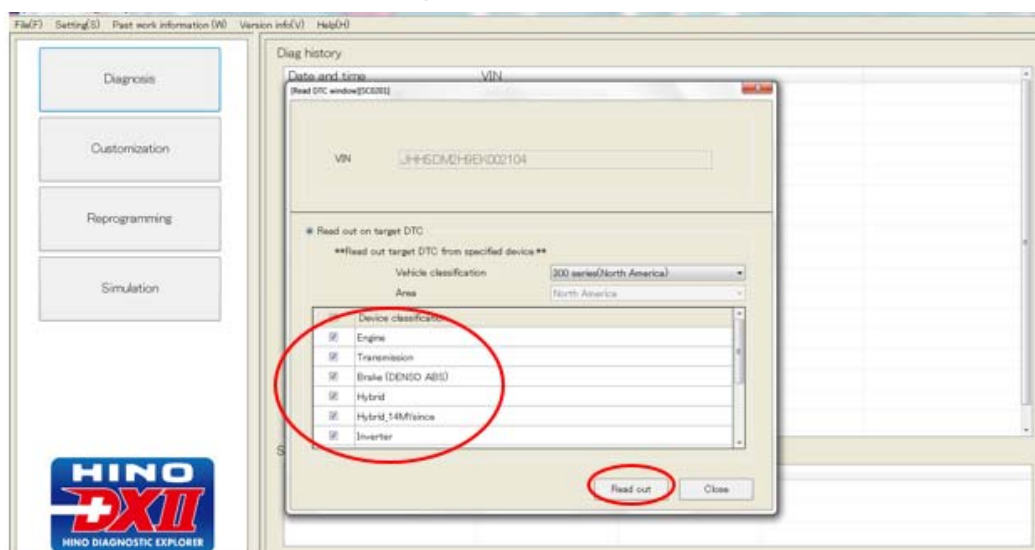
**23.** Check mark the "Device Classification". This should automatically check mark the remaining devices. Select the "Read Out" icon.

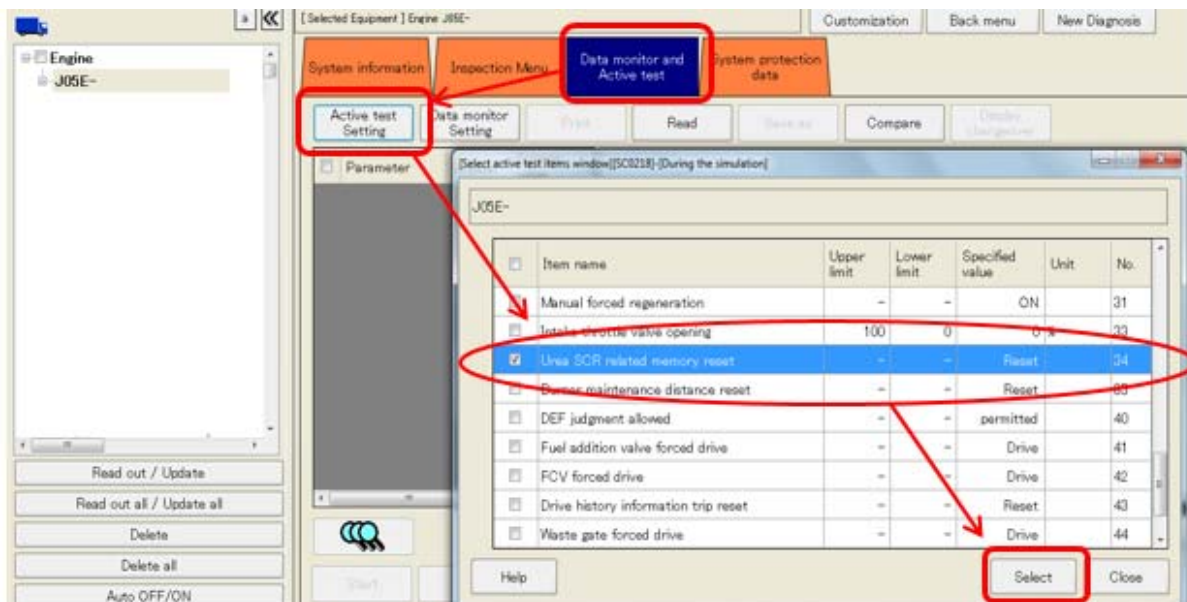
## 27. From the Engine ECU Data Monitor and Active Test menu, select Active Test Setting>Urea SCR Related Memory Reset> then follow the prompts to complete the reset.

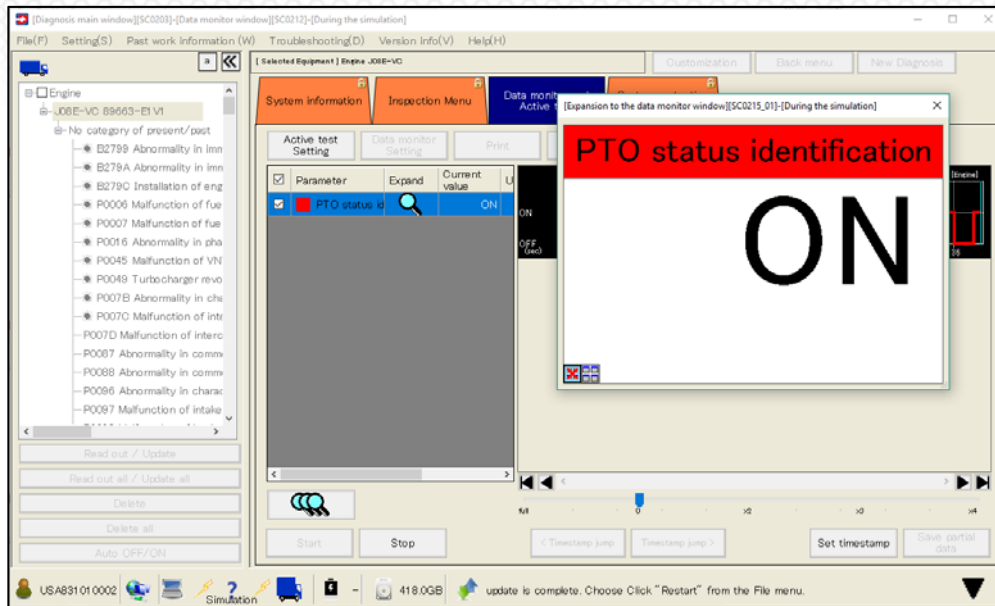
1. Confirm the body application. If no PTO is present, proceed to Step 28 following this procedure. If the vehicle is equipped with a PTO, proceed to step 2, below.
2. Using the DX2 monitor PTO status (PID 8). With the engine running, engage the PTO.

Does the DX2 PTO status display “ON” when the PTO switch is on?

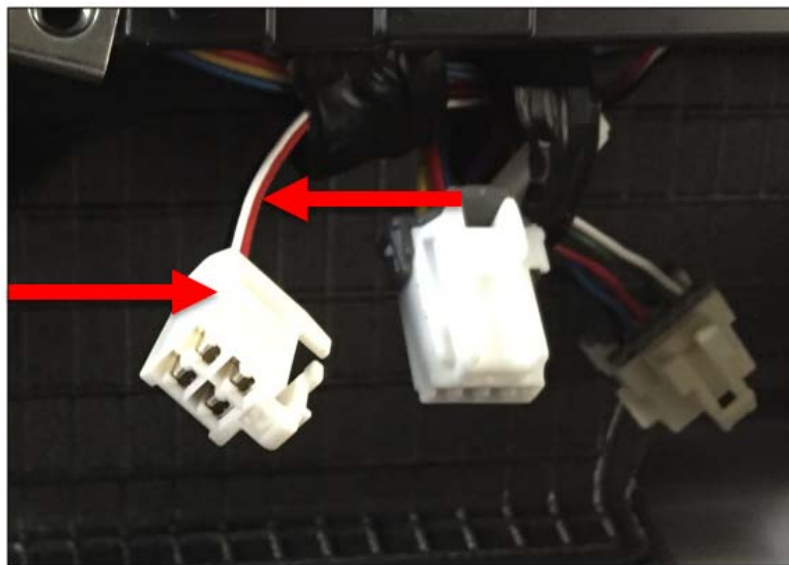
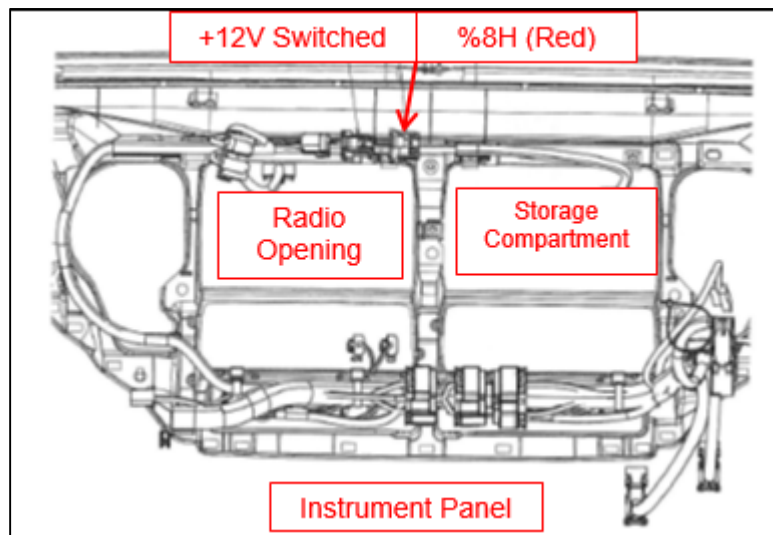
In order to use the cruise control switch to elevate the idle speed, the Engine ECU must receive a switched 12 volt power signal to circuit %8H / PTO SW1 (Red) when the PTO is in use. Also, item number 229 must be set to “1” in the Engine ECU Customization Menu using DXII. Refer to chapters 7 and 11 of the body builder book as well as Tech Tip 17-004 on Hinonet to modify the existing PTO switch wiring.

After the ECU PTO signal has been wired in and item 229 is set to “1”, recheck PTO operation. Verify that the “PTO ON” indicator illuminates when the PTO is engaged, and the engine speed is adjustable with the cruise control switch, or a preset elevated engine speed is reached. Once proper operation of the “PTO ON” indicator and elevated idle speed is verified, proceed to Step 28 following this procedure.

| DX Number | DX Description | Operational Description | |
|---|---|---|---|
| 229 | Cruise Control Switch Inhibit During PTO Operation Flag | Set/resume switch = decrease/ increase RPM.<br>This setting does NOT work when Pre-Set PTO flag is activated.<br>This setting does not work in the following conditions. (1) Cruise main switch is NOT turned ON (08MY or before), (2) Vehicle speed is NOT "0", (3) Gear position is NOT neutral, (4) Service brake is applied, (5) Clutch pedal is applied. | 0=OFF<br>1=ON |

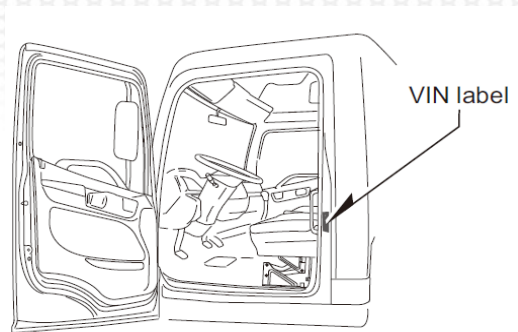
1. Once all above steps in this recall procedure have been completed, apply a recall label to the left door jamb above the VIN label. Fill in the Campaign No, Dealer code, and Repair date. Proceed to the Final Inspection Procedure, below.
