Technical Service Bulletin

GROUP CAMPAIGN	NUMBER 18-01-027
DATE AUGUST 2018	MODEL(S) SONATA (LF)

SUBJECT: SONATA ECM & CLUSTER UPDATE – ENGINE MONITORING LOGIC PRODUCT IMPROVEMENT (SERVICE CAMPAIGN 953)

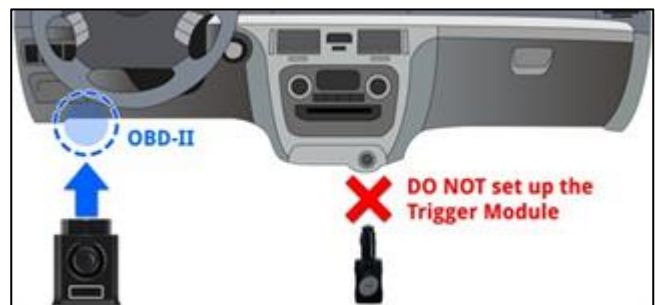
1. Connect the VCI-II into the vehicle's DLC connector under the driver side instrument panel.

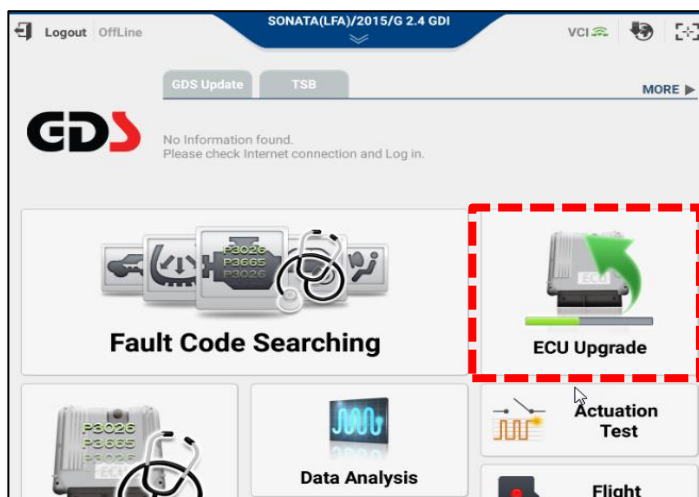
3. Select **ECU Upgrade** from the GDS main screen and then select **Auto Mode**.

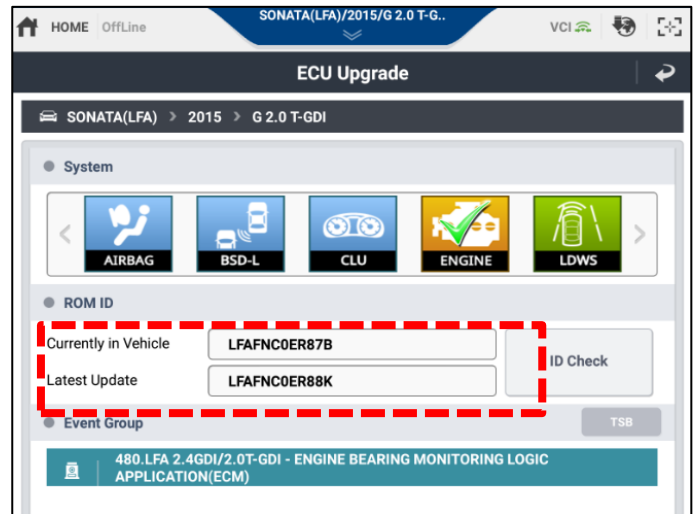
5. Confirm the ROM IDs match those in the ROM Information table for the vehicle specification. Select the event under **Event Group** and then select **Upgrade** to start the update.

The update is performed in two parts. Follow the prompts on the GDS to complete the update.
