PIC6127K (Volt) High Voltage Drive Motor Battery TAC Restriction and Exchange Program

Brand:	Model:	Model Years:	VIN:		Engine	Transmissions:
			from	to	Engine:	Transmissions.
Chevrolet	Volt	2016 - 2019	All	All	L3A	MKV

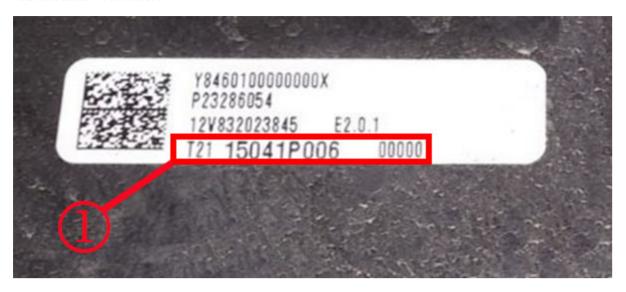
6.2 The battery has a battery identification tag that is located on the right side of the battery. Locate the tag and record the 16 digit battery identification number (BIN). The BIN is the bottom most number on the label and it starts with a "T" indicator (See Photo Below). If the battery is not out of the vehicle yet, you can find the BIN by installing the MDI and using GDS 2. Access the Battery Energy Control Module and look under the identification information section and the sixteen digit number will be listed under the parameter: Hybrid/EV Battery Pack Identification Number.
