SERVICE BULLETIN

ENGINE TURNS OFF OR HESITATES WHEN ACCELERATING FROM A STOP DURING HOT AMBIENT TEMPERATURES (+100° F)

APPLIED VEHICLES: 2012-2017 Versa Sedan (N17)
2014-2017 Versa Note (E12)

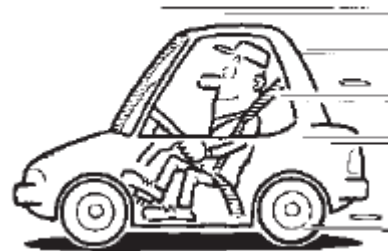
Figure A

- For 2013 Versa Sedan only: This procedure may require reprogramming of the **ECM and TCM** which means most steps in this procedure may need to be done twice.
- Most instructions for reprogramming with CONSULT-III plus (C-III plus) are displayed on the CONSULT PC screen.
- If you are not familiar with the reprogramming procedure, [click here](#). This will link you to the "CONSULT- III plus (C-III plus) Reprogramming" general procedure.
- Take the vehicle for a 10 minute drive in order to meet the following Idle Air Volume Learn (IAVL) conditions:
 - Engine coolant temperature: 70 -100°C (158 -212°F)
 - Battery voltage: More than 12.9V (At idle)
 - Transmission: Warmed up

- After reprogramming is complete, you will be required to perform Throttle Valve Closed Position, Idle Air Volume Learn (IAVL), Accelerator Closed Position, and DTC erase. The above conditions are required for IAVL to complete.

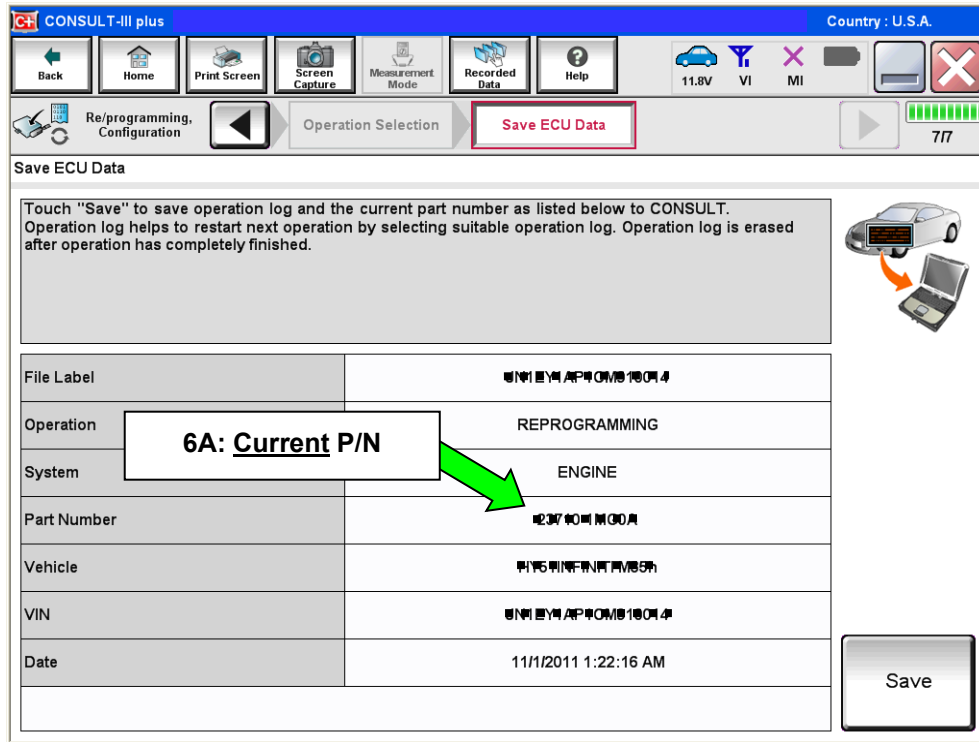
6. When you get to the screen shown in Figure 2, confirm this bulletin applies as follows:
- A. Find the ECM **Part Number** and write it on the repair order.

NOTE: This is the current ECM Part Number (P/N).

5. Follow the on-screen instructions and navigate the C-III plus to the screen shown in Figure 2 on the next page.

- B. Compare the P/N you wrote down to the numbers in the **Current ECM Part Number** column in **Table A**, beginning on the next page.
- If there is an ECM P/N match, this bulletin applies. Continue with the ECM reprogramming procedure.
 - If there is not an ECM P/N match, this bulletin does not apply.

1. If ECM reprogramming is needed, complete it first.
2. When ECM reprogramming is complete, restart the reprogramming process for the TCM.
3. When you get to step 6 on page 4, confirm TCM reprogramming is needed as follows:
NOTE: The screen in Figure 2 on page 4 will be similar for TCM reprogramming.
 - A. Find the **TCM Part Number** and write it on the repair order.
 - B. Compare the P/N you wrote down to the number in the **Current TCM Part Number** column in **Table B**, below.
 - If there is a TCM P/N match, continue with TCM reprogramming procedure.
 - If there is not a TCM P/N match, this procedure is complete.

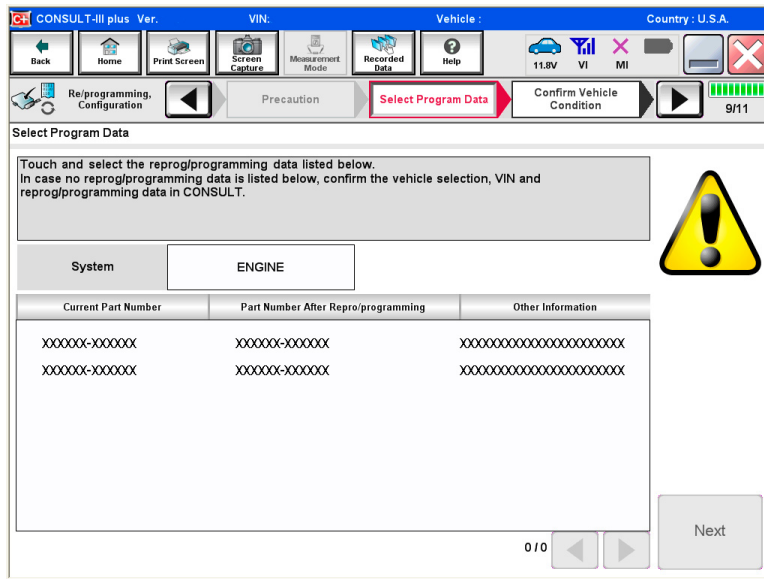
- In some cases, more than one new P/N for reprogramming is available.
 - If there is more than one new P/N, the screen in Figure 3 displays.
 - Select and use the reprogramming option that **does not** have the message “Caution! Use ONLY with NTBXX-XXX”.
- If you get this screen and it is blank (no reprogramming listed), it means there is no reprogramming available for this vehicle.

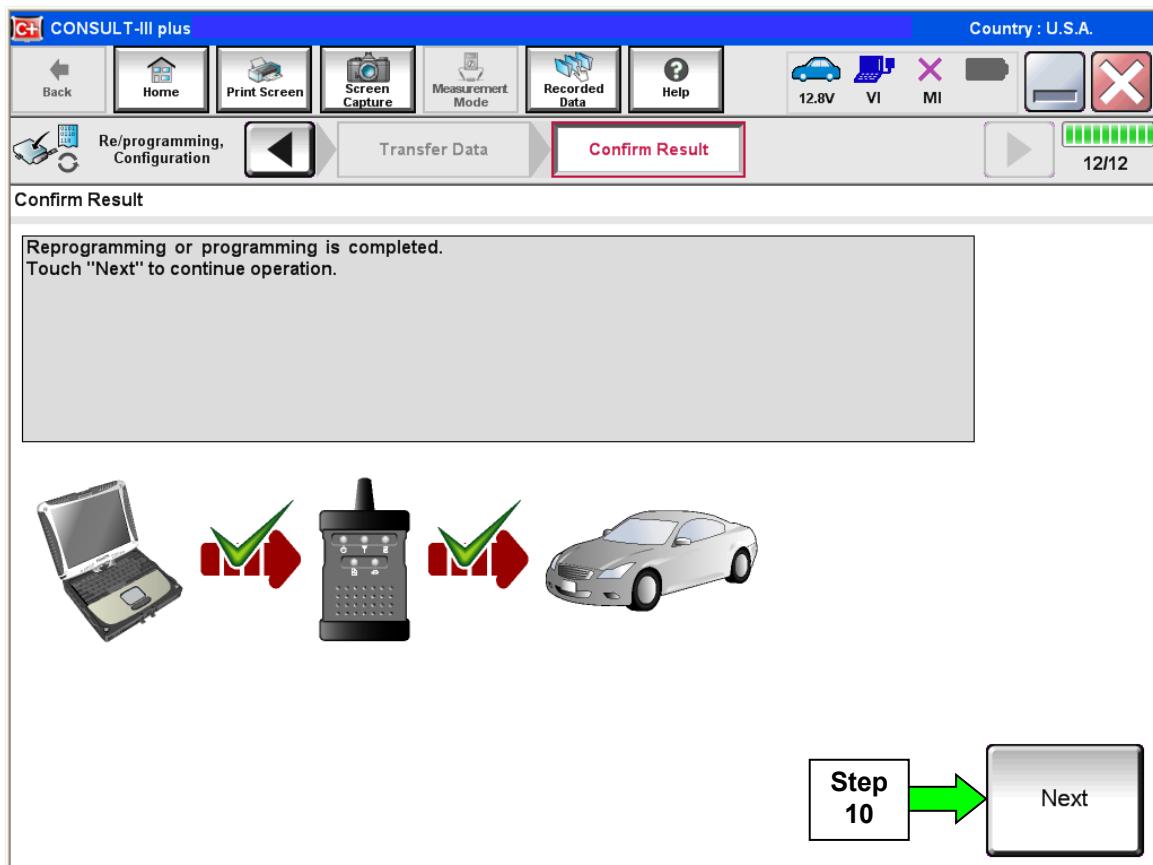
8. When the screen in Figure 5 displays, reprogramming is complete.

NOTE: If the screen in Figure 5 does not display (reprogramming does not complete), refer to the information on the next page.

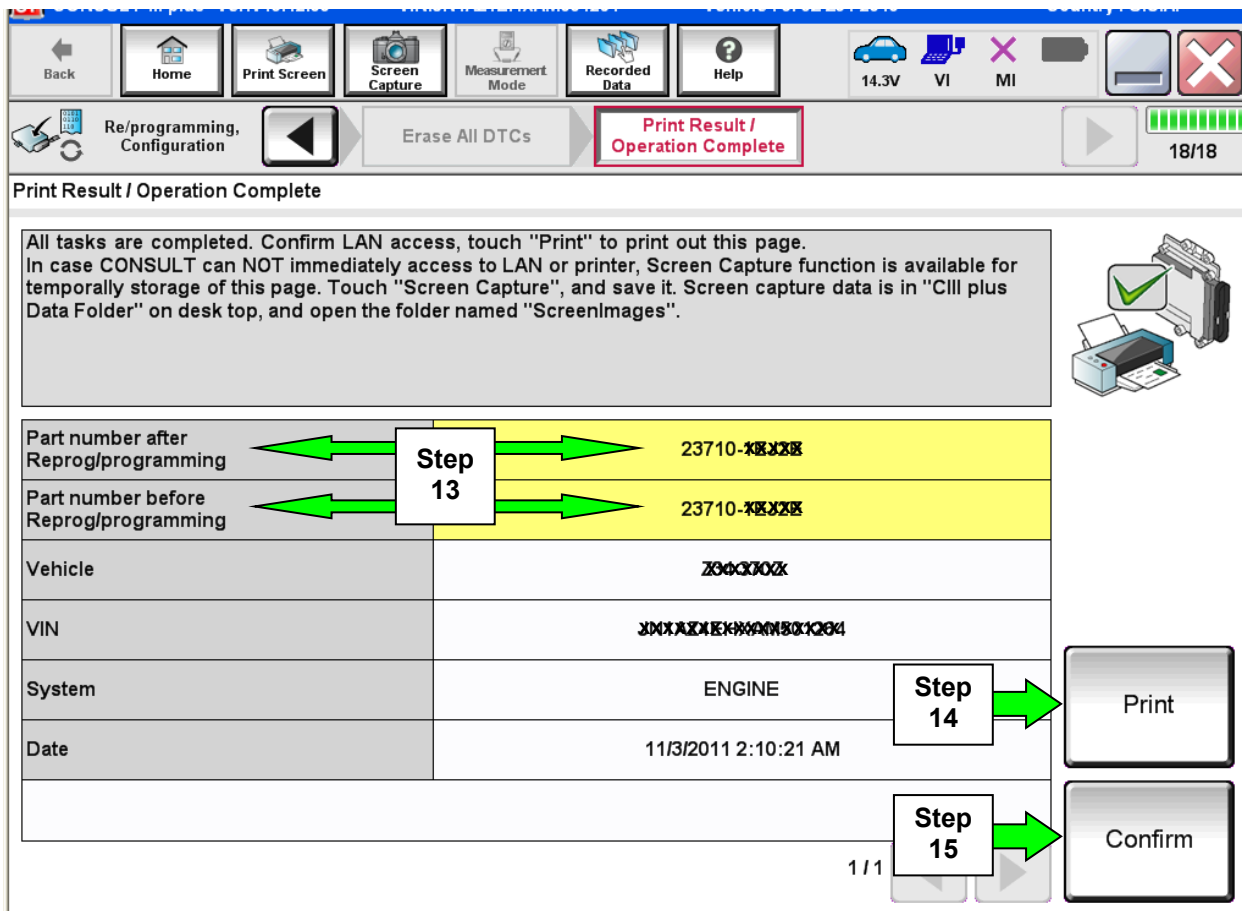
12. When the entire reprogramming process is complete, the screen in Figure 8 will display.

13. Verify the before and after part numbers are different.

14. Print a copy of this screen (Figure 8) and attach it to the repair order for warranty documentation.
