SERVICE BULLETIN

Classification: AT18-003	Reference: NTB18-058	Date: August 10, 2018
-----------------------------	-------------------------	--------------------------

2015 SENTRA; ENHANCED DIAGNOSTIC LOGIC FOR CVT

APPLIED VEHICLES: 2015 Sentra (B17)

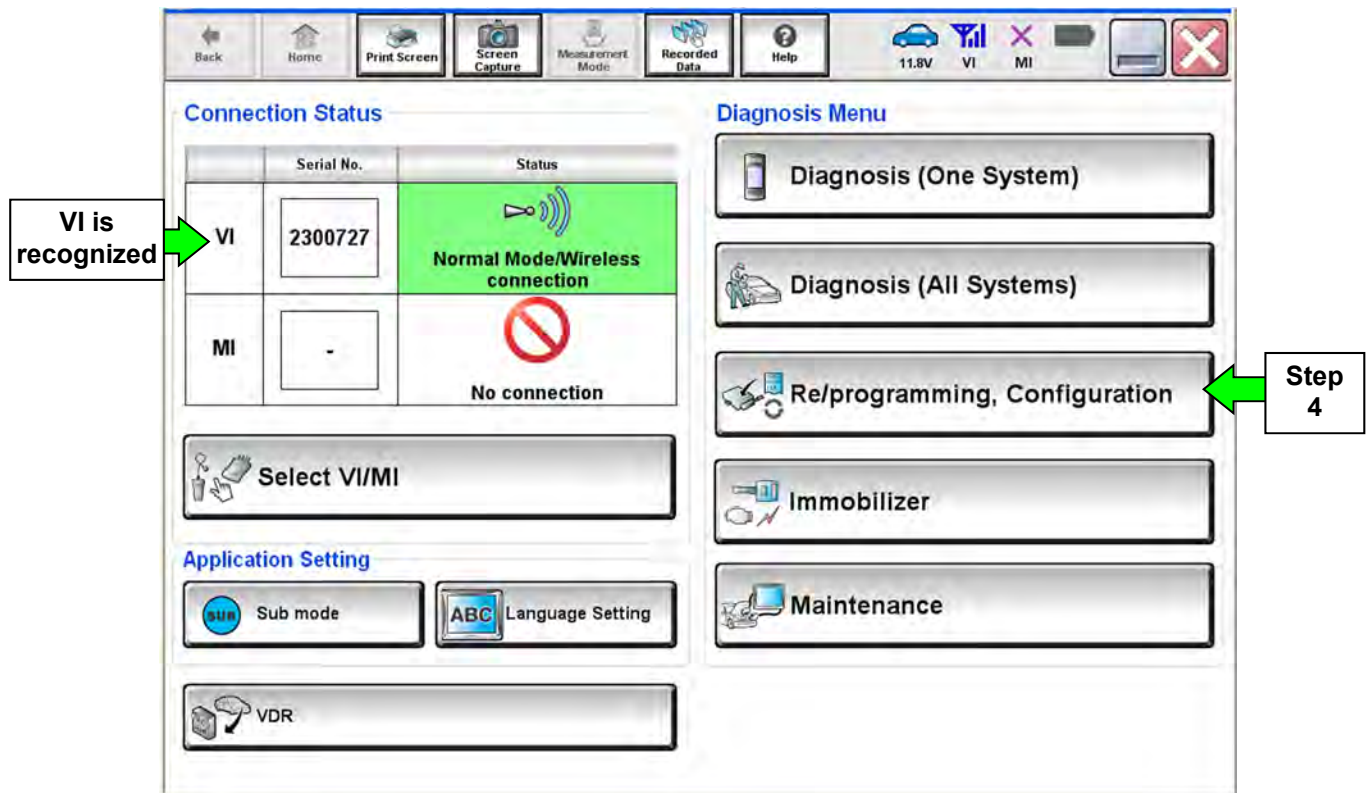
Figure 1

1. Connect the CONSULT PC to the vehicle to begin the reprogramming procedure.
2. Start C-III plus.
3. Wait for the plus VI to be recognized.
 - The serial number will display when the plus VI is recognized.
4. Select **Re/programming, Configuration**.

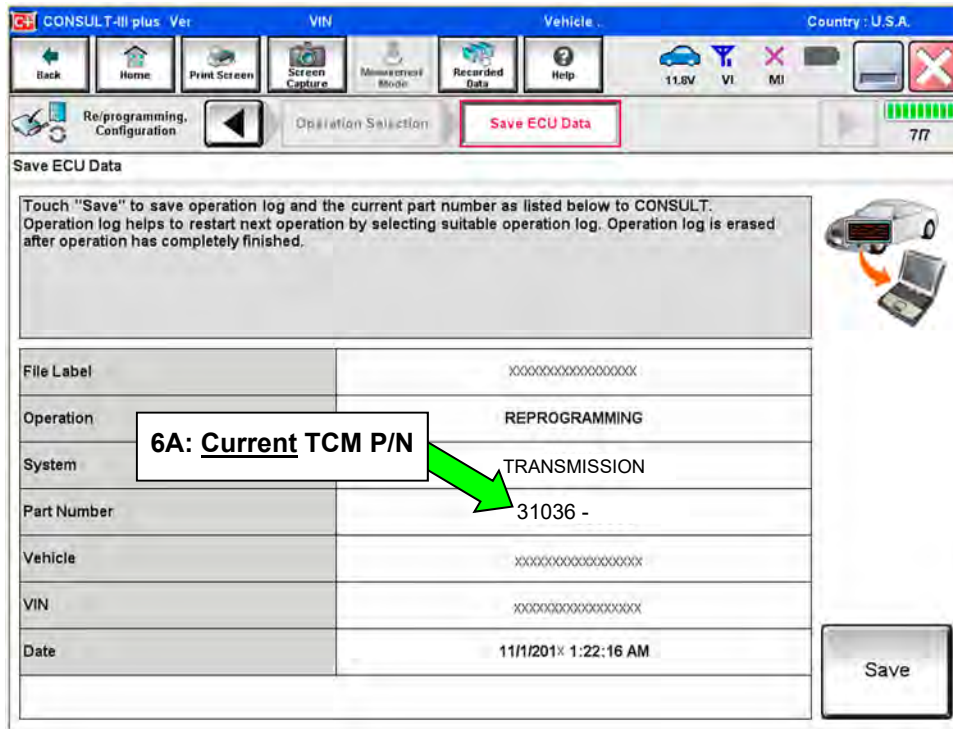
6. When you get to the screen shown in Figure 2, confirm this bulletin applies as follows.

A. Find the TCM **Part Number** and write it on the repair order.

NOTE: This is the current TCM Part Number (P/N).

5. Follow the on-screen instructions and navigate the C-III plus to the screen shown in Figure 2 on the next page.

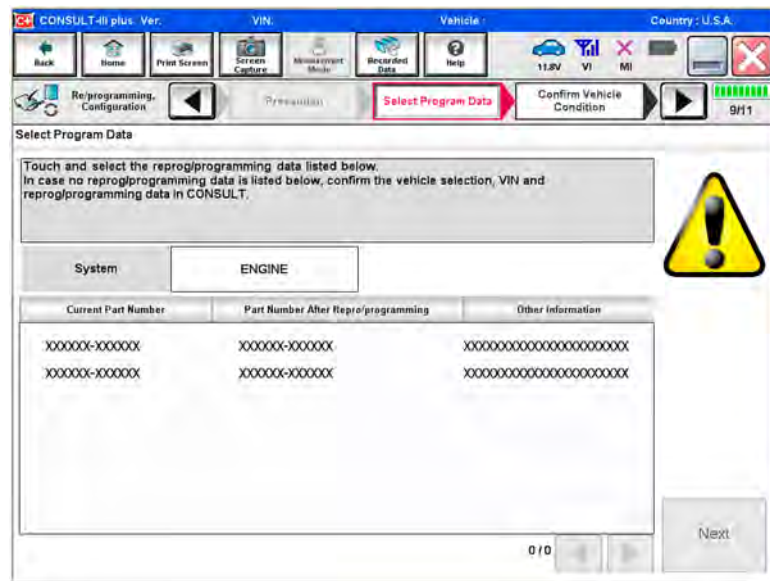
- In some cases, more than one new P/N for reprogramming is available.
 - If there is more than one new P/N, the screen in Figure 3 displays.
 - Select and use the reprogramming option that **does not** have the message “Caution! Use ONLY with NTBXX-XXX”.
- If you get this screen and it is blank (no reprogramming listed), it means there is no reprogramming available for this vehicle.

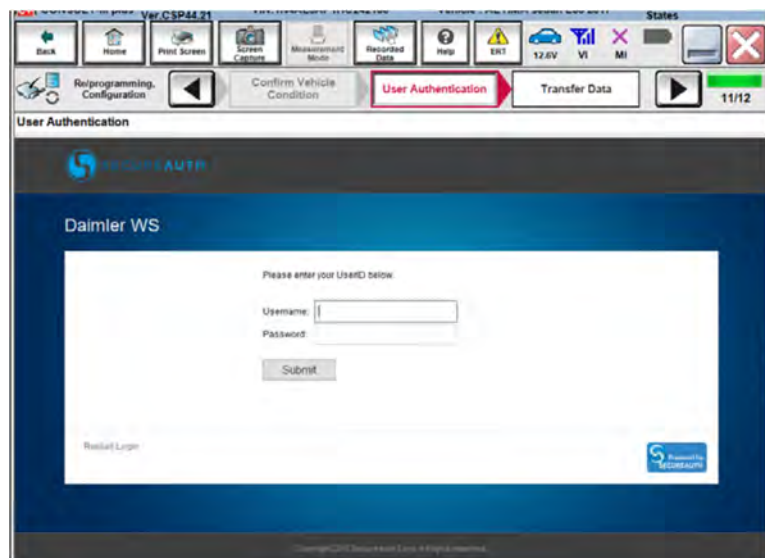
Figure 4

- Before reprogramming will start, you will be required to enter your User Name and Password.
 - The CONSULT PC must be connected to the Internet (Wi-Fi or cable).
 - If you do not know your User Name and Password, contact your Service Manager.

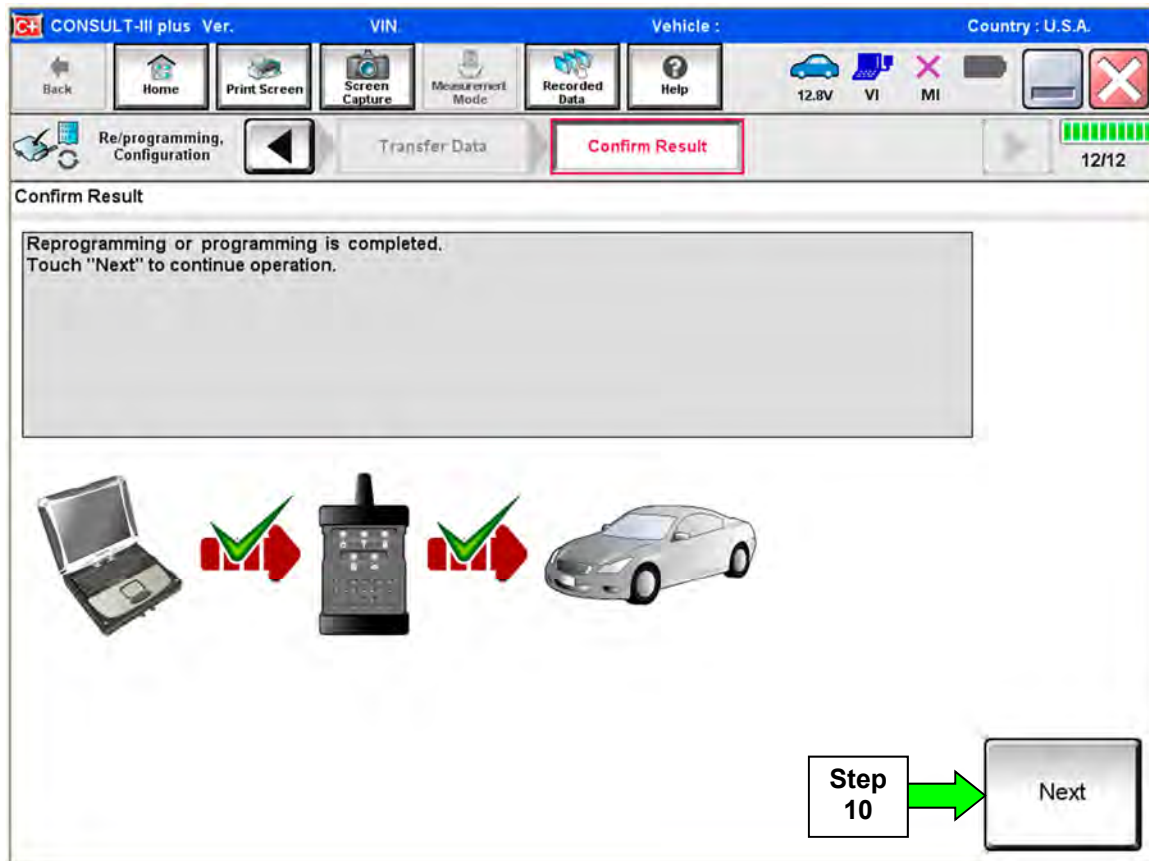
8. When the screen in Figure 5 displays, reprogramming is complete.

NOTE: If the screen in Figure 5 does not display (indicating that reprogramming did not complete), refer to the information on the next page.

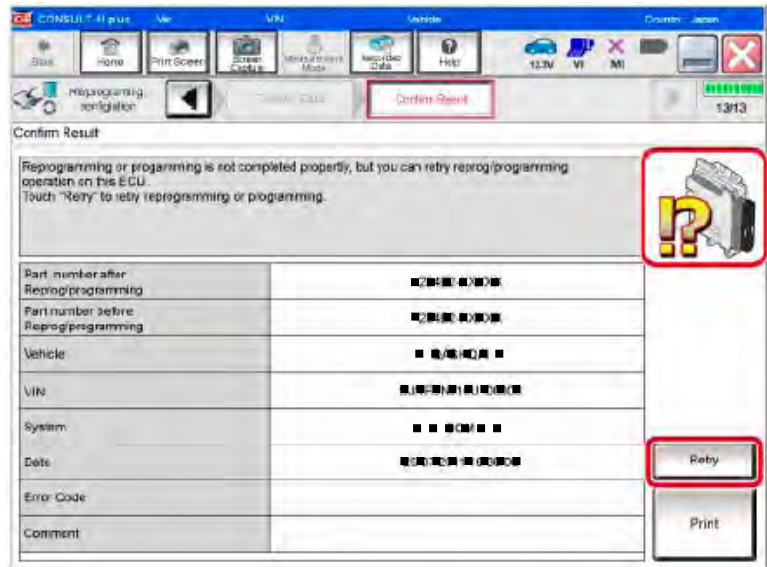
Figure 6

If reprogramming does not complete and the “!?” icon displays as shown in Figure 6:

- Check battery voltage (12.0–15.5 V).
- Ignition is ON, engine OFF.
- External Bluetooth® devices are OFF.
- All electrical loads are OFF.
- **Select retry and follow the on screen instructions.**
- “Retry” may not go through on first attempt and can be selected more than once.

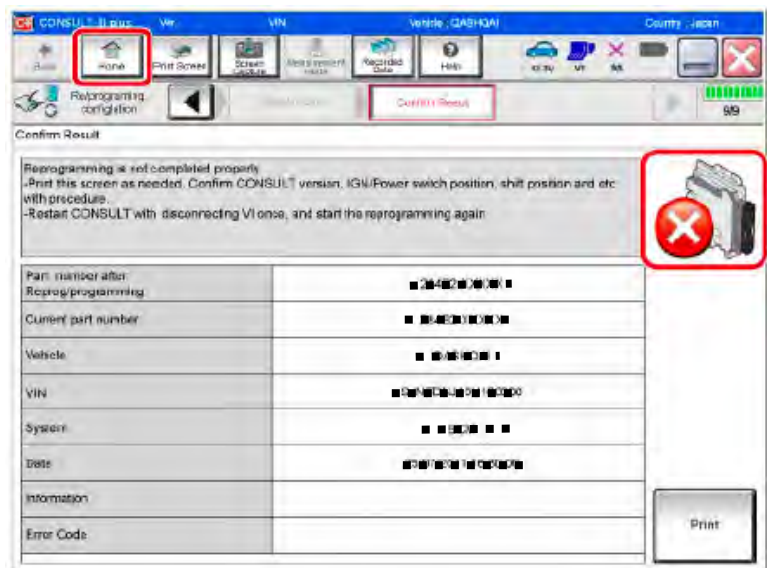
Figure 7

If reprogramming does not complete and the “X” icon displays as shown in Figure 7:

- Check battery voltage (12.0 – 15.5 V).
- CONSULT A/C adapter is plugged in.
- Ignition is ON, engine OFF.
- Transmission is in Park.
- All C-III plus / plus VI cables are securely connected.
- All C-III plus updates are installed.
- **Select Home, and restart the reprogram procedure from the beginning.**

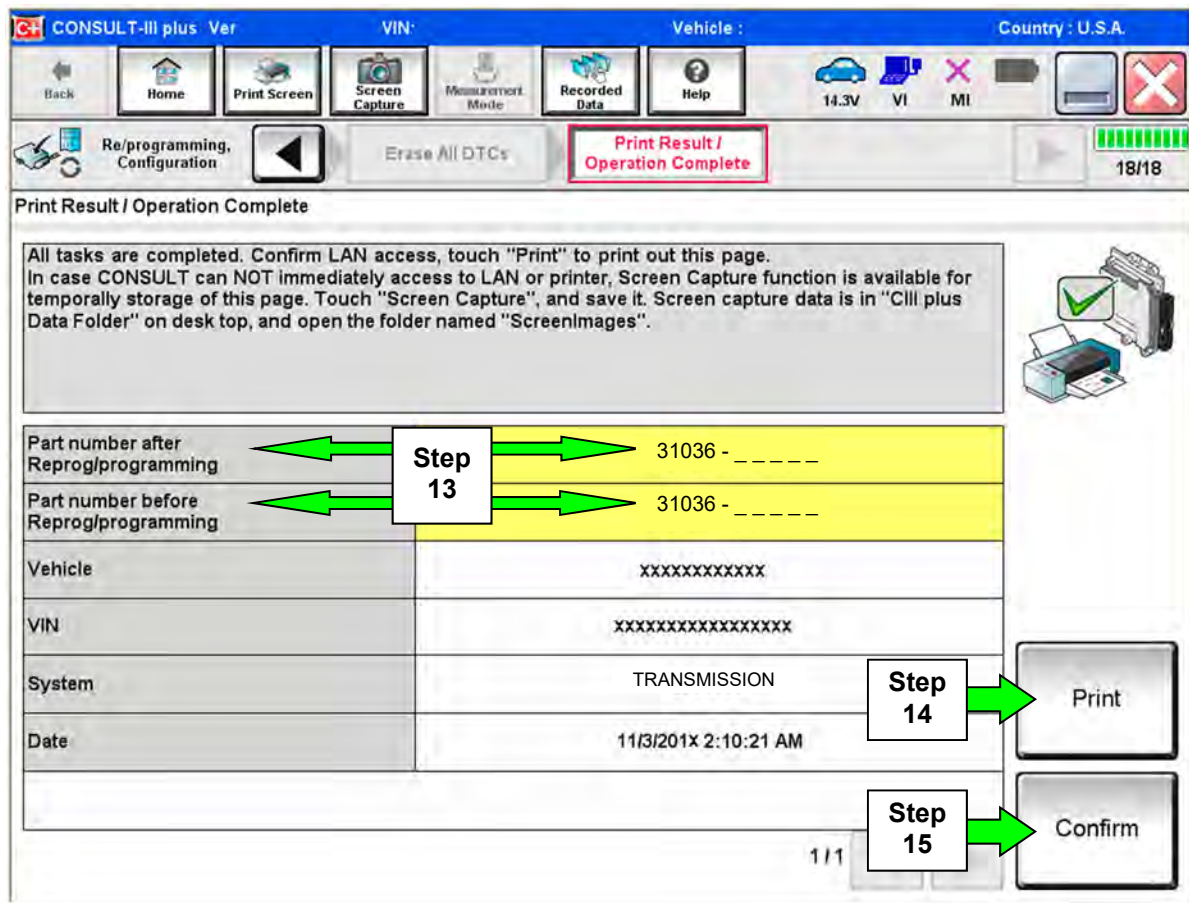
11. Follow the on-screen instructions to **Erase All DTCs**.
12. When the entire reprogramming process is complete, the screen in Figure 8 will display.
13. Verify the before and after part numbers are different.
14. Print a copy of this screen (Figure 8) and attach it to the repair order for warranty documentation.
15. Select **Confirm**.
