**Product Update: MID Shows BATTERY CHARGE LOW or bATT LOW**

(Supersedes 11-073, dated December 13, 2011, to revise the information marked with the black bar)

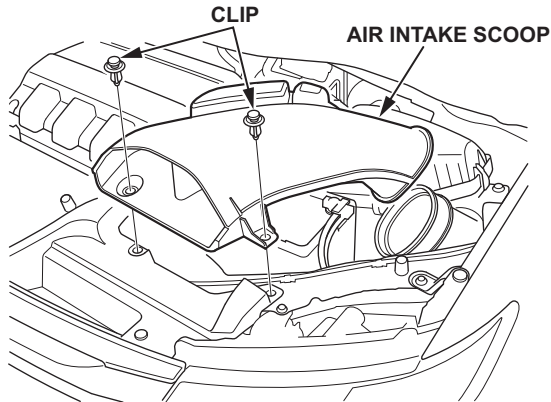
1. Turn the ignition switch to LOCK(0).
2. Remove the air intake scoop.

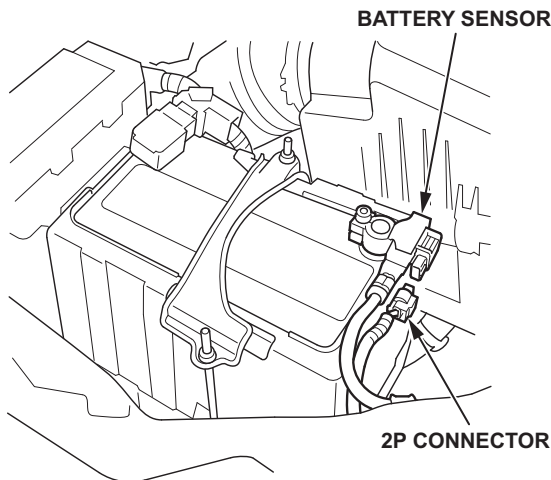
3. Disconnect the battery sensor 2P connector.

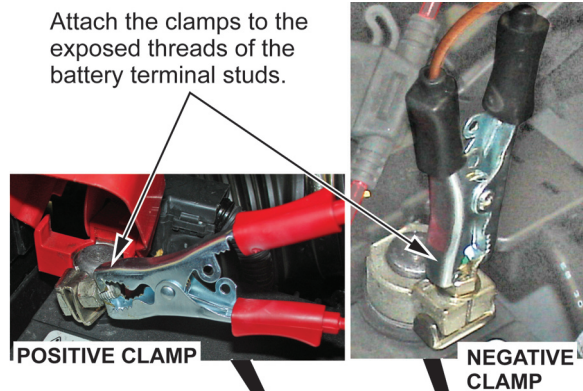
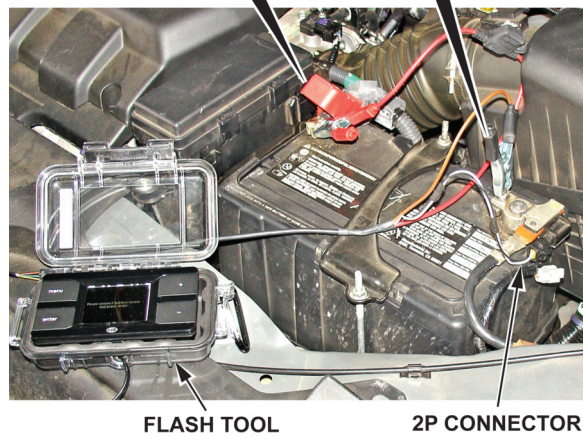
4. Connect the Flash Pack tool's positive clamp, then connect the negative clamp to the corresponding battery terminal studs.

NOTE: Make sure the clamps are securely on the battery studs. If the clamps slip off while updating the software, the battery sensor will be damaged.

Attach the clamps to the exposed threads of the battery terminal studs.
