Radar and/or Advanced Drive Assist System (ADAS) Reprogram

Reference: PC637
Date: August 17, 2018

PC637 – ROGUE/ROGUE HYBRID RADAR & ADAS REPROGRAM

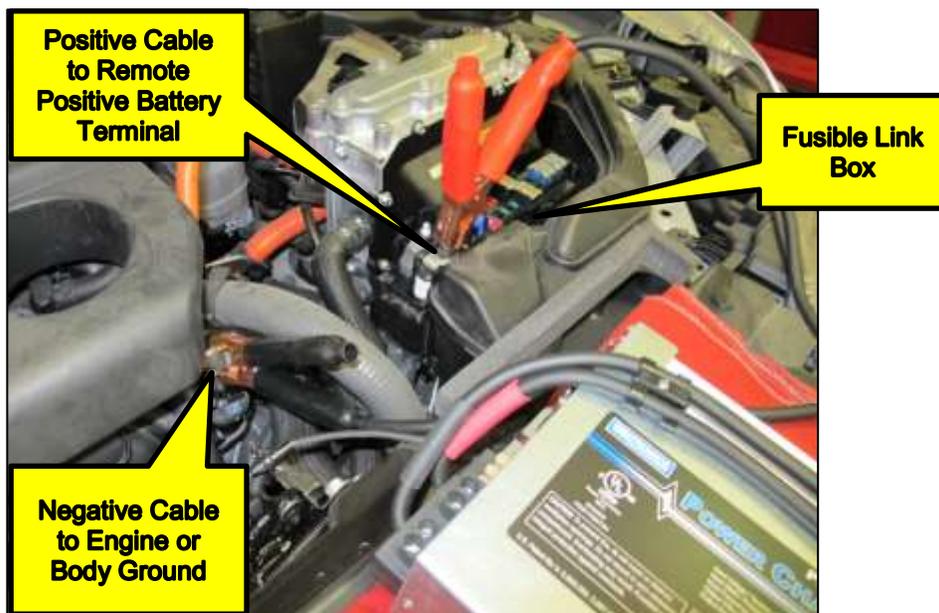
Figure 1

3a. Hybrid Vehicle GR-8 set-up:

- Locate the fusible link box behind the engine cleaner.
- Push the tab in and lift up to remove the lid and expose the remote positive battery terminal.
- Connect GR-8 Positive cable to remote positive 12V battery terminal.
- Connect GR-8 Negative cable to engine or body ground.

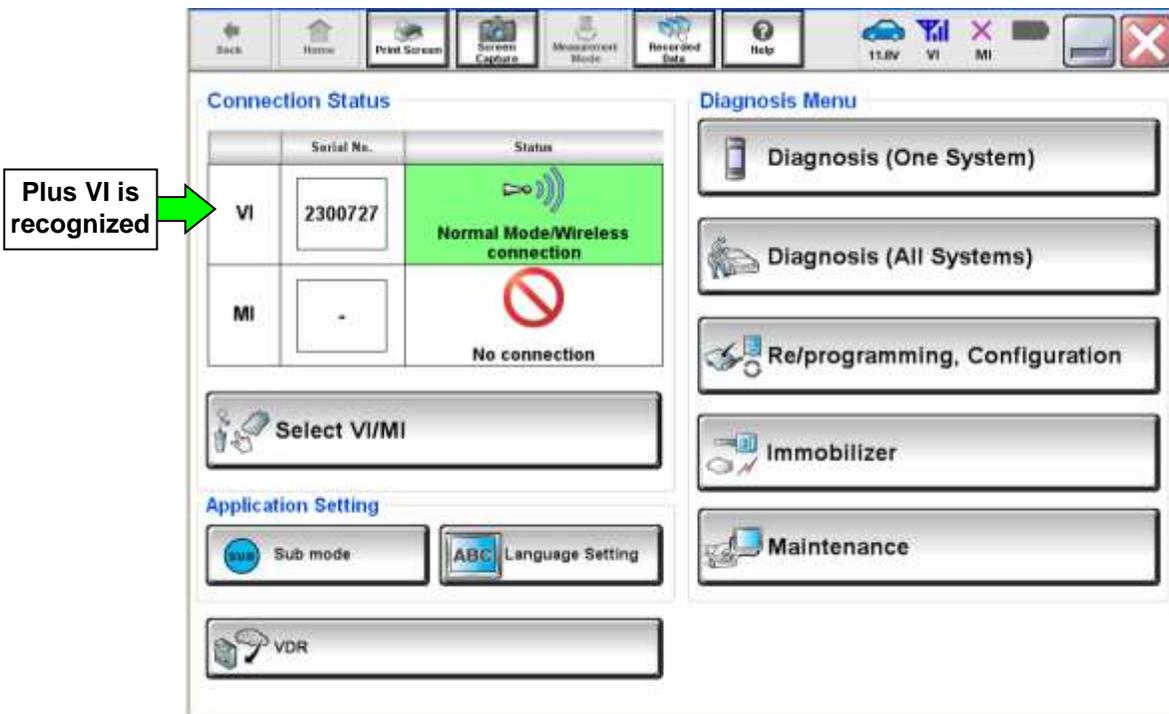
Figure 2

9. Wait for the plus VI to be recognized.
 - Serial number will display when the plus VI is recognized.

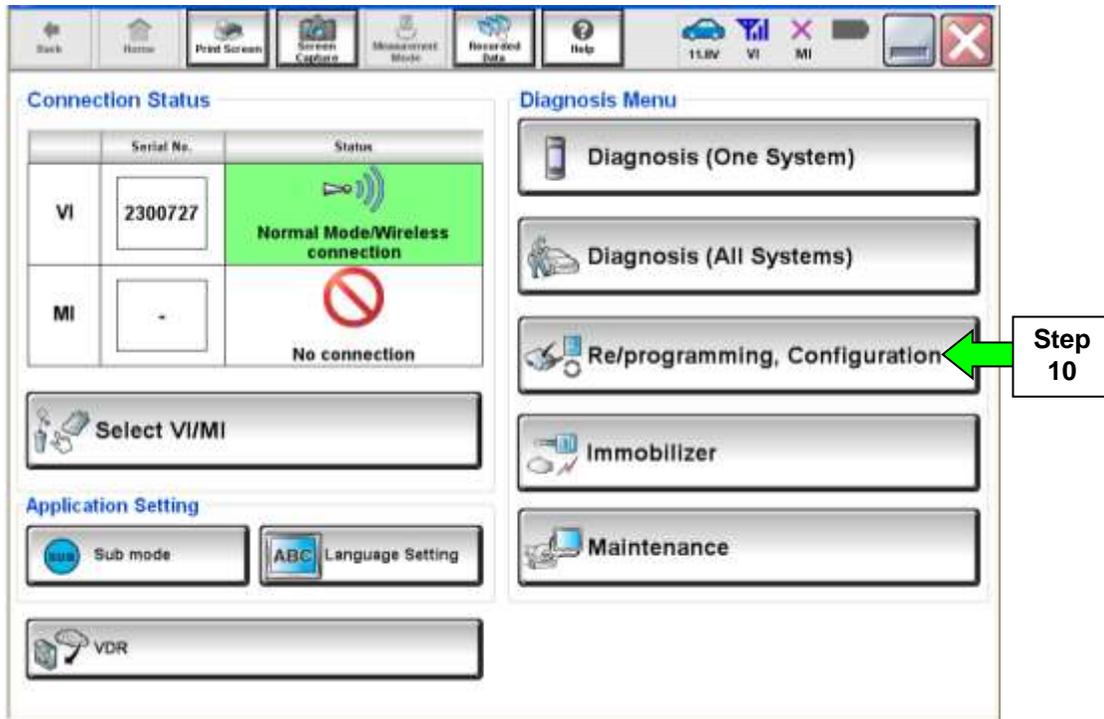
Figure 3

10. Select **Re/programming, Configuration**.

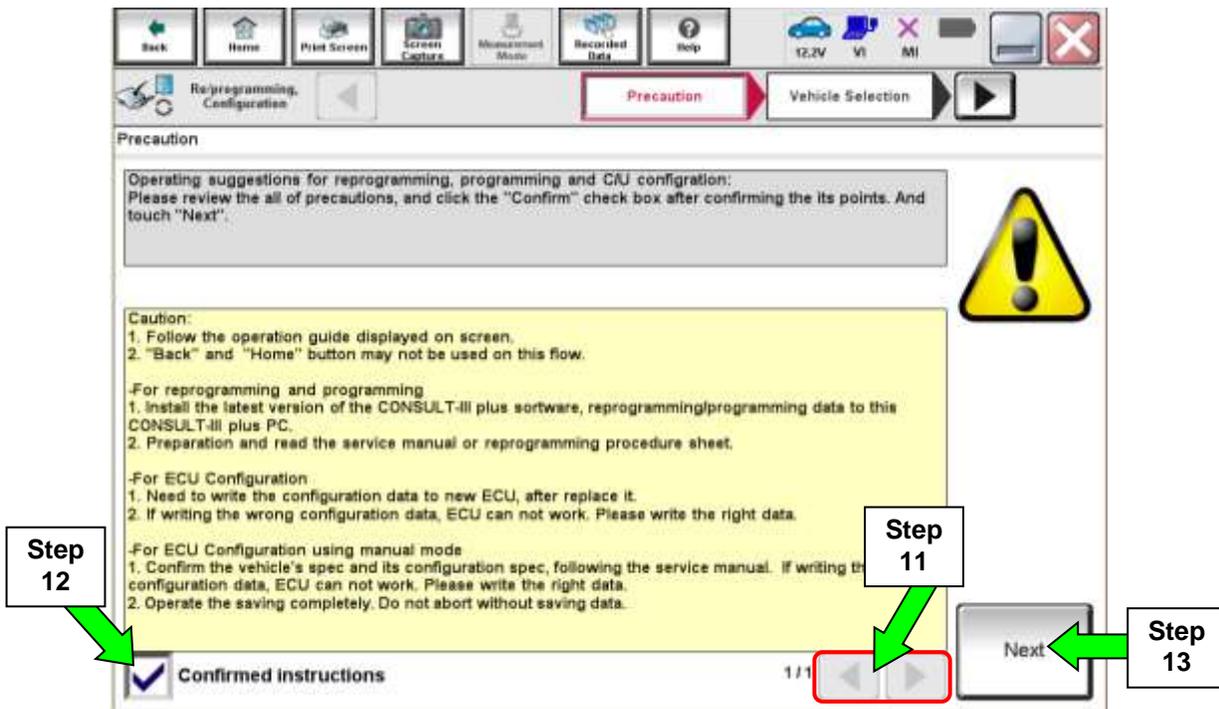
Figure 4

11. Use arrows (if needed) to view and read all precautions.

12. Check the box confirming the precautions have been read.

13. Select **Next**.

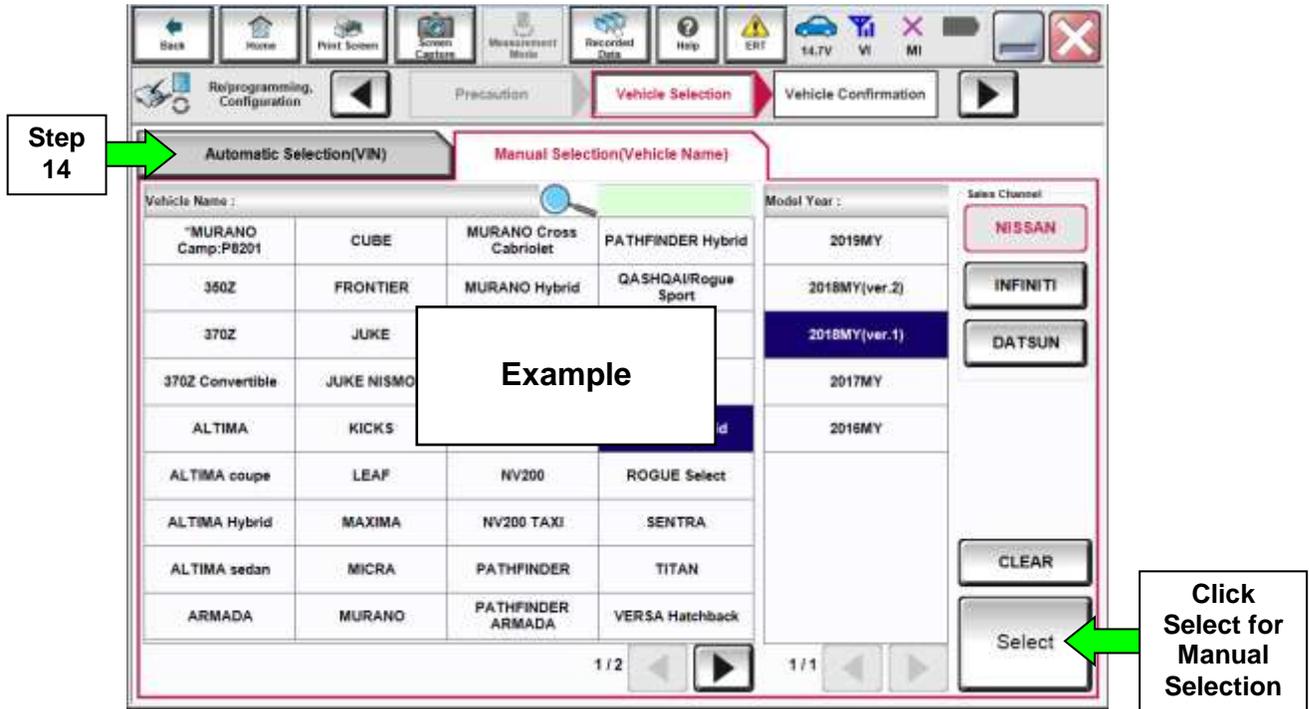
14. Select **Automatic Selection(VIN)**.

- If the screen in Figure 5 does not display, skip to step 15.
- Use **Manual Selection** if Automatic Selection does not pull VIN. Click Select.

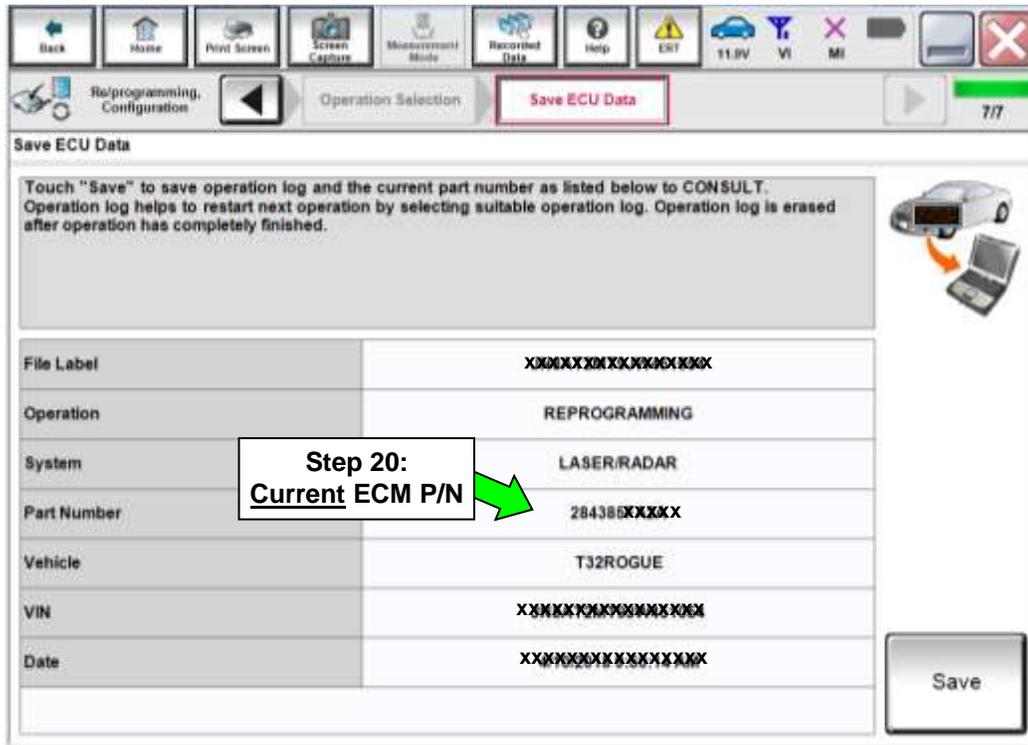
Figure 10

20. When you get to the screen shown in Figure 10, confirm that a reprogram or new control unit is available with the flow chart below.

Find the LASER/RADAR **Part Number** and write it on the repair order.

NOTE: This is the current LASER/RADAR Part Number (P/N).

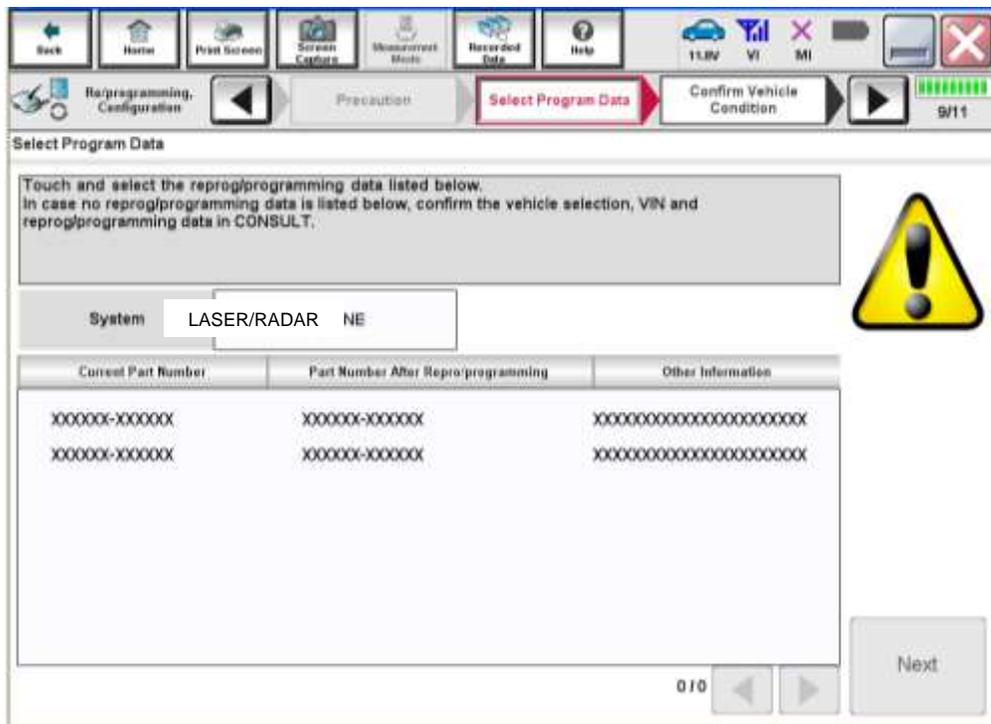
- In some cases, more than one new P/N for reprogramming is available.
 - If more than one new P/N is available, the screen in Figure 14 displays.
 - Select and use the reprogramming option that does **not** have the message “Caution! Use ONLY with NTBXX-XXX”.
- If you get this screen in Figure 14 and it is blank (no reprogramming listed), it means there is no reprogramming available for the Laser/Radar control unit in this vehicle. Proceed to **ICC/ADAS Reprogramming** on page 21.

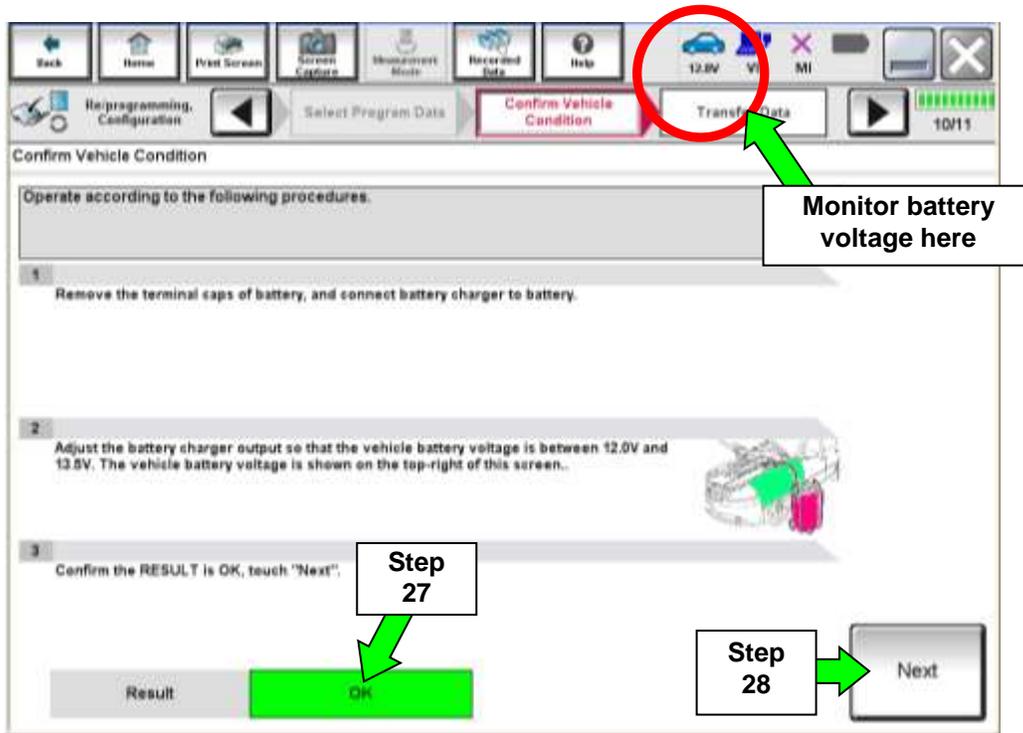
Figure 15

27. Make sure **OK** is highlighted **green** (battery voltage must be between 12.0 and 15.5 Volts).

IMPORTANT: Battery voltage must stay between 12.0 and 15.5 Volts during reprogramming or ECM reprogramming may be interrupted and ECM/TCM may be damaged.

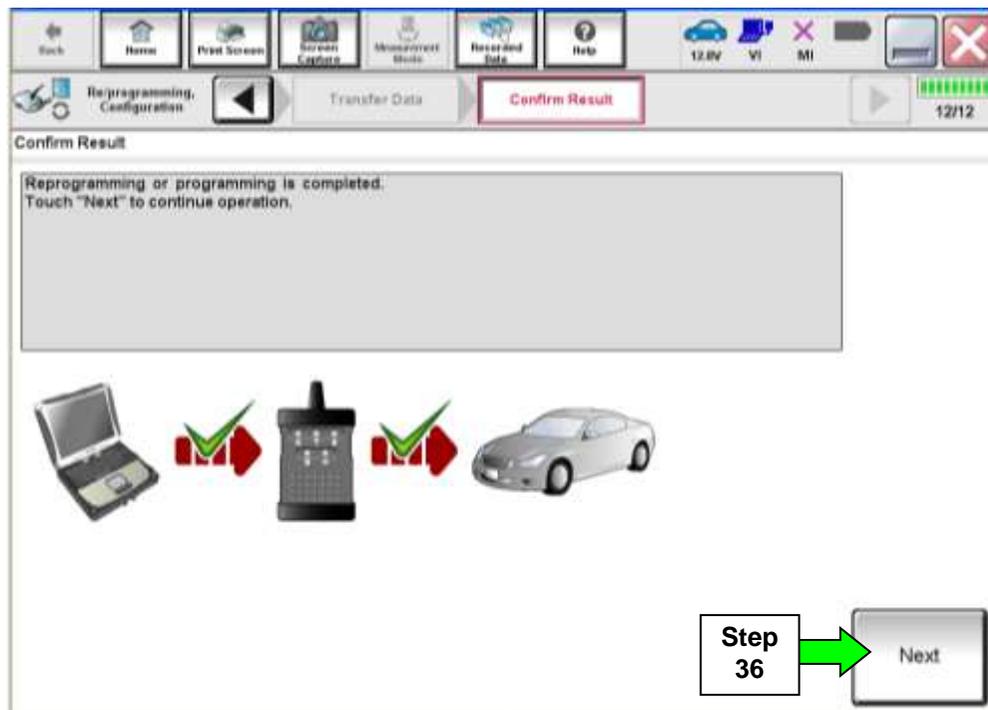
35. When the screen in Figure 21 displays, the reprogramming is complete.

NOTE: If the screen in Figure 21 does not display (indicating that reprogramming did not complete), refer to the information on the next page.

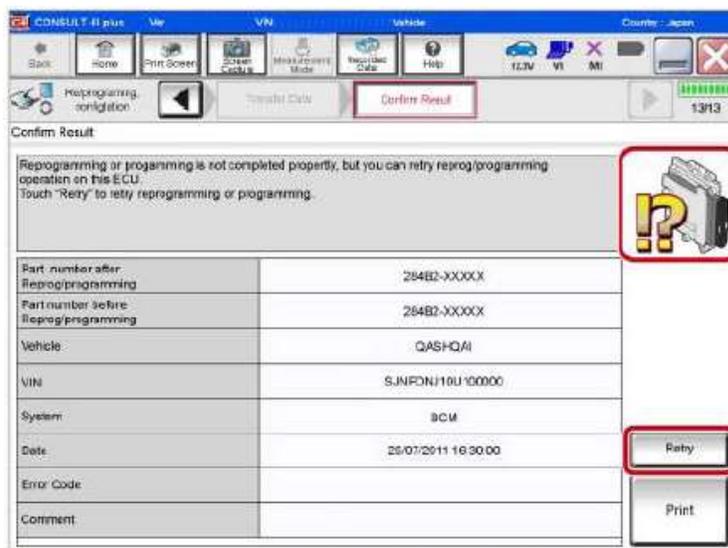
Figure 22

If reprogramming does not complete and the “!?” icon displays as shown in Figure 22:

- Check battery voltage (12.0 - 15.5 V).
- Ignition is ON, engine OFF.
- External Bluetooth® devices are OFF.
- All electrical loads are OFF.
- **Select retry and follow the on screen instructions.**
- “Retry” may not go through on first attempt and can be selected more than once.

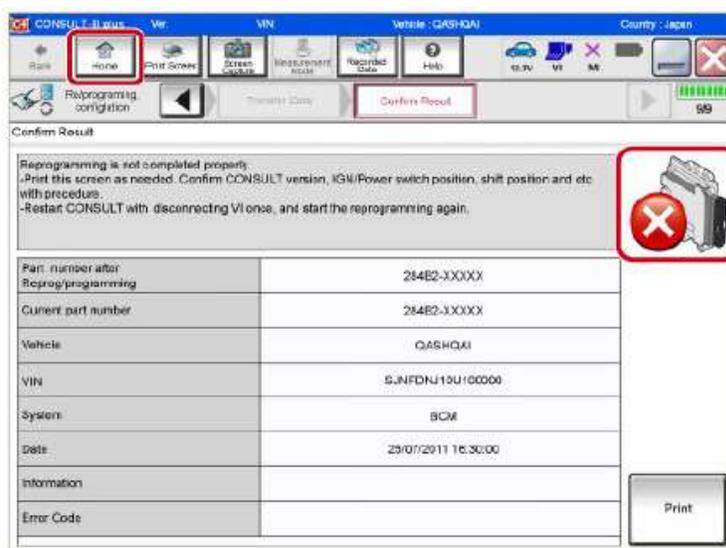
Figure 23

If reprogramming does not complete and the “X” icon displays as shown in Figure 23:

- Check battery voltage (12.0 - 15.5 V).
- CONSULT A/C adapter is plugged in.
- Ignition is ON, engine OFF.
- Transmission is in Park.
- All C-III plus / VI cables are securely connected.
- All C-III plus updates are installed.
- **Select Home, and restart the reprogram procedure from the beginning.**

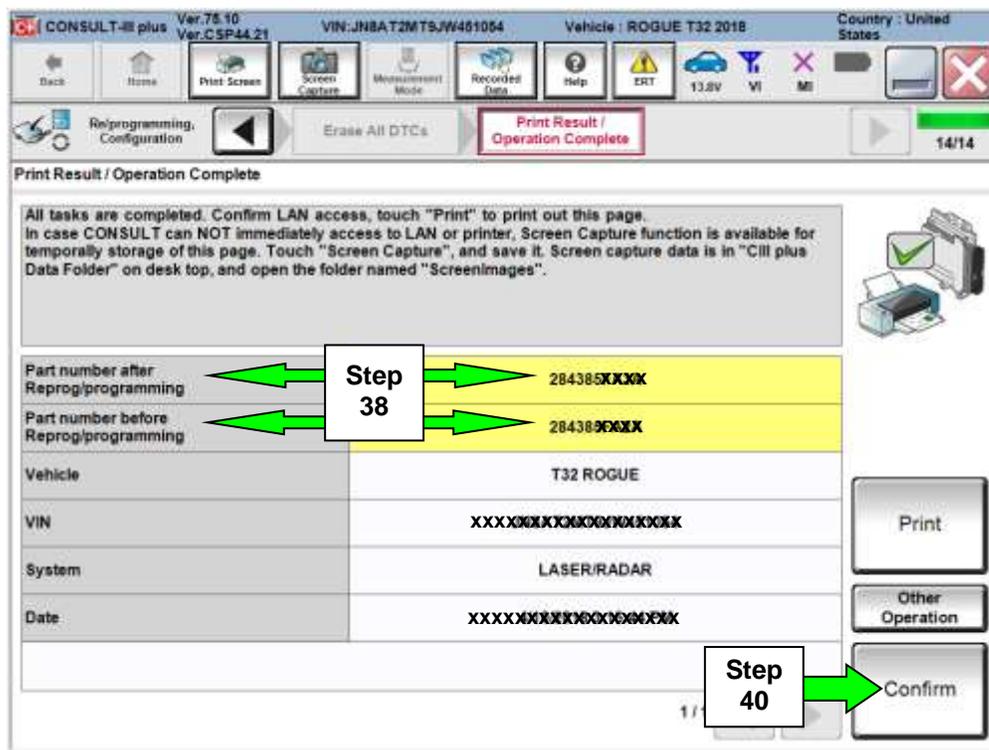
Figure 25

38. Verify the before and after part numbers are different.

39. Print a copy of this screen (Figure 25) and attach it to the repair order.

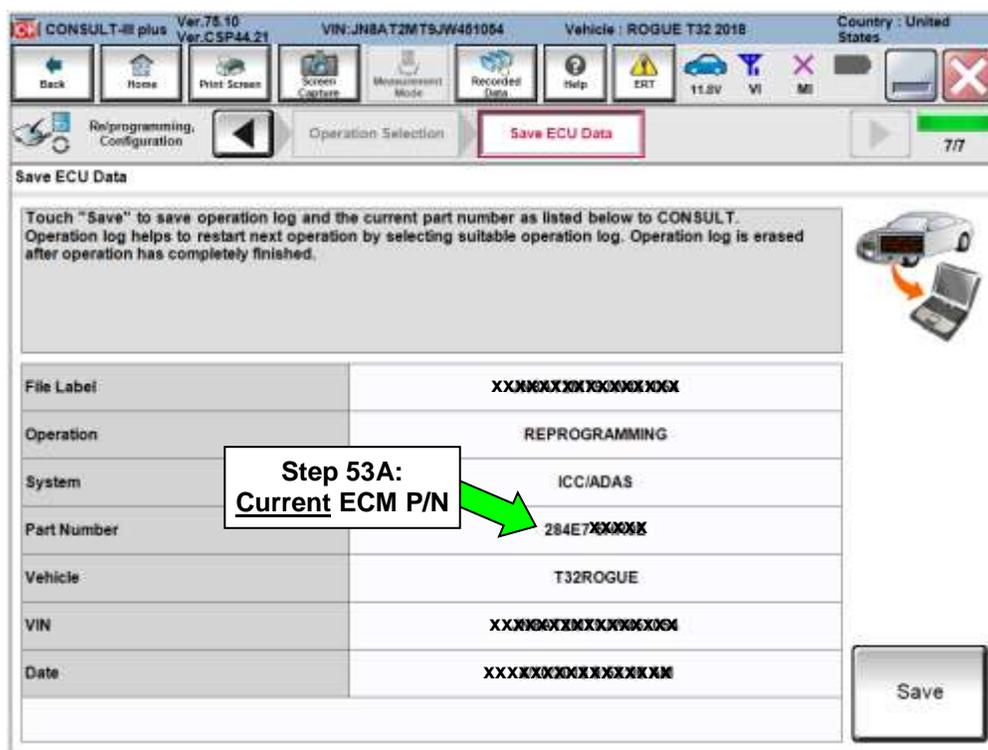
Figure 35

53. When you get to the screen shown in Figure 35, confirm that a reprogram is available as follows.

A. Find the ICC/ADAS **Part Number** and write it on the repair order.

NOTE: This is the current ICC/ADAS Part Number (P/N).

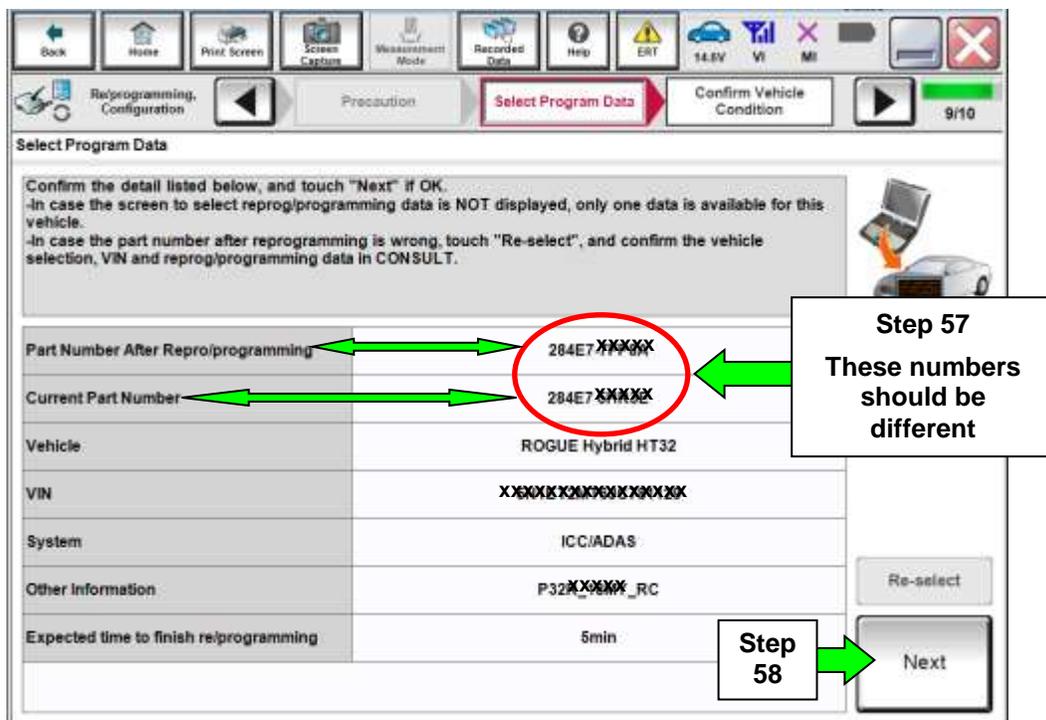
Figure 37

57. Read the **Current Part Number** and **Part Number After Reprogramming**. They should be different.

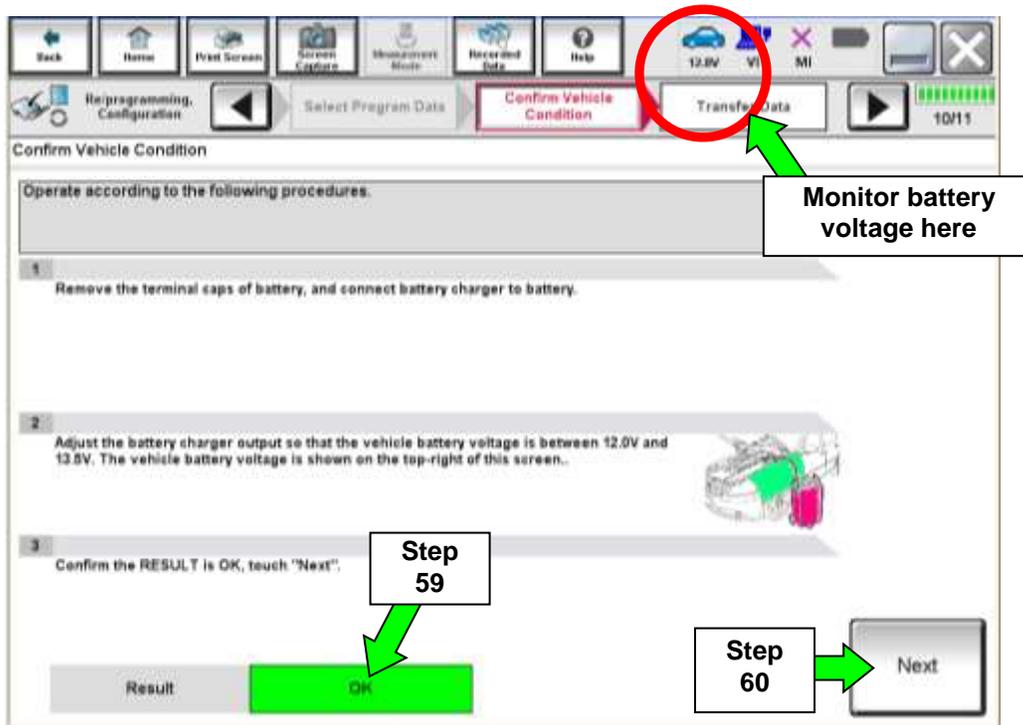
Figure 39

59. Make sure **OK** is highlighted **green** (battery voltage must be between 12.0 and 15.5 Volts).

IMPORTANT: Battery voltage must stay between 12.0 and 15.5 Volts during reprogramming or ECM reprogramming may be interrupted and ECM/TCM may be damaged.

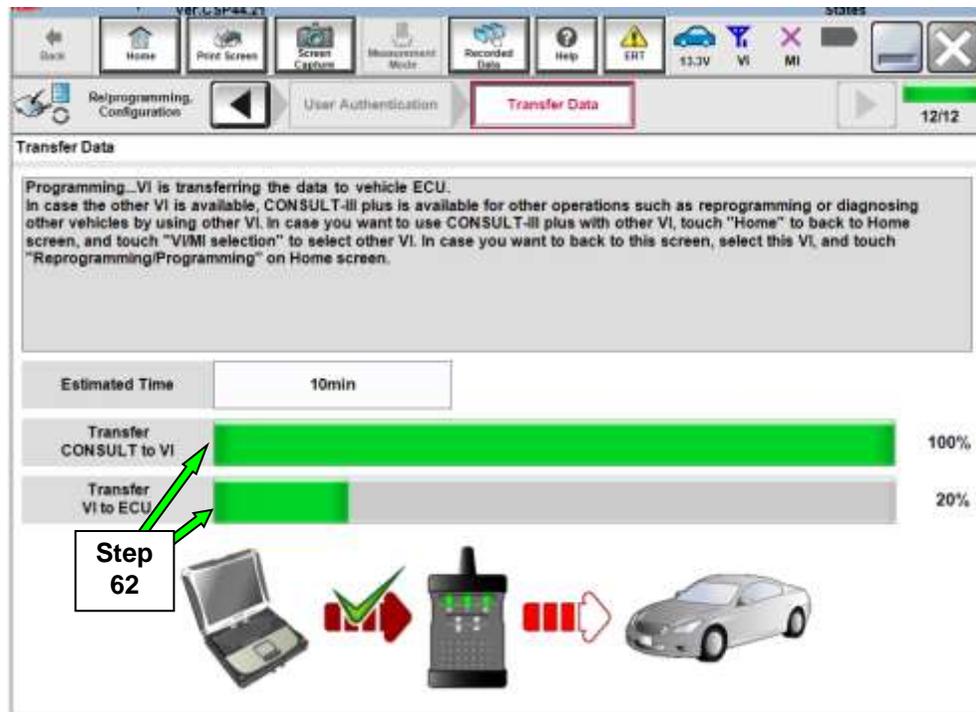
Figure 41

62. Wait for both progress bars to complete.

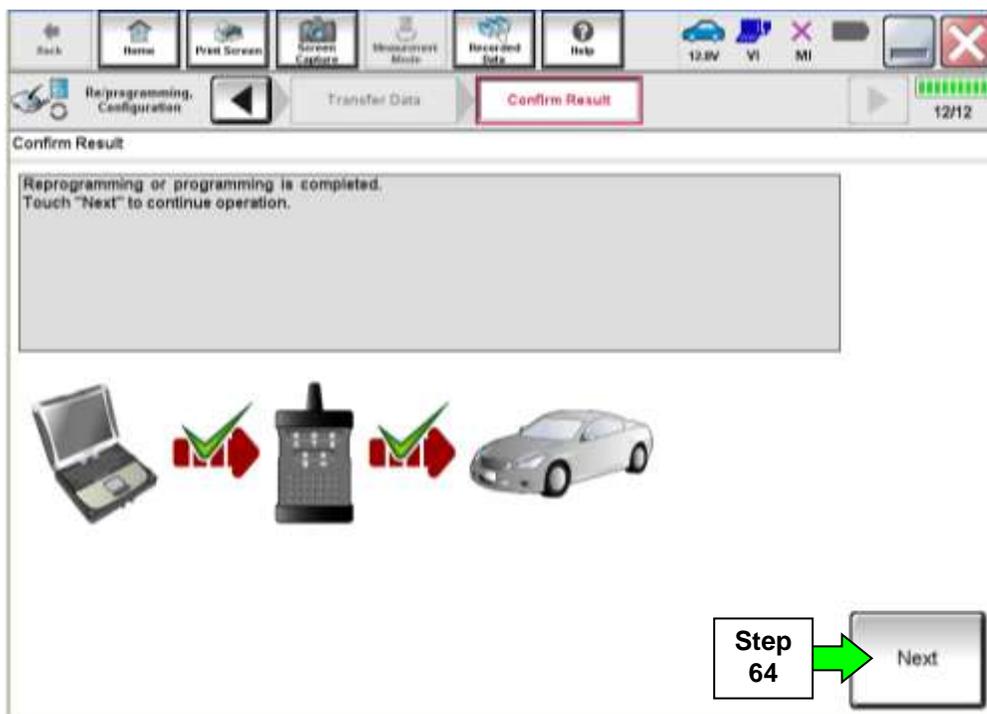
63. When the screen in Figure 42 displays, reprogramming is complete.

NOTE: If the screen in Figure 42 does not display (indicating that reprogramming did not complete), refer to ICC/ADAS recovery on the next page.

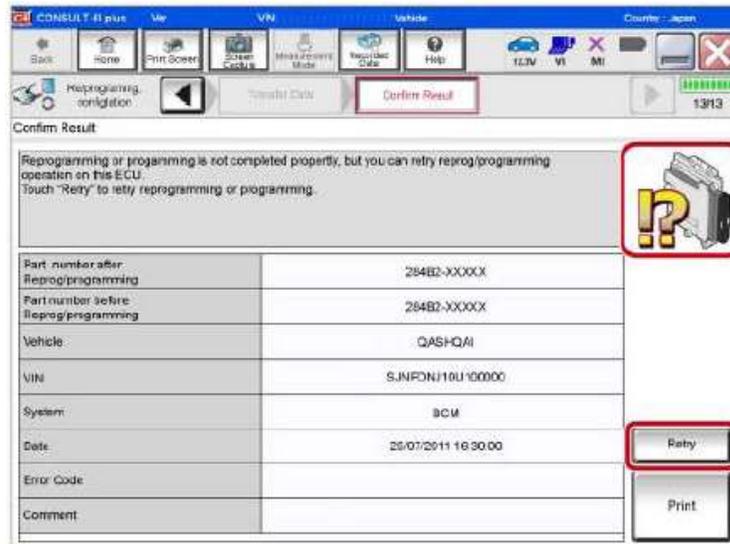
Figure 43

If reprogramming does not complete and the “!?” icon displays as shown in Figure 43:

- Check battery voltage (12.0 - 15.5 V).
- Ignition is ON, engine OFF.
- External Bluetooth® devices are OFF.
- All electrical loads are OFF.
- **Select retry and follow the on screen instructions.**
- **“Retry” may not go through on first attempt and can be selected more than once.**

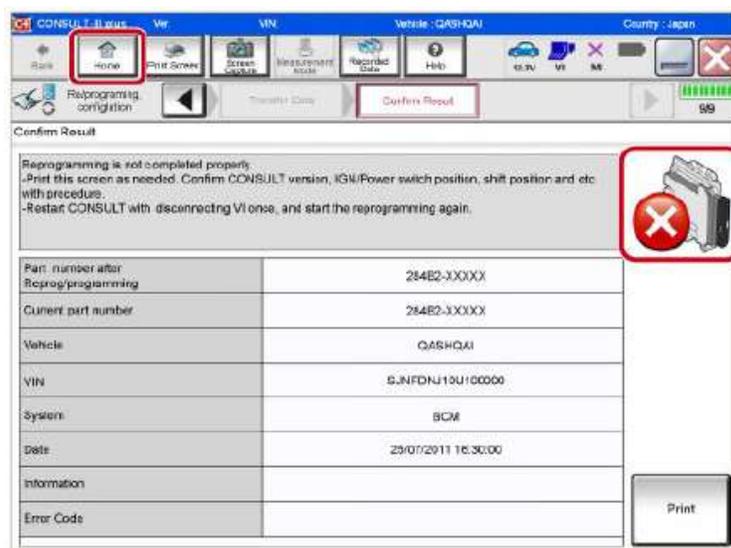
Figure 44

If reprogramming does not complete and the “X” icon displays as shown in Figure 44:

- Check battery voltage (12.0 - 15.5 V).
- CONSULT A/C adapter is plugged in.
- Ignition is ON, engine OFF.
- Transmission is in Park.
- All C-III plus / VI cables are securely connected.
- All C-III plus updates are installed.
- **Select Home, and restart the reprogram procedure from the beginning.**

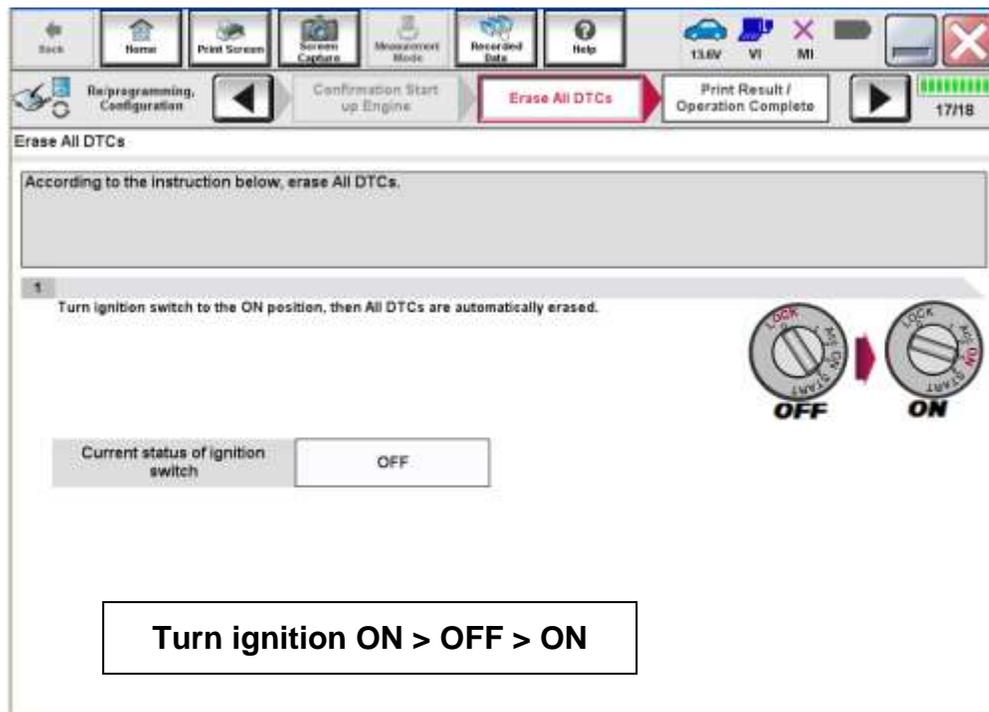
Figure 45

66. **Erase all DTCs** as follows:

- a. Turn the vehicle OFF.
- b. Turn the vehicle ON.
- c. Wait for DTC erase to complete.

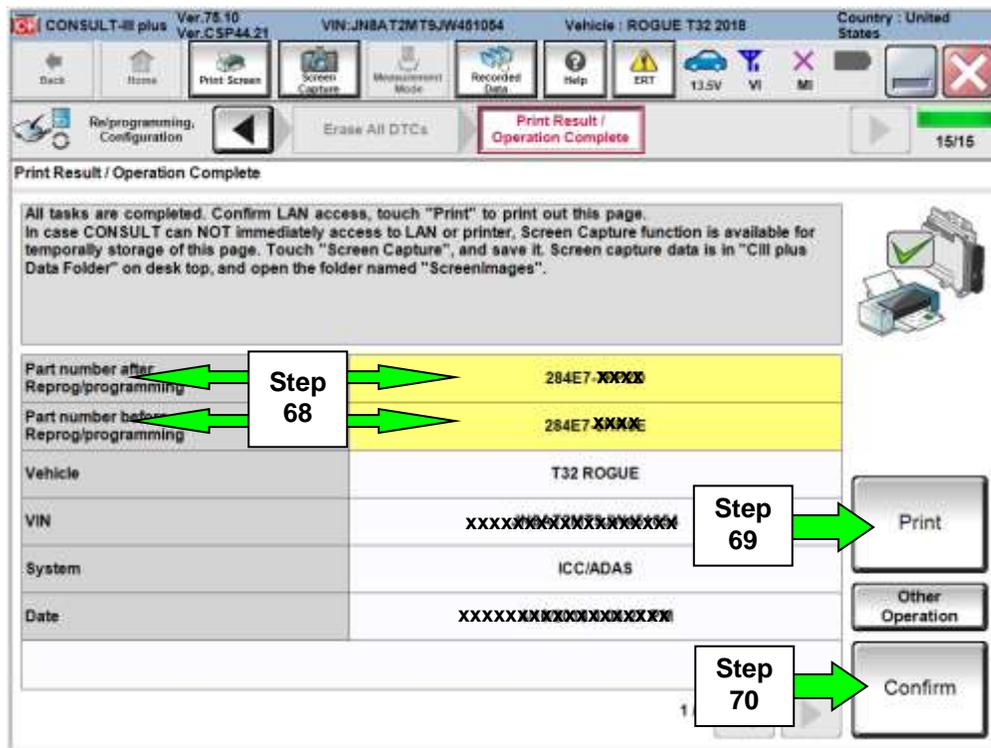
67. When the entire reprogramming process is complete, the screen in Figure 46 will display.

68. Verify the before and after part numbers are different.

69. Print a copy of this screen (Figure 46) and attach it to the repair order for warranty documentation.

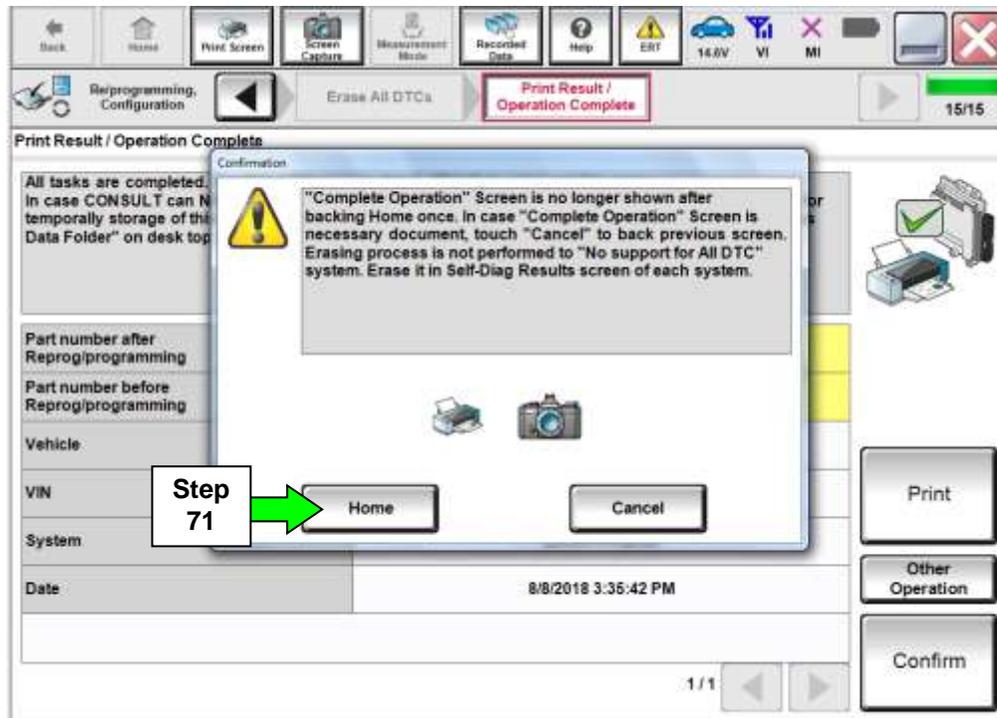
Figure 47

70. Select **Confirm**.

71. Select **Home**
