SERVICE BULLETIN

Classification: EL18-018b	Reference: NTB18-045b	Date: September 28, 2018
------------------------------	--------------------------	-----------------------------

2011-2015 LEAF; 12 VOLT BATTERY LOSES CHARGE AND/OR TELEMATICS SERVICES DO NOT WORK

APPLIED VEHICLES: 2011-2015 LEAF (ZE0)

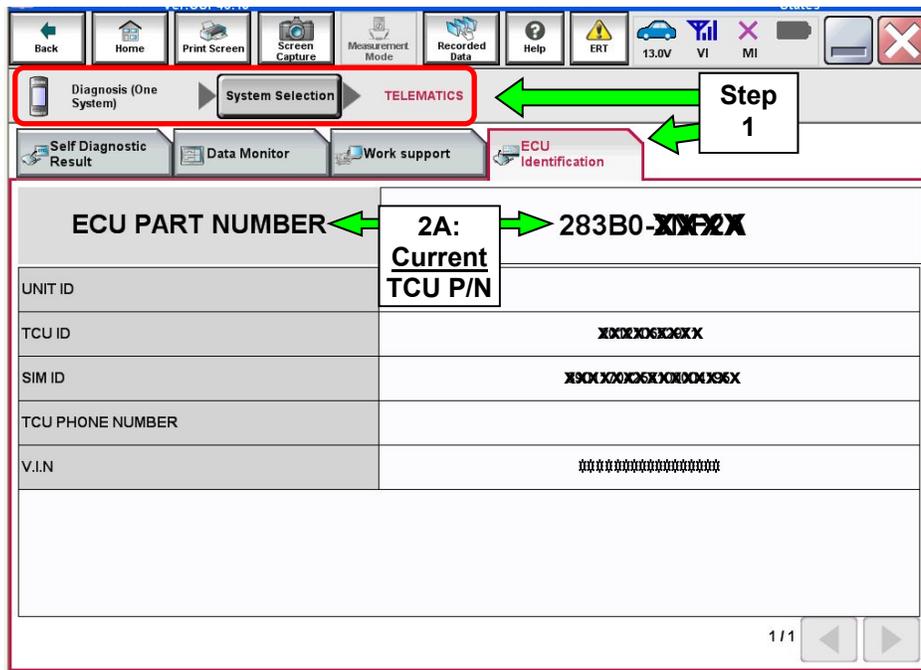
Figure 1

1. With CONSULT-III plus (C-III plus), go to **Diagnosis (One System) > System Selection > TELEMATICS > ECU identification**.
2. When you get to the screen shown in Figure 1, confirm this bulletin applies as follows.

A. Find the TCU **Part Number** and write it on the repair order.

NOTE: This is the current TCU Part Number (P/N).

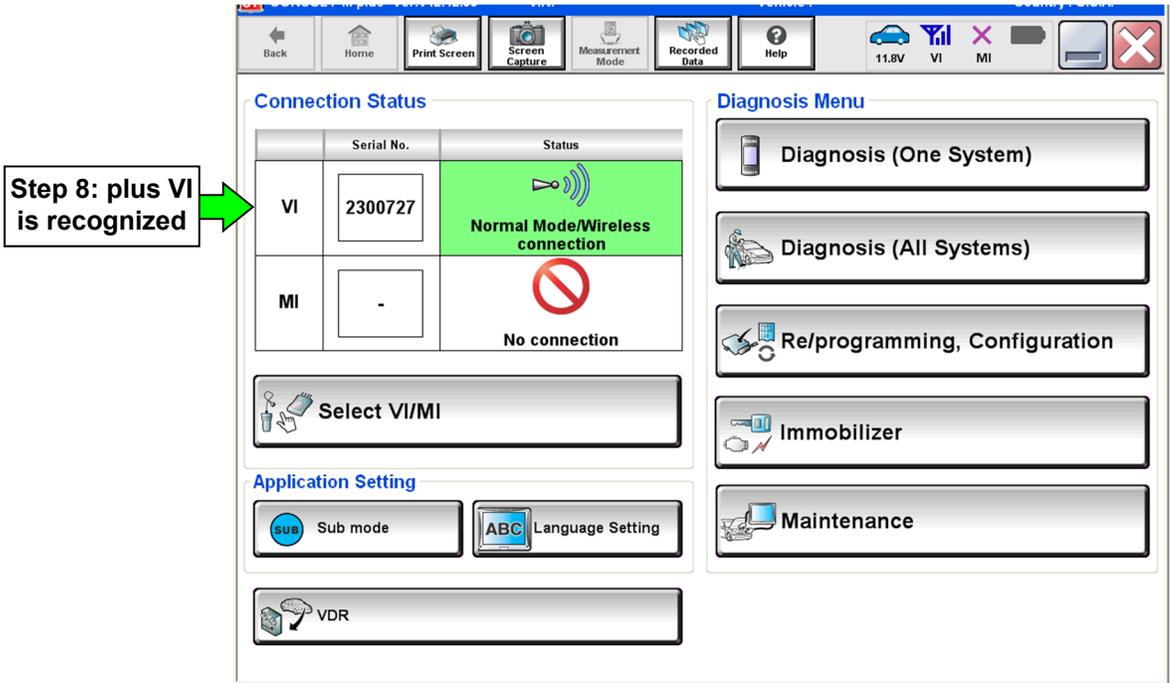
Figure 2

6. Turn ON the CONSULT PC.
7. Select (open) C-III plus.
8. Wait for the plus VI to be recognized.
 - The serial number (**Serial No.**) will display when the plus VI is recognized.

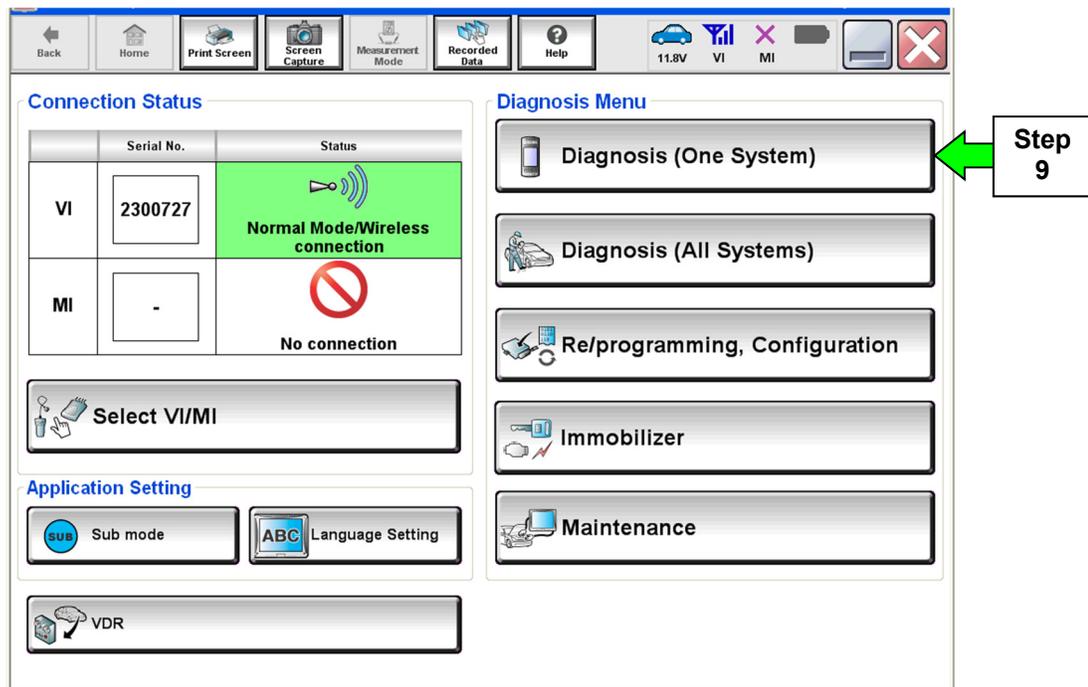
Figure 3

9. Select **Diagnosis (One System)**.

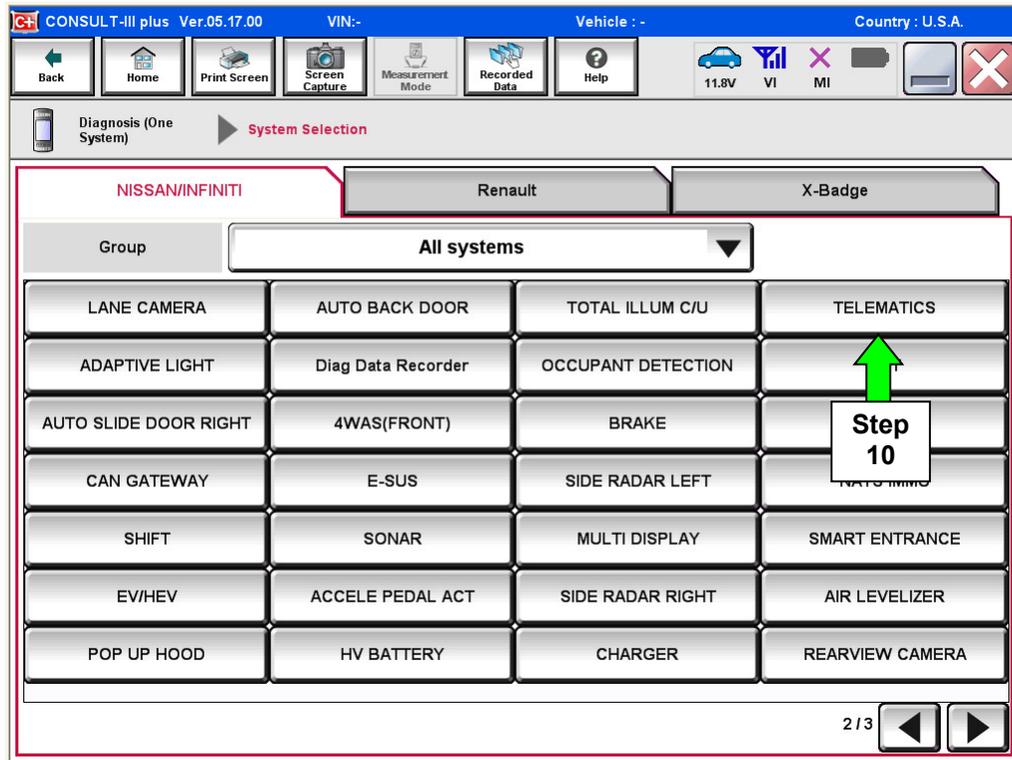
Figure 4

10. Select Telematics.

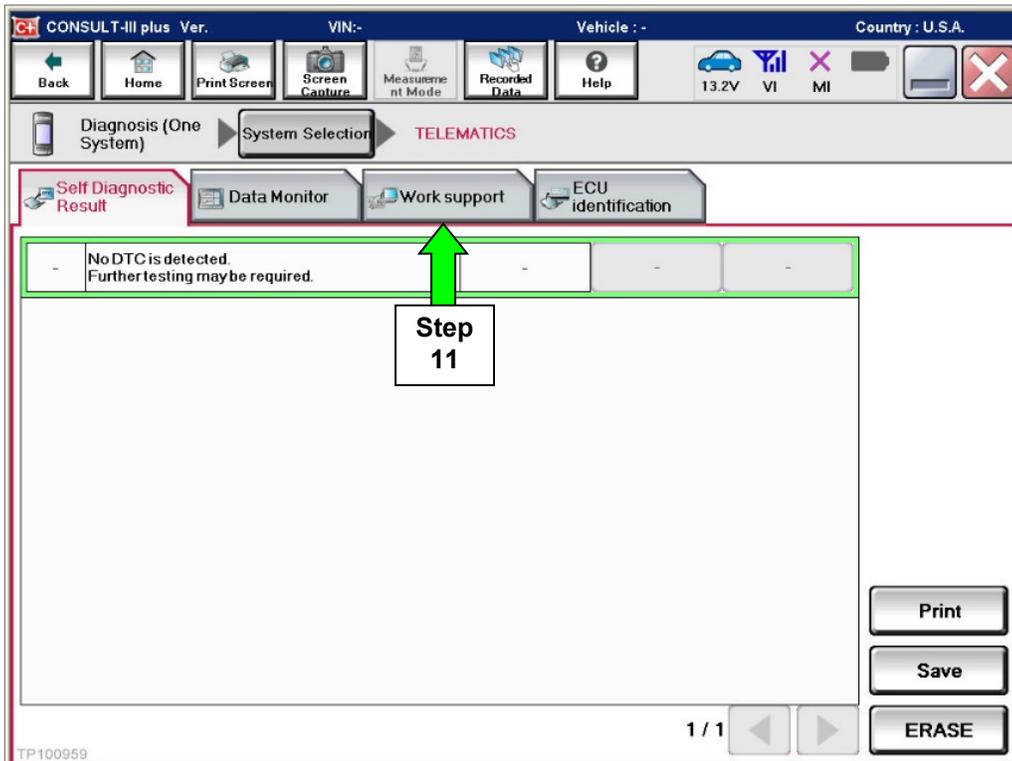
Figure 5

11. Select Work Support.

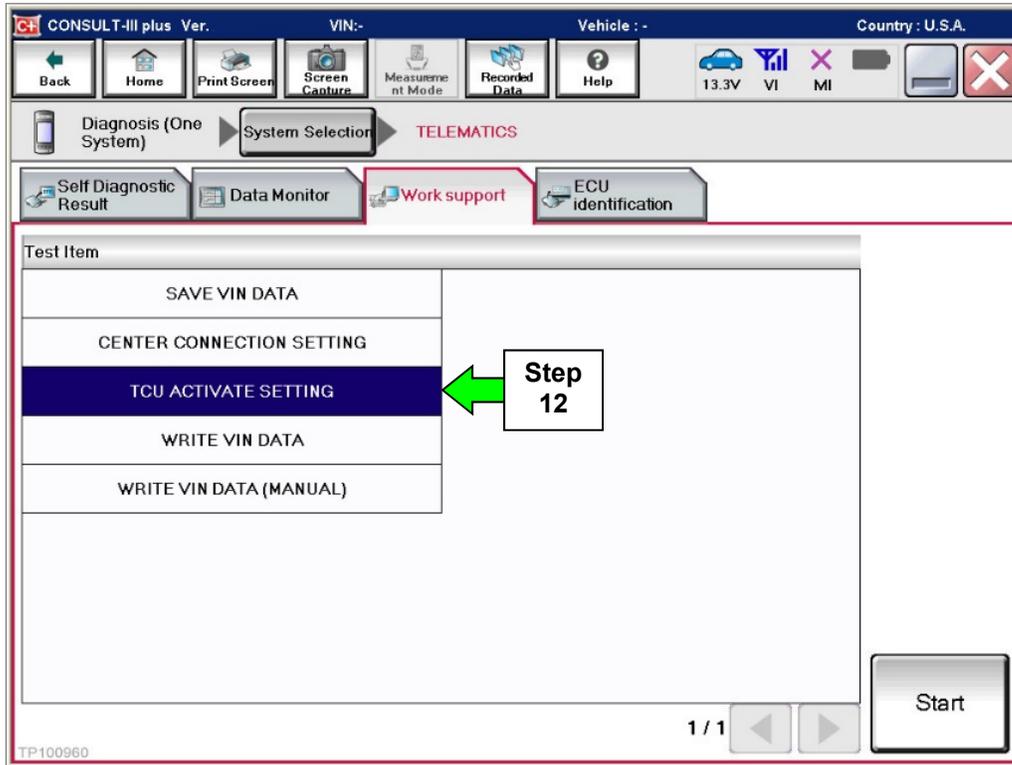
Figure 6

12. Select (highlight) **TCU ACTIVATE SETTING**.

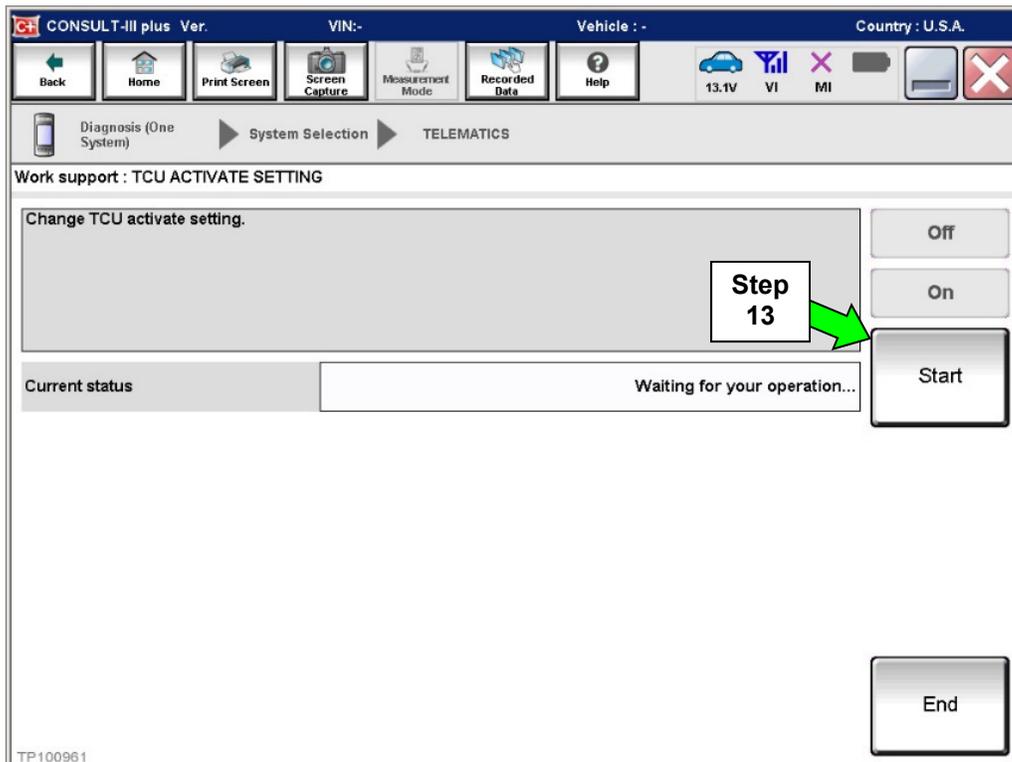
Figure 7

13. Select **Start**.

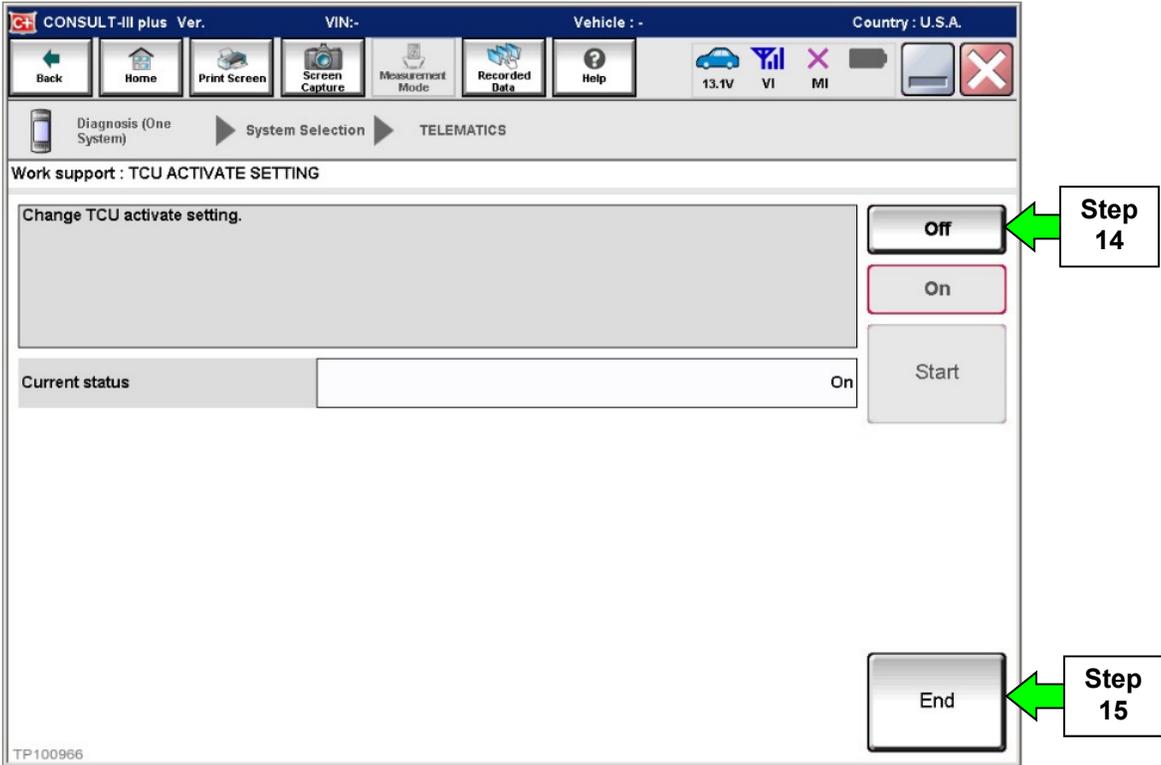
Figure 8

14. Select **OFF**.

15. Select **END**, and then wait 40 seconds.

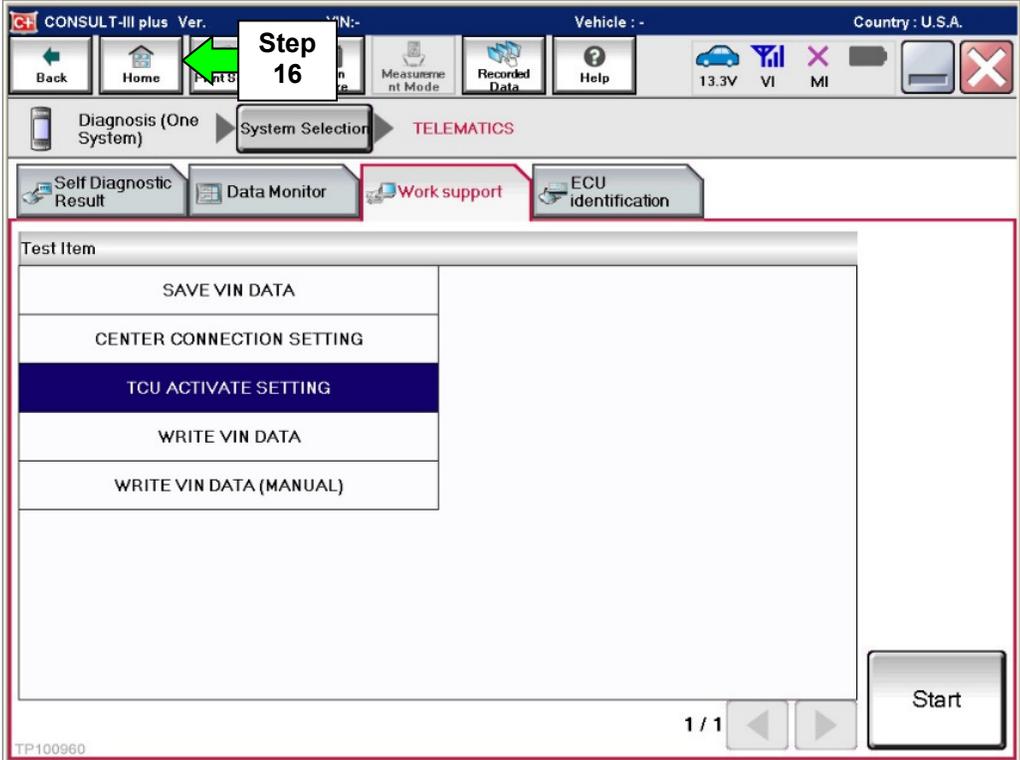
Figure 9

16. Select **Home**, and then go to the next page.

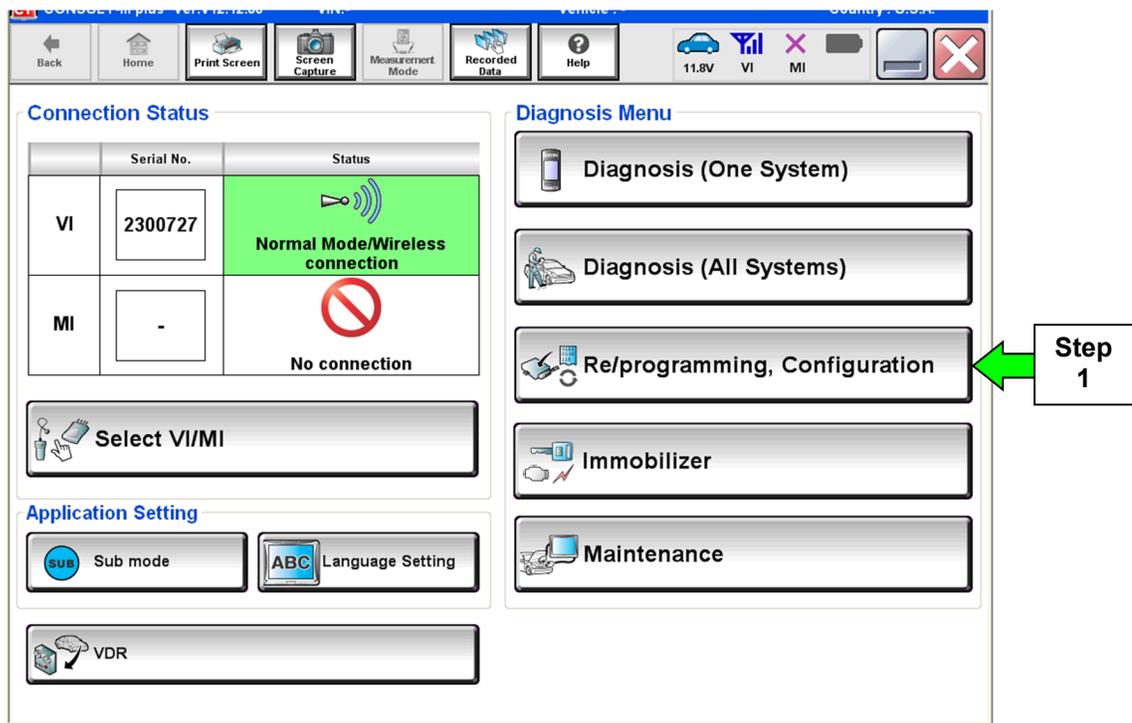
Figure 10

1. Select **Re/programming, Configuration**.

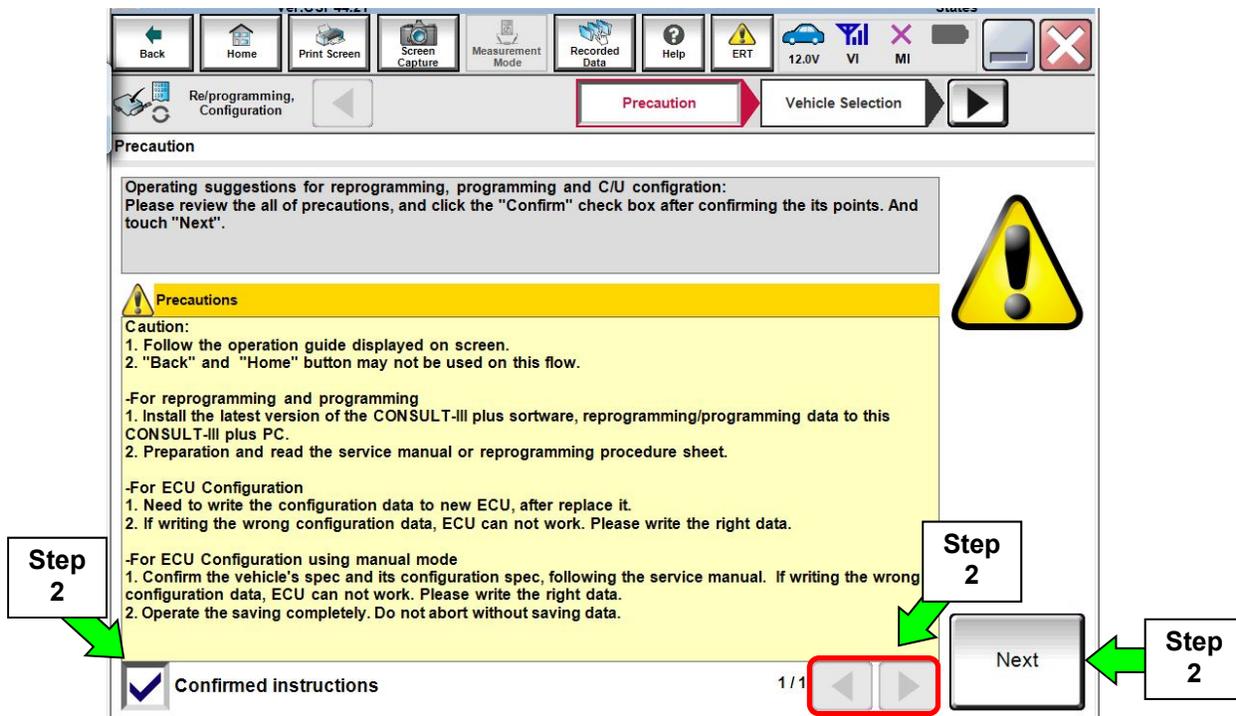
Figure 11

2. Use the arrows (if needed) to view and read all precautions, check the **Confirmed instructions** box, and then select **Next**.

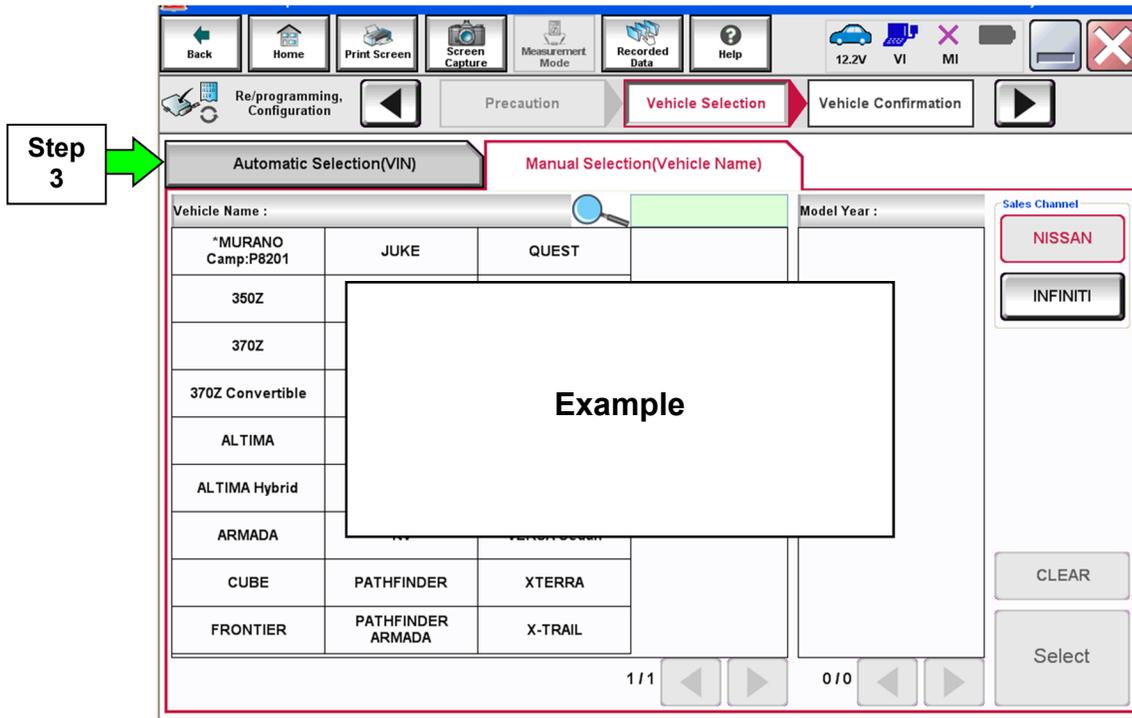
3. Select **Automatic Selection(VIN)**.

- If the screen in Figure 12 does not display, skip to step 4.

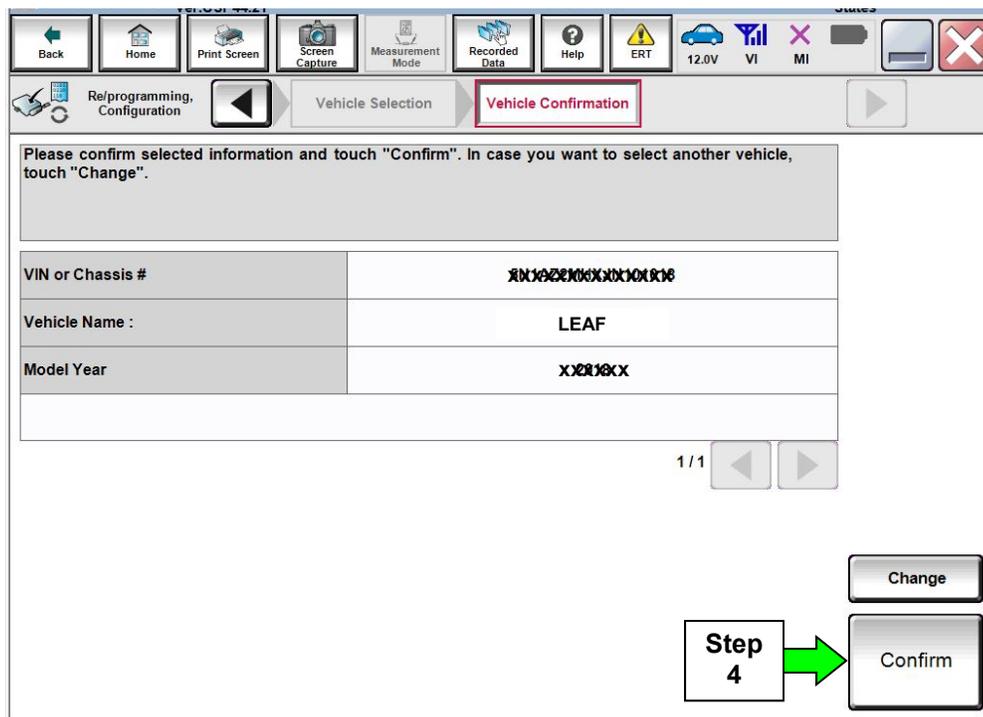
Figure 13

4. If the **VIN or Chassis #** matches the vehicle's VIN, select **Confirm**.

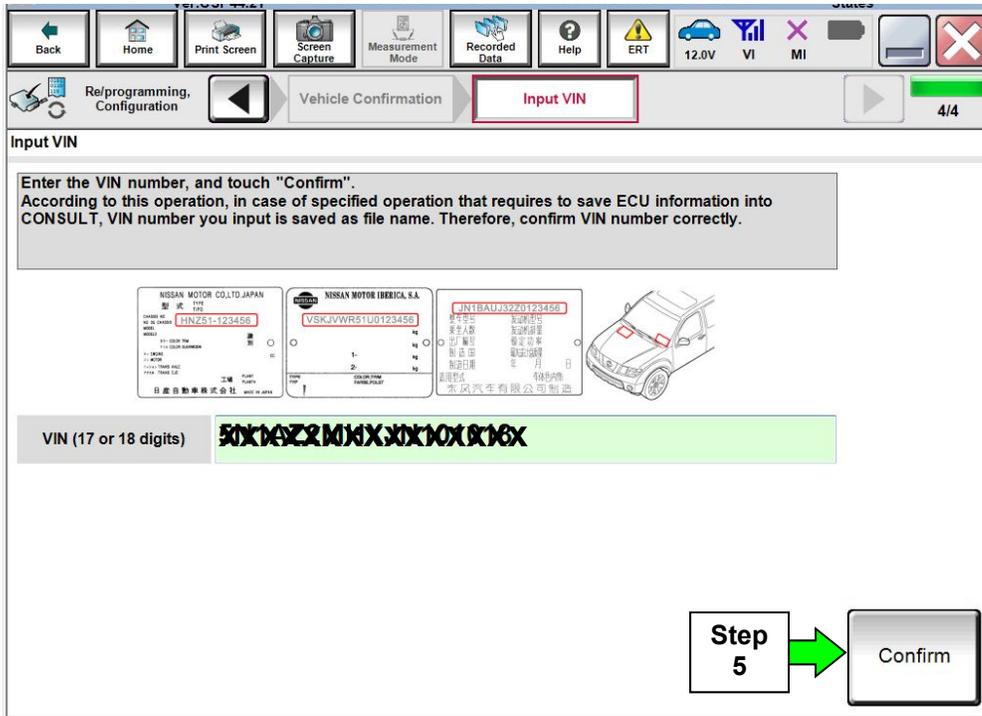
Figure 14

5. Select **Confirm**.

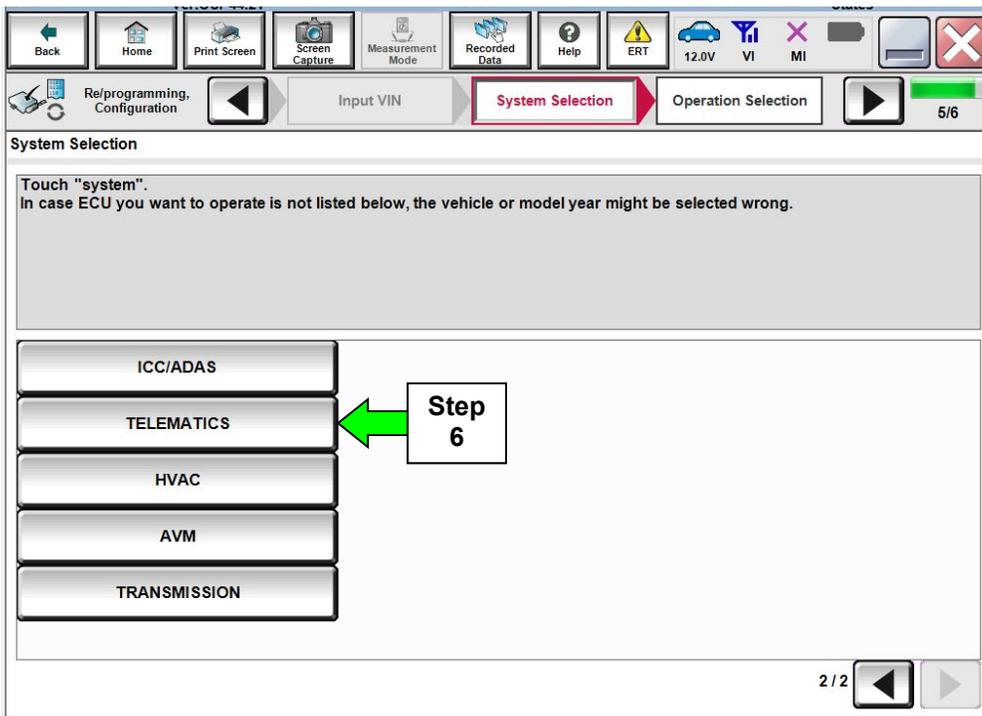
Figure 15

6. Select **TELEMATICS**.

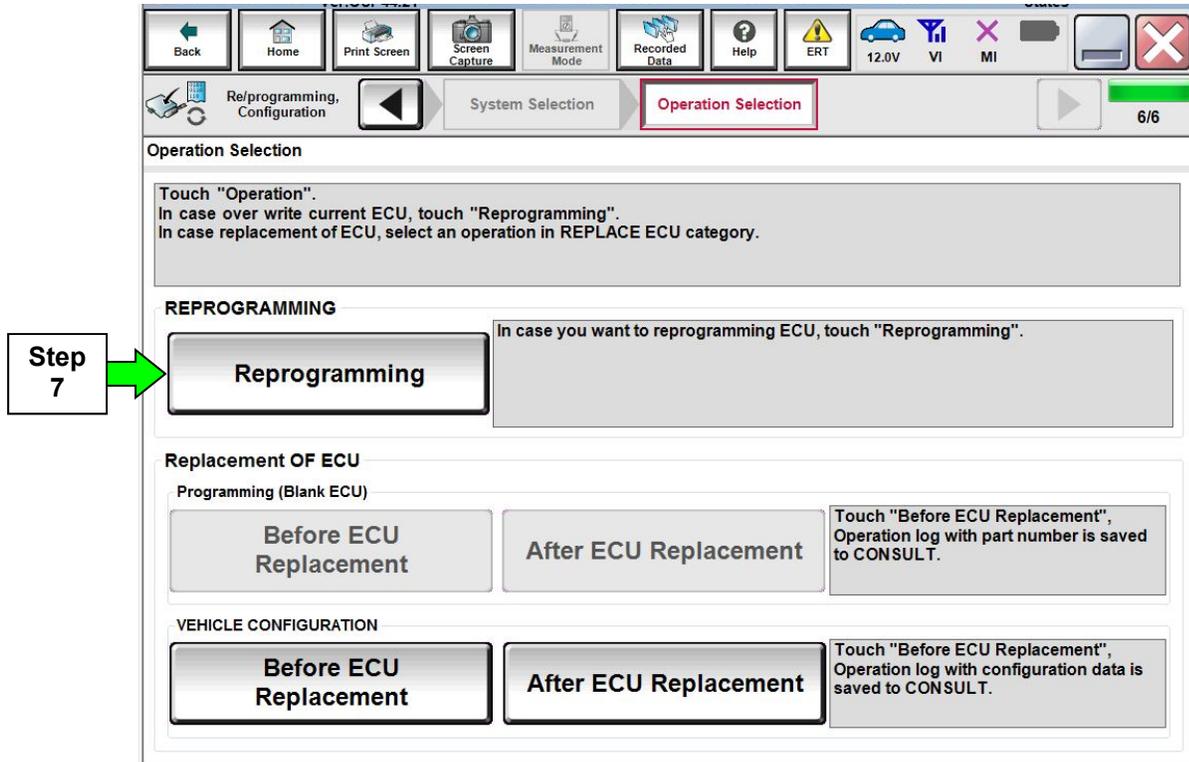
Figure 16

7. Select Reprogramming.

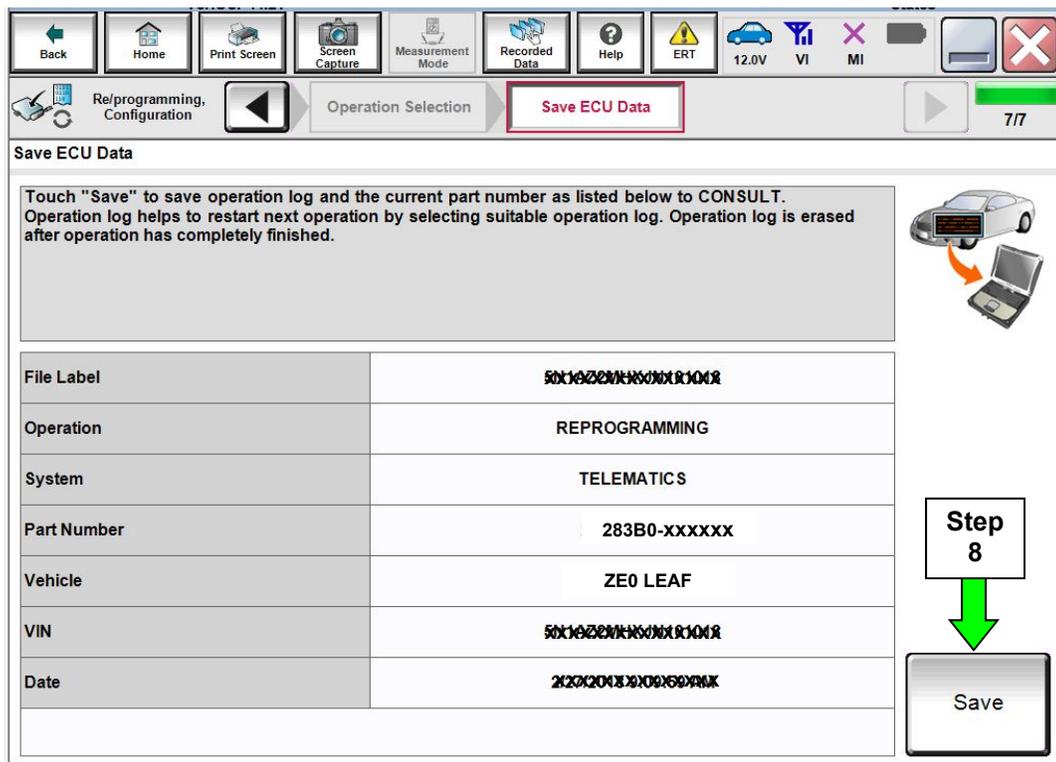
Figure 17

8. Select Save.

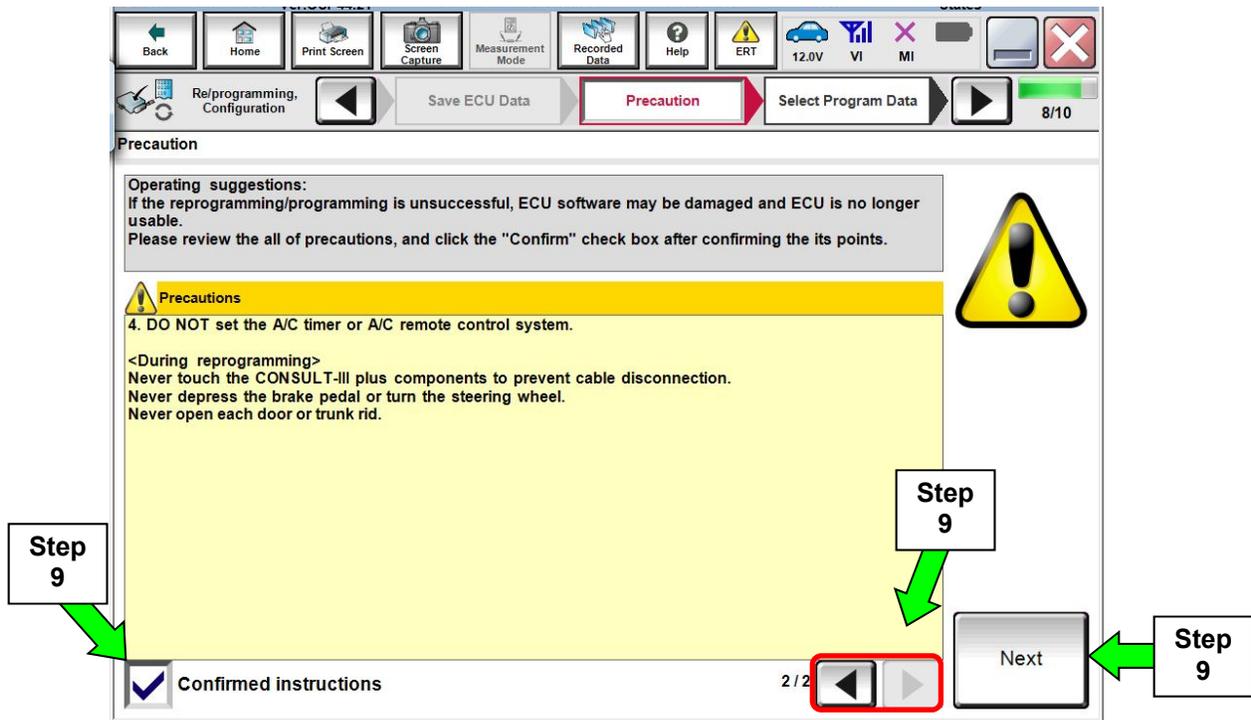
Figure 18

- Use the arrows (if needed) to view and read all precautions, check the **Confirmed Instructions** box, and then select **Next**.

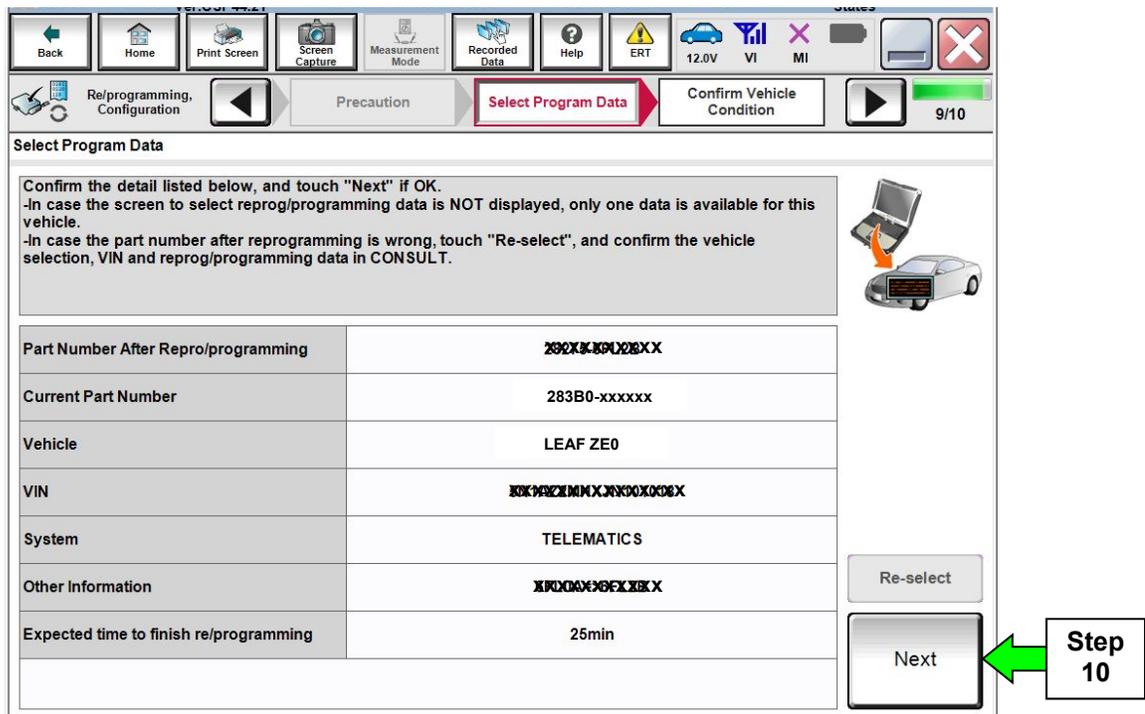
Figure 19

- Verify the **Current Part Number** and **Part Number After Reprogramming** are different, and then select **Next**.

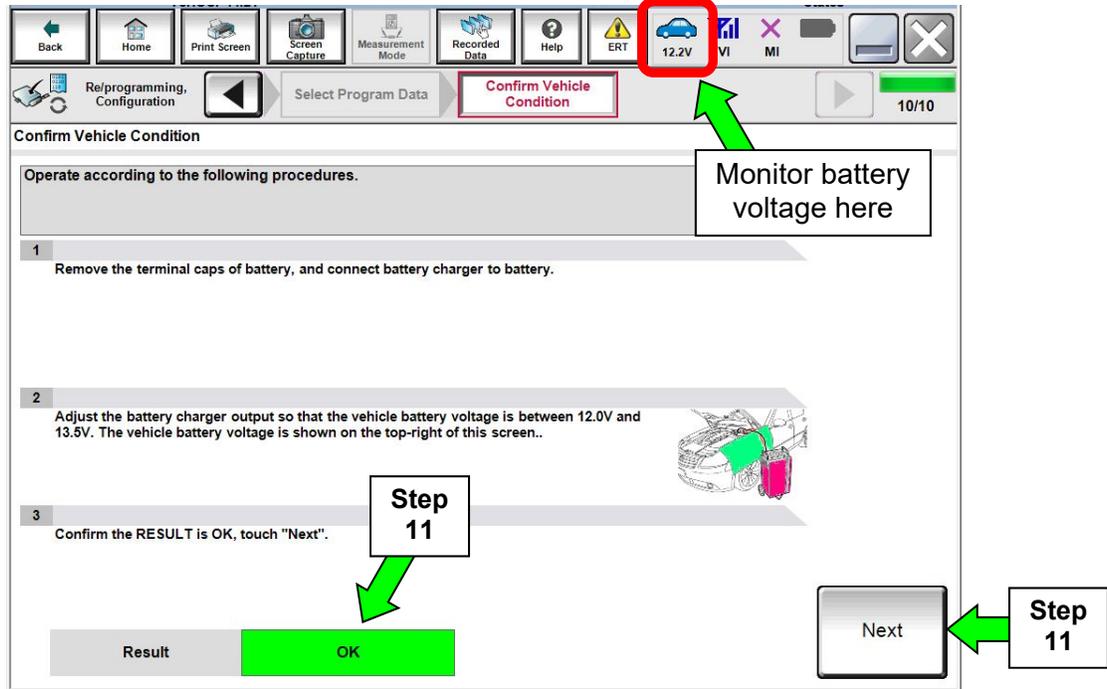
Figure 20

11. Verify **OK** is highlighted **green** (battery voltage must be between **12.0 and 15.5 volts**), and then select Next.

IMPORTANT: Battery voltage must stay between **12.0 and 15.5 volts** during reprogramming. If not, reprogramming may be interrupted and the TCU may be damaged.

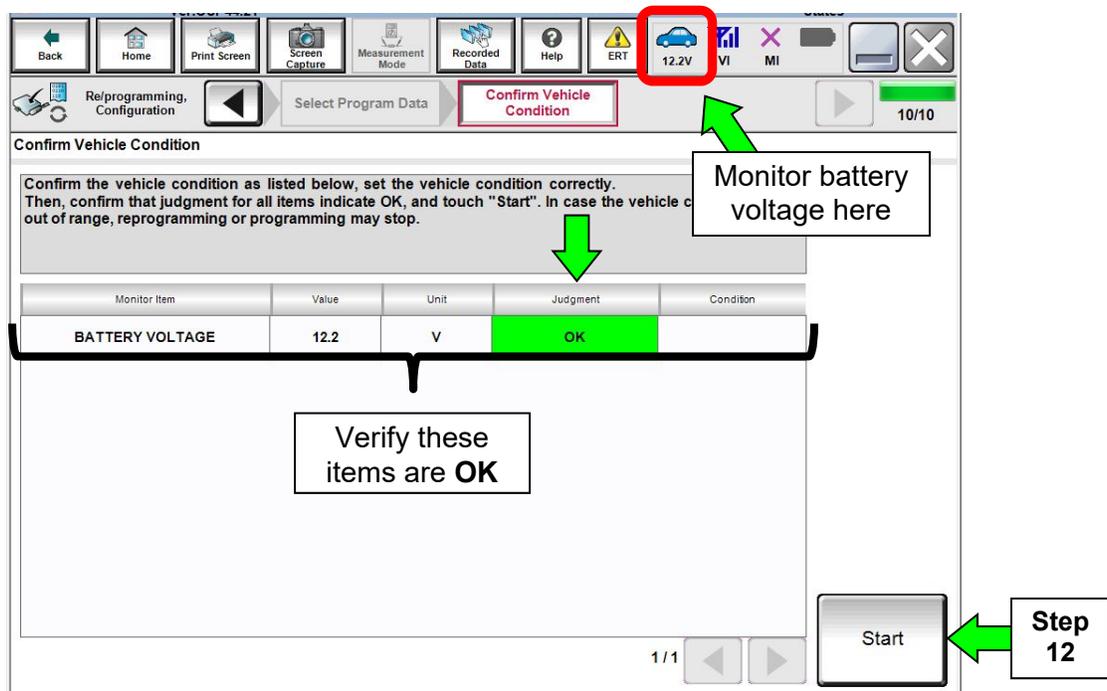
Figure 21

12. Verify all items listed under **Confirm Vehicle Condition** are **OK**, and then select **Start**.

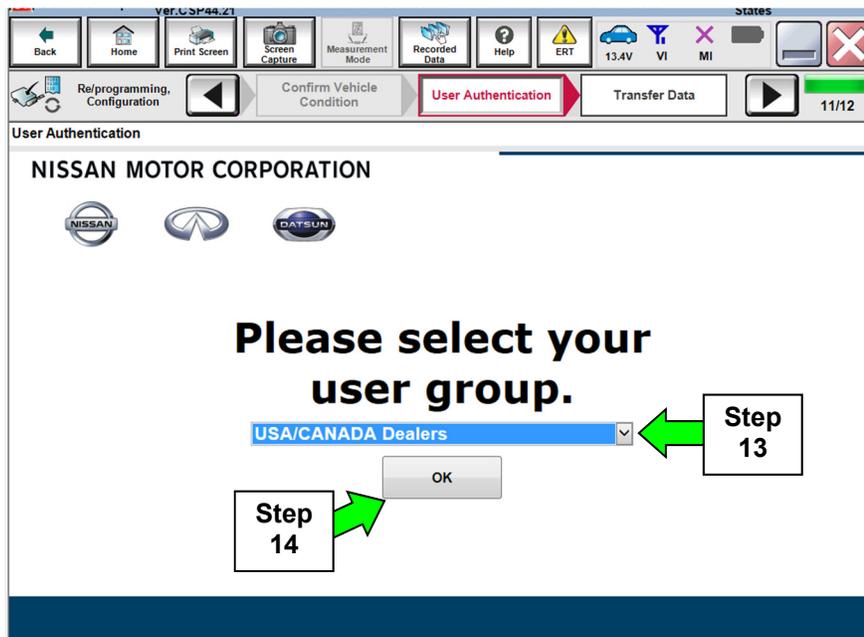
Figure 22

13. Select **USA/CANADA Dealers**.

14. Select **OK**.

- The above screen may not display if the CONSULT PC has remained ON since the last reprogramming.
- If the CONSULT PC is not connected to the Internet, the screen in Figure 23 will display.

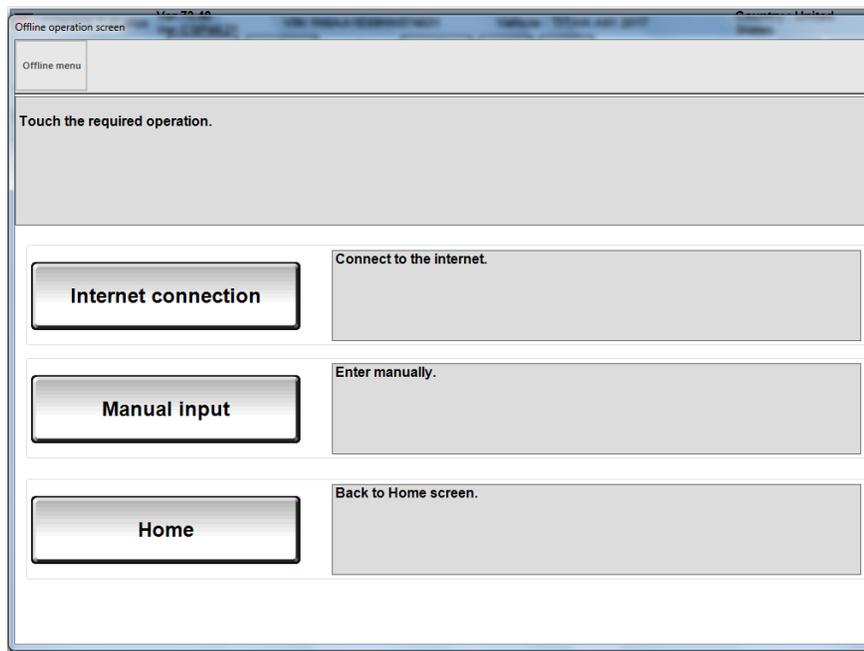
Figure 23

- Before reprogramming will start, you will be required to enter your **Username** and **Password**.
- The CONSULT PC must be connected to the Internet (Wi-Fi or cable).
- If you do not know your **Username** and **Password**, contact your service manager.

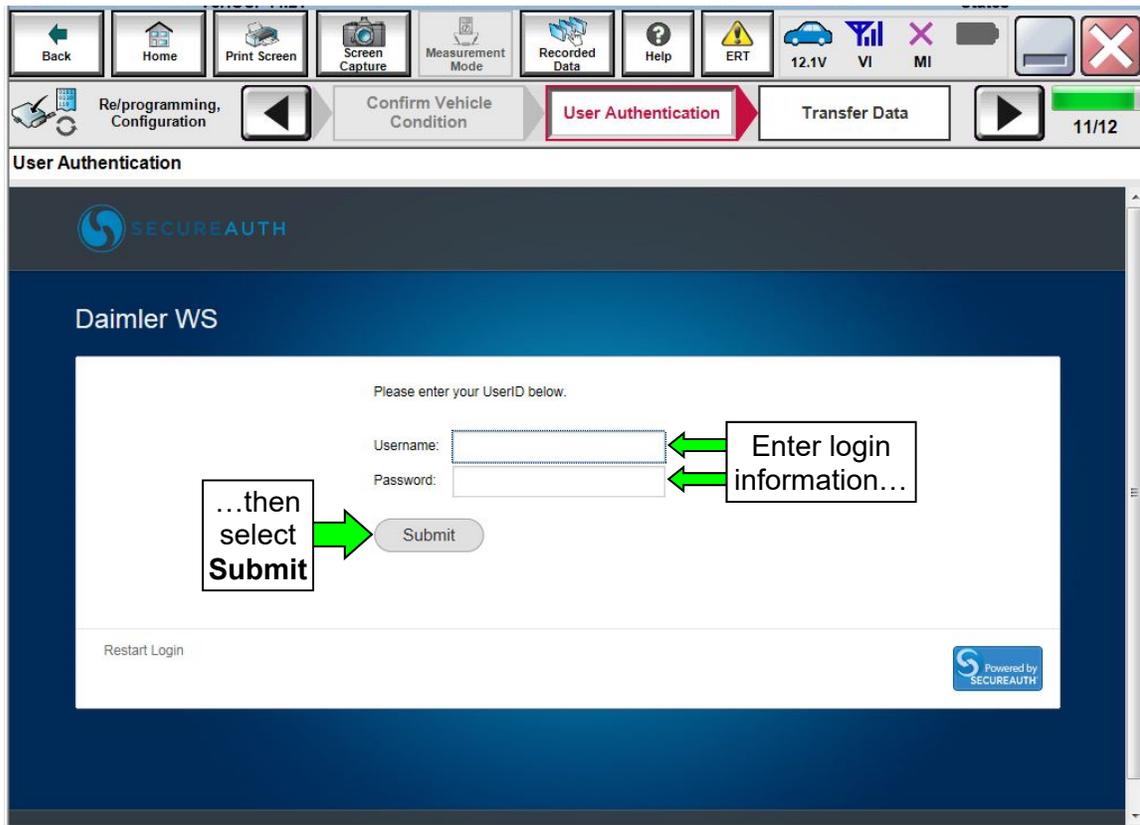
Figure 24

15. Start the reprogramming process by selecting **Submit**.

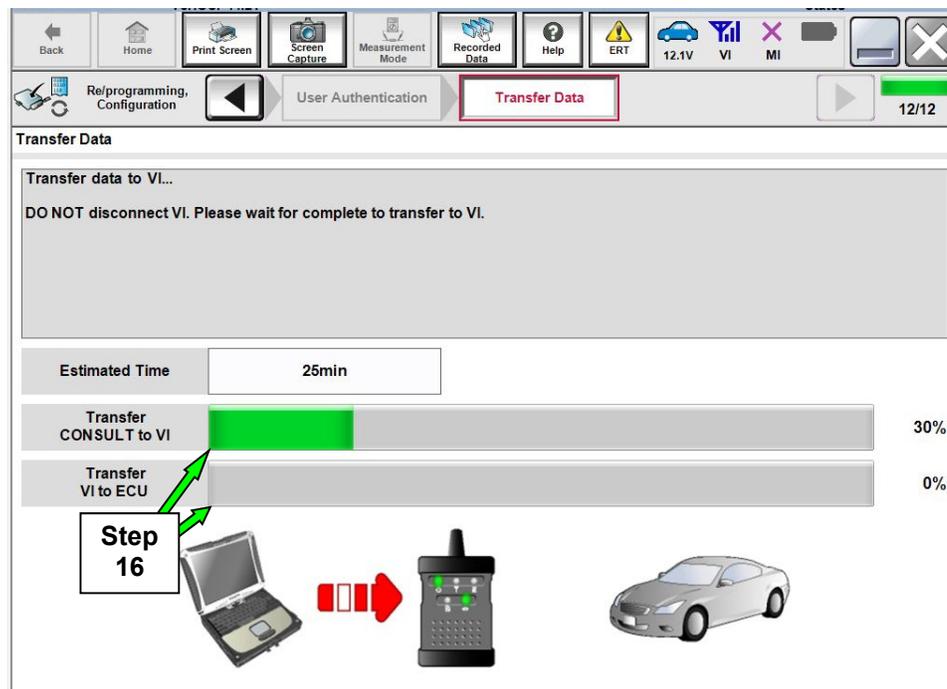
Figure 25

16. The progress bar (Figure 25) should go to approximately 10%, and then the error message in Figure 26 should appear. This is normal.

NOTE: If a different error message displays, go to **Electronic Control Unit Recovery** on the next page.

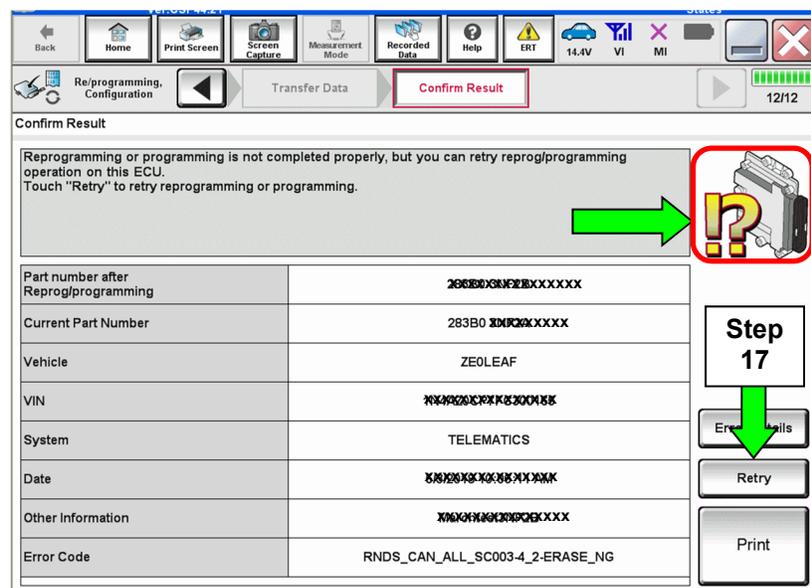
17. When the screen in Figure 26 displays, verify the following, and then select **Retry**.

- Check battery voltage (12.0–15.5 volts).
- Ignition is ON, engine OFF.
- External Bluetooth® devices are OFF.
- All electrical loads are OFF.
- **Select Retry and follow the on screen instructions.**
- “Retry” may not go through on the first attempt and can be selected more than once.

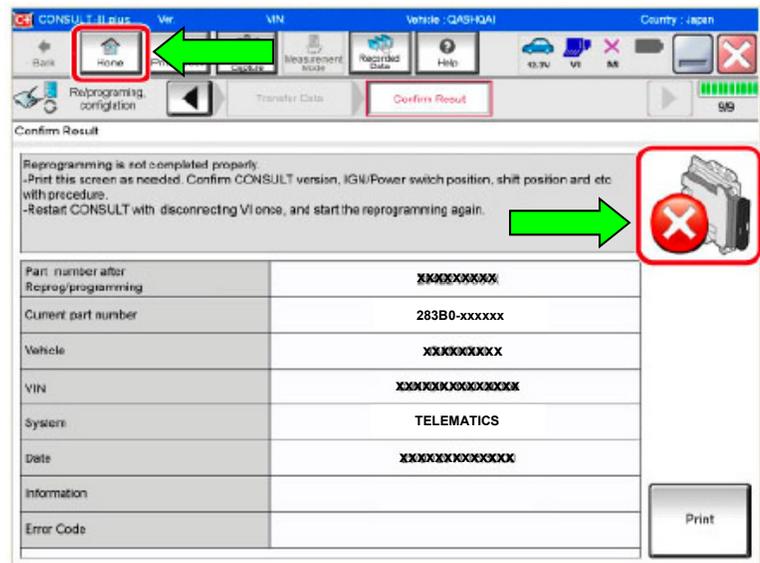
Figure 27

If reprogramming does not complete and the “X” icon displays as shown in Figure 27:

- Check battery voltage (12.0 – 15.5 volts).
- CONSULT A/C adapter is plugged in.
- Ignition is ON, engine OFF.
- Transmission is in Park.
- All C-III plus / VI cables are securely connected.
- All C-III plus updates are installed.
- **Select Home, and restart the reprogram procedure from the beginning.**

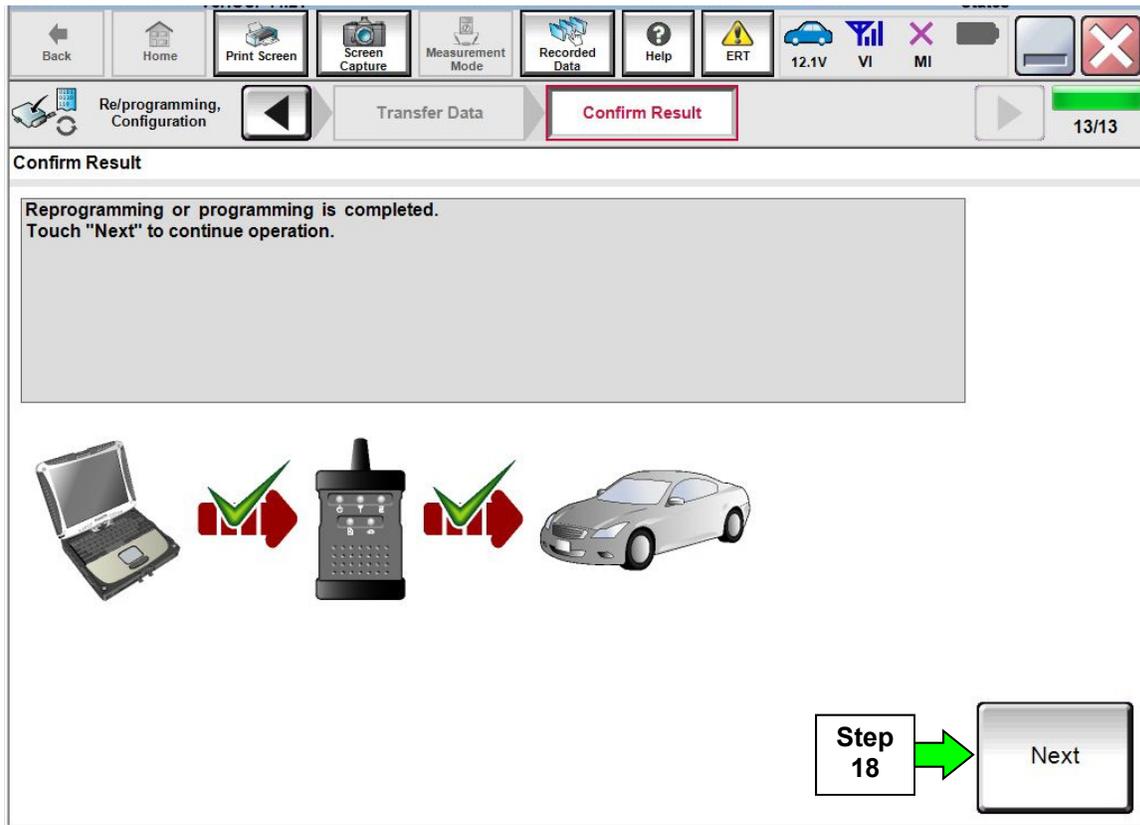
Figure 28

18. Select **Next**.

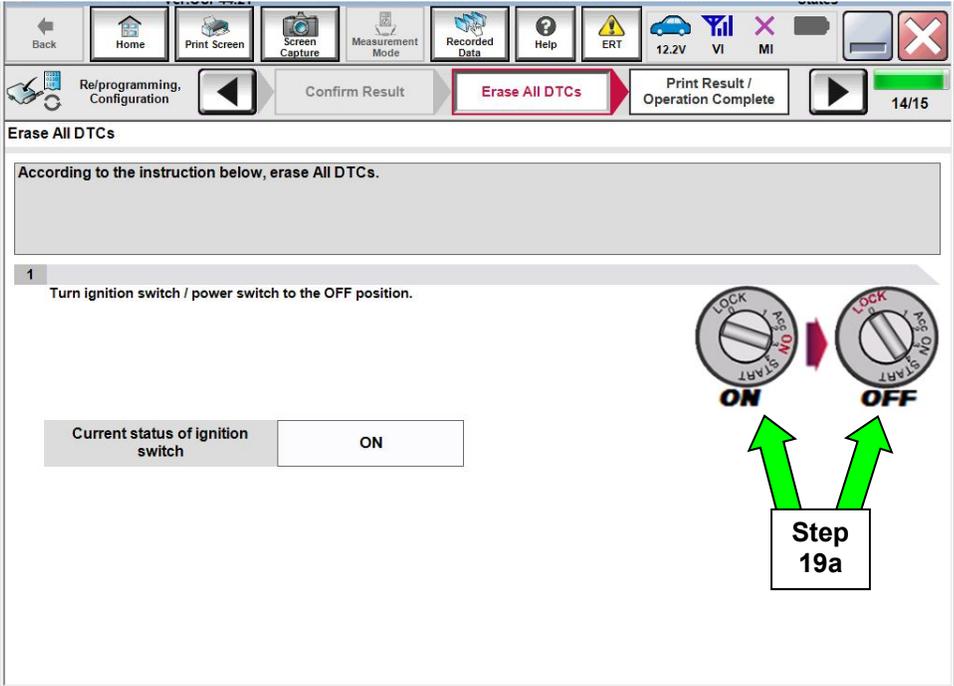
Figure 29

19. Erase all DTCs as follows:

- a. Turn the ignition OFF.
