SERVICE BULLETIN

Classification: EL18-018b	Reference: NTB18-045b	Date: September 28, 2018
------------------------------	--------------------------	-----------------------------

2011-2015 LEAF; 12 VOLT BATTERY LOSES CHARGE AND/OR TELEMATICS SERVICES DO NOT WORK

APPLIED VEHICLES: 2011-2015 LEAF (ZE0)

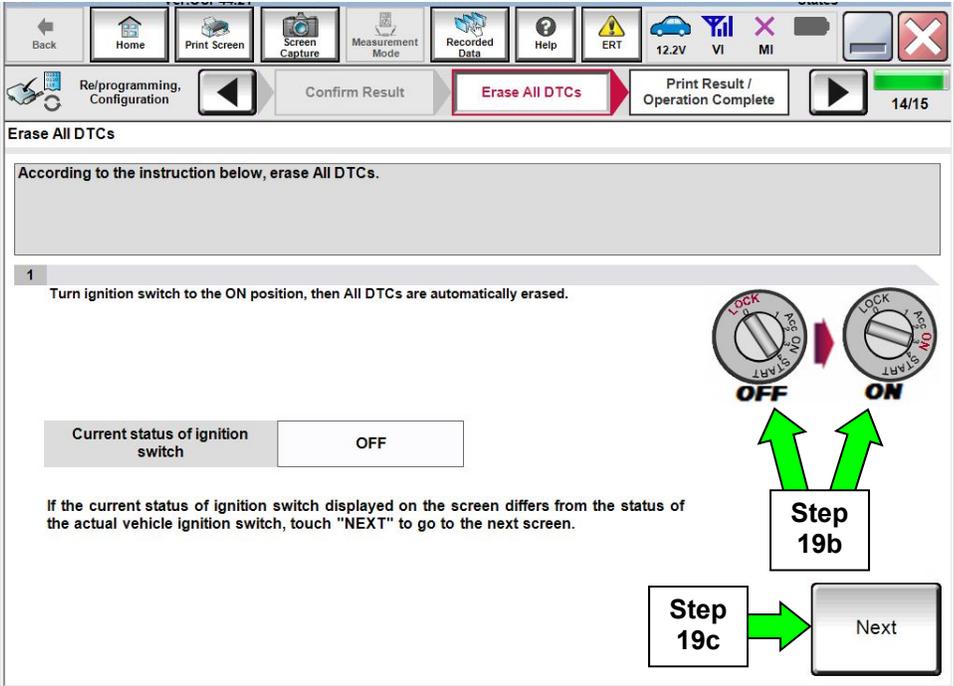
Figure 30

- b. Turn the ignition ON.
- c. Wait for DTC erase to complete, and then select **Next**.

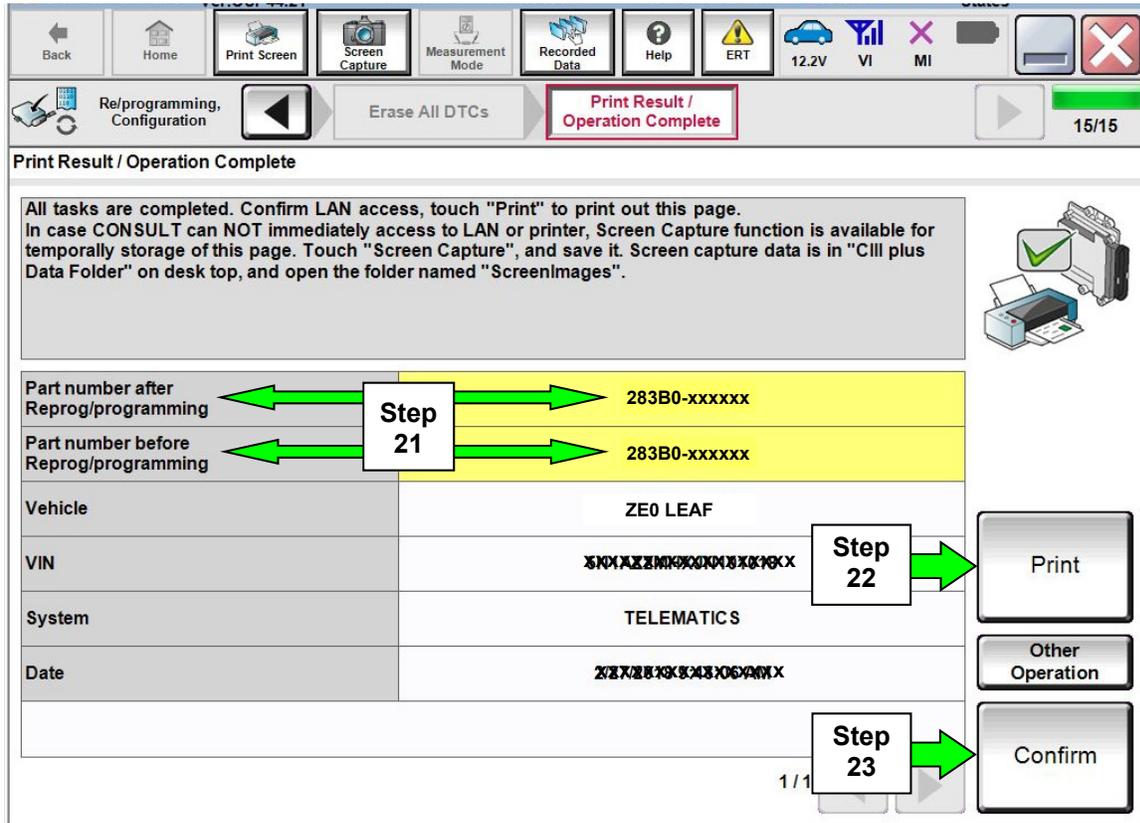
20. When the entire reprogramming process is complete, the screen in Figure 31 will display.
21. Verify the before and after part numbers are different.
22. Print a copy of this screen (Figure 31) and attach it to the repair order for warranty documentation.
23. Select **Confirm**.

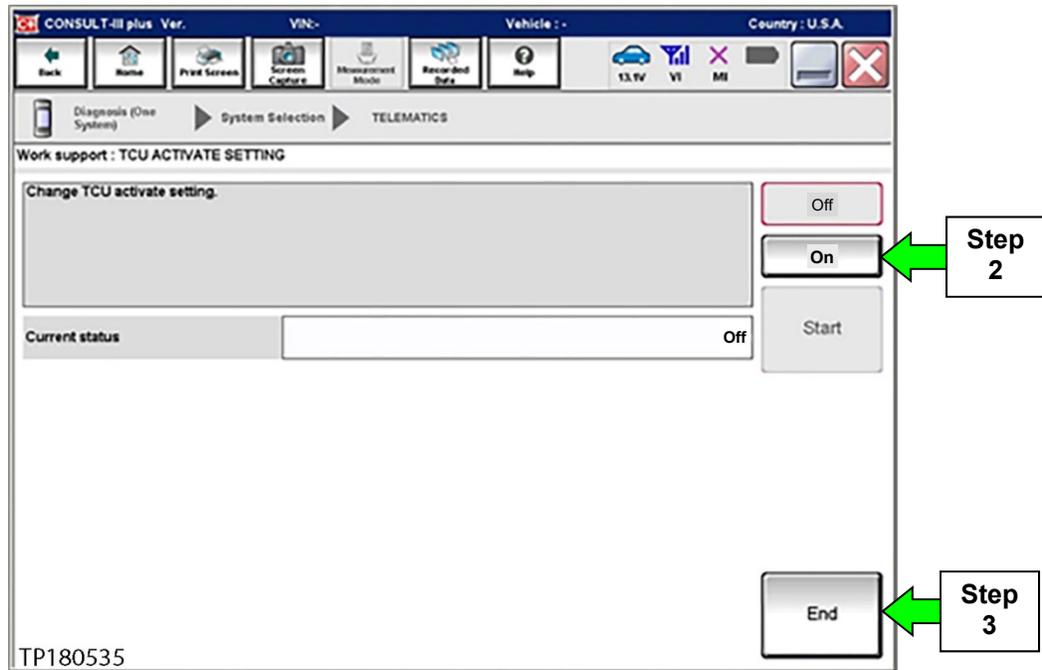
1. Got back to the Home screen, and then follow steps 9-13 starting on page 4 to get to Figure 32 below.
2. Select **On**.
3. Select **End**, and then wait 40 seconds.
