WJ60 - Adapting Vehicle Order in the Instrument Cluster and Re-Coding PCM and Air-Conditioning Control Unit (Workshop Campaign)

Model Line: **Cayenne (9YA)**

Subject: **Instrument cluster**

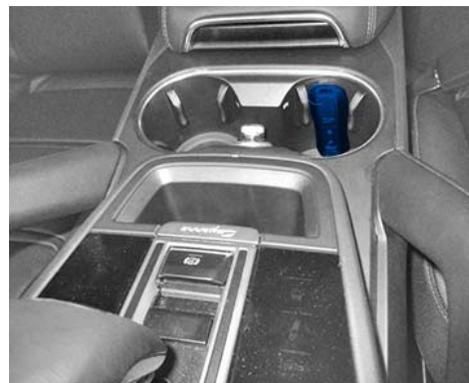
Emergency start tray

- 2 Position the driver's key in the rear area of the left cupholder in the center console between the holding struts (emergency start tray) in order to guarantee a permanent radio link between the vehicle and driver's key ⇒ *Emergency start tray*.
- 3 **9900 - PIWIS Tester 3** must be connected to the vehicle communication module (VCI) via the **USB cable**. Then connect the communication module to the vehicle and switch on the PIWIS Tester.
- 4 Switch on the ignition.
- 5 On the PIWIS Tester start screen, call up the '**Diagnostics**' application. The vehicle type is then read out, the diagnostic application starts and the control unit selection screen is populated.

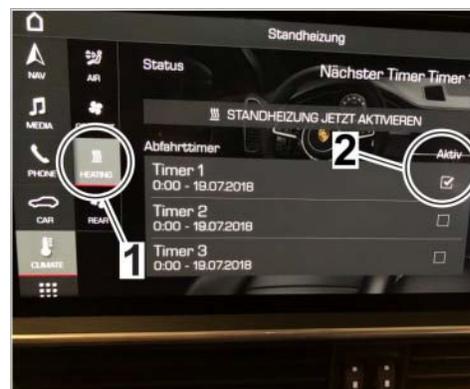
PCM Climate menu

- 9 Select the '**CLIMATE**' menu on the PCM touch-screen.
- 10 Select the submenu '**HEATING**' ⇒ *PCM Climate menu -1-* and activate Timer 1 ⇒ *PCM Climate menu -2-*.
When the procedure is finished, set the vehicle back to its original status. To do this, continue with **Step 11**.

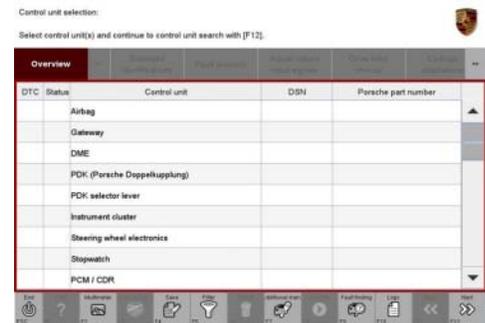
Control unit selection

- 1.6 Once you have erased the fault memories, select the **'Overview'** menu to return to the control unit selection screen ⇒ *Control unit selection*.
- 2 Create Vehicle Analysis Log (VAL).
Return the VAL together with the VAL created when you started the work using the PIWIS Tester.
- 3 Switch off the ignition.
- 4 Disconnect the PIWIS Tester from the vehicle.
- 5 Switch off and disconnect the battery charger.
- 6 Enter the campaign in the Warranty and Maintenance booklet.
