Entune Audio Head Unit Software Update (Denso-Ten)

Service Category Audio/Visual/Telematics

YEAR(S)	MODEL(S)	ADDITIONAL INFORMATION
2018	Sienna

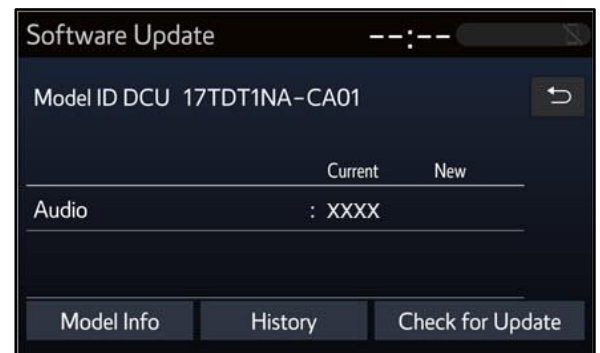
Figure 4.

6. Verify that the software version is the same or earlier than indicated in the Introduction.

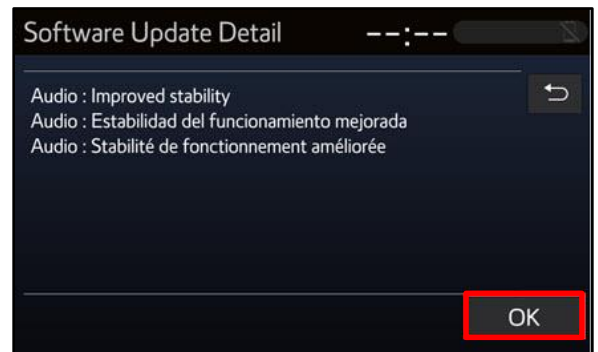
Figure 6.

- Select Ok on the Software Update Detail screen.

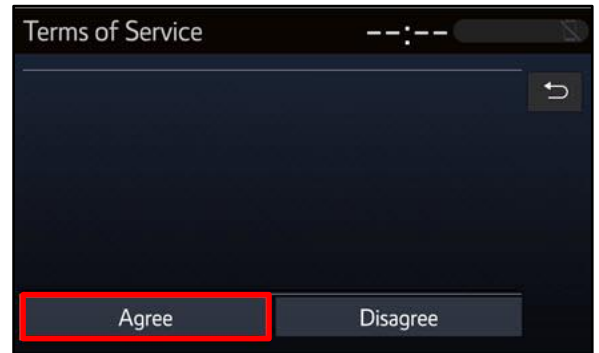
Figure 7.

12. Select Agree on the Terms of Service screen.

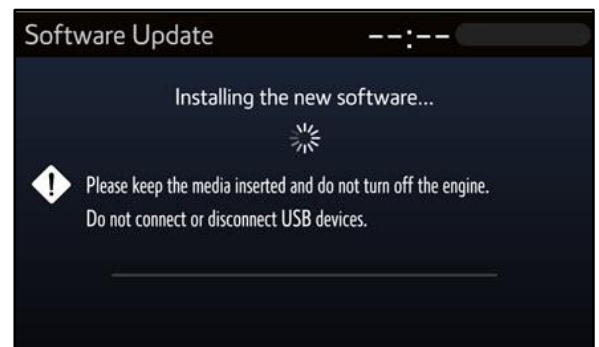
Figure 9.

14. Once the head unit begins installation, the update will take approximately 10 minutes.

- Do NOT turn off the ignition or ACC before the software is ready for updating.
- Do NOT remove the USB flash drive until instructed in step 17.

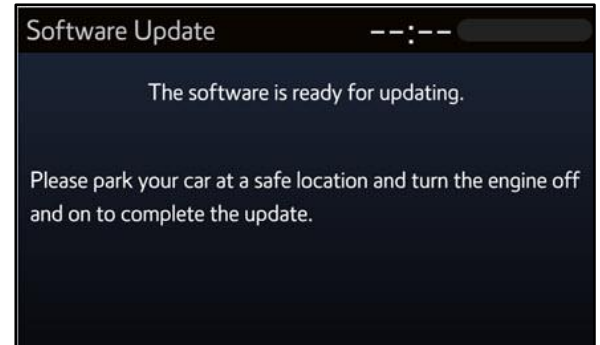
Figure 10.

15. When the “The software is ready for updating” screen appears, turn OFF the ignition.
