# TECHNICAL BULLETIN

303-01A: Engine - INGENIUM I4 2.0L Diesel

Service Action: Balancer Shaft Whine

MODEL:	MODEL YEAR:	VIN:	ASSEMBLY PLANT:	APPLICABILITY:
Range Rover Velar (LY)	2018	700004-724548	Solihull	INGENIUM I4 2.0L Diesel

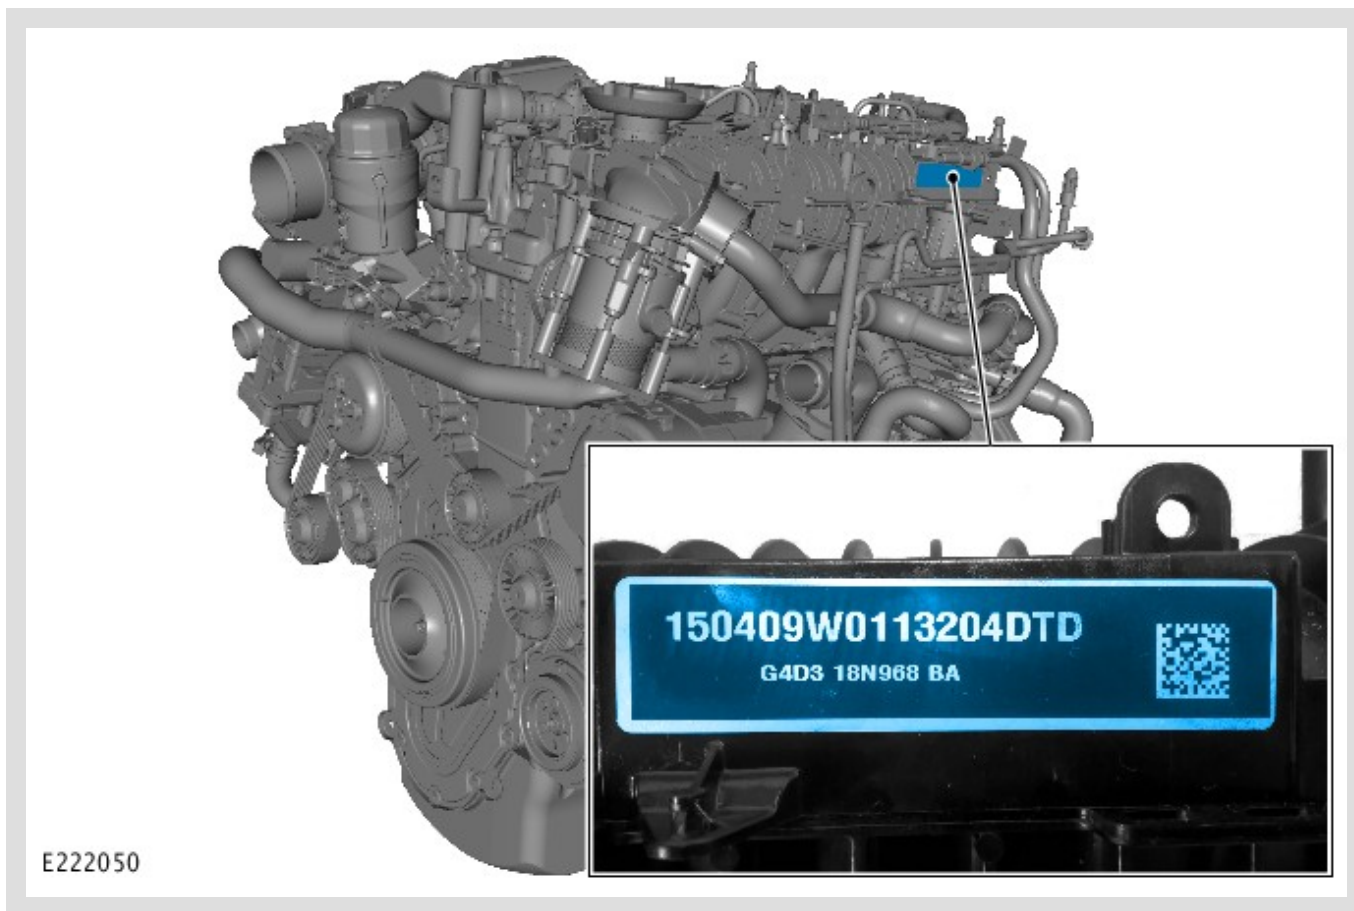
The engine build date is the first 6 characters (YY/MM/DD) of the engine serial number.

Locate and record the engine serial number.
