GROUP ENG	MODEL 2019MY Niro (DE P/HEV) Optima (Plug-in) Hybrid (JF P/HEV)
	NUMBER 195	DATE October 2018
TECHNICAL SERVICE BULLETIN		
SUBJECT: SERVICE ACTION: ECU FREEZE FRAME DATA LOGIC IMPROVEMENT (SA360)

SERVICE ACTION: ECU FREEZE FRAME DATA LOGIC IMPROVEMENT (SA360)

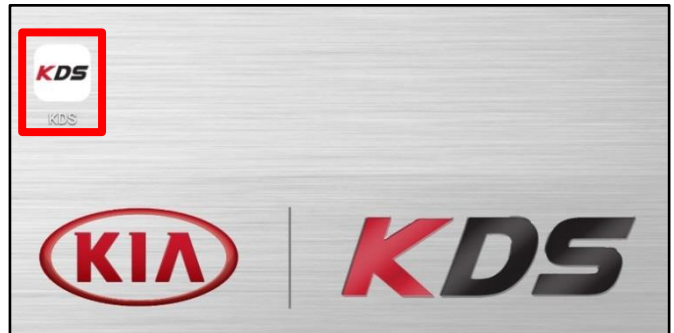
2. With the ignition ON, turn ON the KDS tablet. Select **KDS** from the home screen.

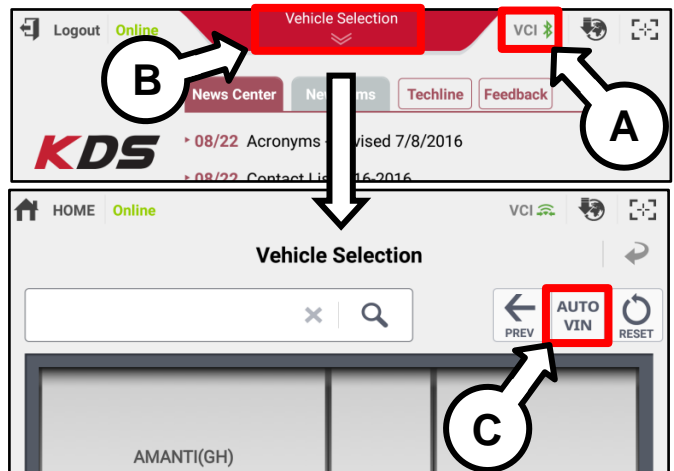
3. Confirm communication with VCI (A) and then configure the vehicle (B) using the **AUTO VIN** (C) feature.

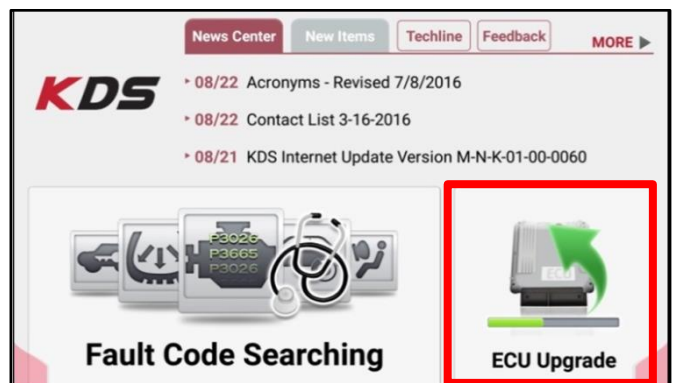
4. Select **ECU Upgrade**.

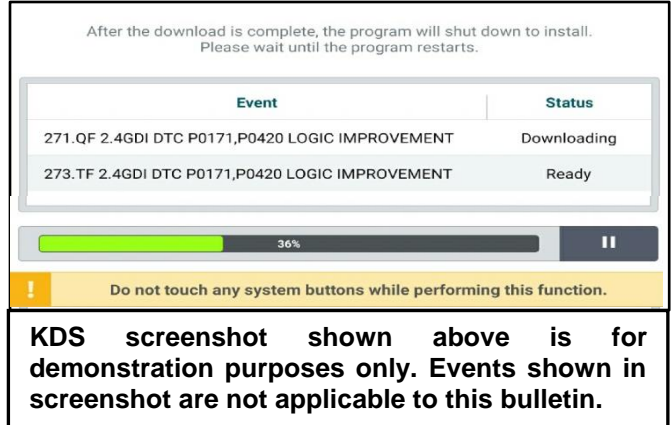
- The KDS will check the server for recently uploaded Events and then automatically download **Upgrade Event #389 (Niro) or #390 (Optima)**.

The vehicle must be identified in Vehicle Selection to download an Event for that vehicle.

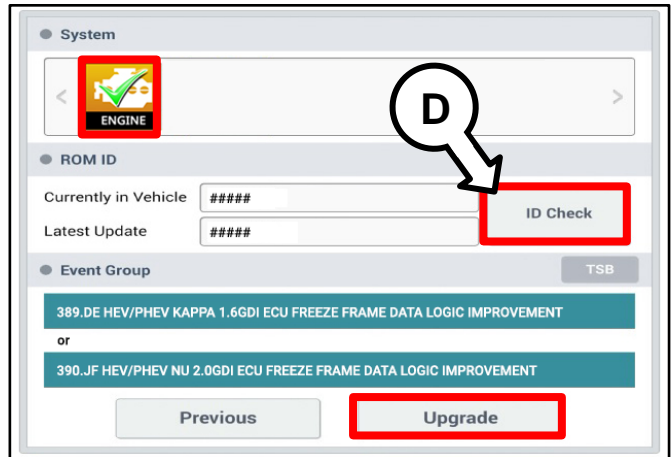
- Select the **Engine** system under the System selection menu.

Touch **ID Check** (D) and confirm that the latest update is available.

Select **Upgrade Event #389 (Niro) or #390 (Optima)** and select **Upgrade** to continue.

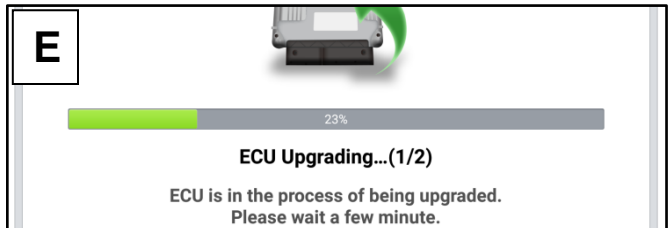
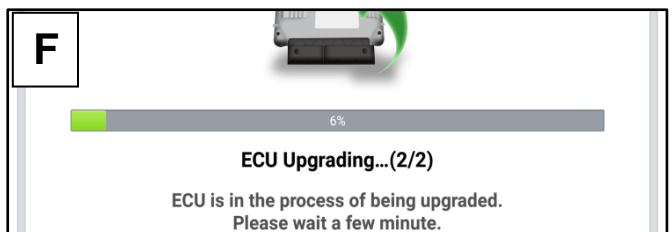
- The ECU upgrade will begin and the progress of the upgrade will appear on the bar graph. Upgrade part (1/2) (E) will download the upgrade event to the VCI-II. Upgrade part (2/2) (F) will upgrade the ECU.

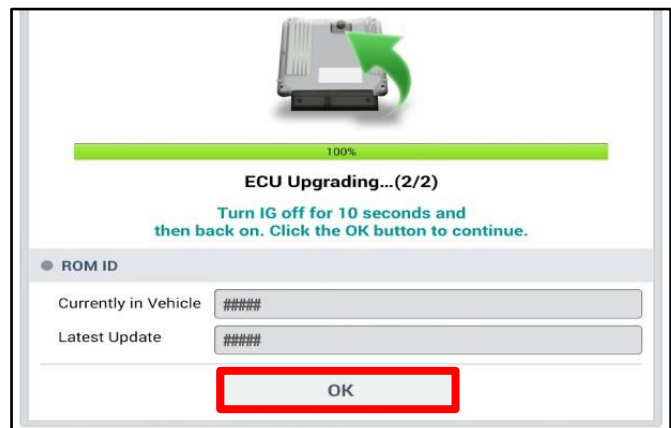
10. When instructed on the KDS, turn the ignition **OFF** for ten (10) seconds then back on. Touch **OK** to continue.

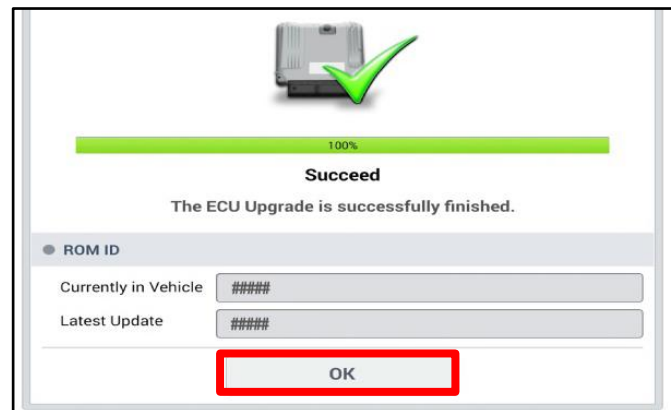
11. Once the upgrade is complete, touch **OK** to finalize the procedure.

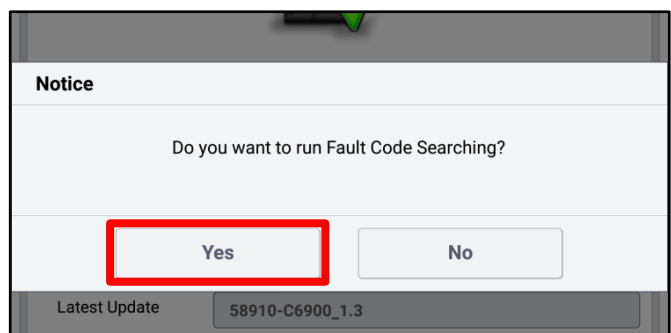
12. When prompted, select **YES** to check for Diagnostic Trouble Codes (DTC) and erase any DTCs stored such as EPS, ESC, and TPMS that may have been set during the upgrade.
