MODEL
2011-2014MY
Optima (QF/TF)
2012-2014MY
Sorento (XMa)
2011-2013MY
Sportage (SL)

NUMBER
1803

PRODUCT IMPROVEMENT CAMPAIGN

SUBJECT: KNOCK SENSOR DETECTION SYSTEM - ECU
LOGIC IMPROVEMENT (PI1803)

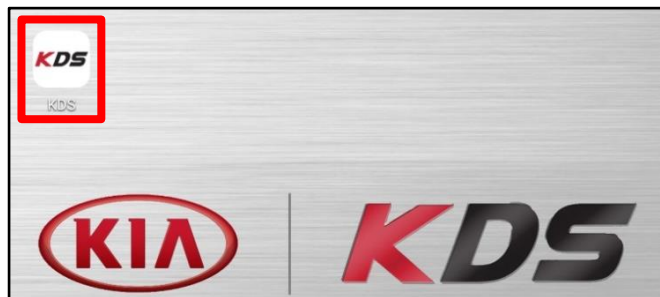
2. With the ignition ON, turn ON the KDS tablet. Select **KDS** from the home screen.
