415-01

Service Action: InControl Touch Pro Software Updates

MODEL:	MODEL YEAR:	VIN:
Discovery Sport (LC)	2019	778795-786998
Discovery (LR)	2019	079584-083663
Range Rover Evoque (LV)	2019	324788-334400
Range Rover Velar (LY)	2019	778653-788811
Range Rover Sport (LW)	2019	414812-819396
Range Rover (LG)	2019	509423-521747

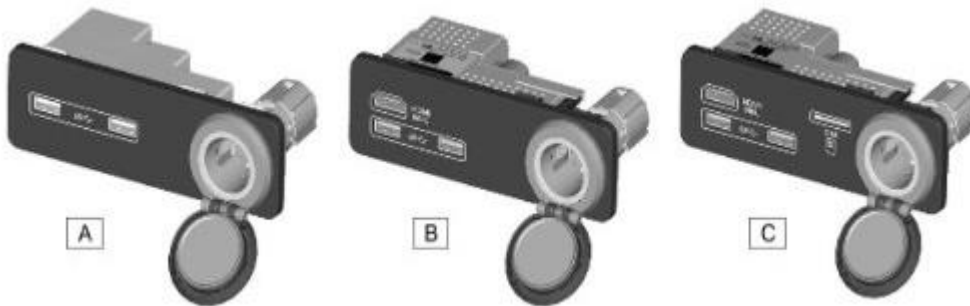
Verify the vehicle's media interface panel.

- If '**A**', go to Step 21. Vehicle NOT eligible for Smartphone pack activation.
- If '**B**' or '**C**', go to Step 12. Vehicle eligible for Smartphone pack activation.
