Technical Service Bulletin

SUBJECT:			No: TSB-18-13-002REV
MIL ILLUMINATION WITH DTC P061A - REVISED			DATE: October 2018
			MODEL: 2018-2019 Eclipse Cross
CIRCULATE TO:	<input type="checkbox"/> GENERAL MANAGER	<input checked="" type="checkbox"/> PARTS MANAGER	<input checked="" type="checkbox"/> TECHNICIAN
<input checked="" type="checkbox"/> SERVICE ADVISOR	<input checked="" type="checkbox"/> SERVICE MANAGER	<input checked="" type="checkbox"/> WARRANTY PROCESSOR	<input type="checkbox"/> SALES MANAGER

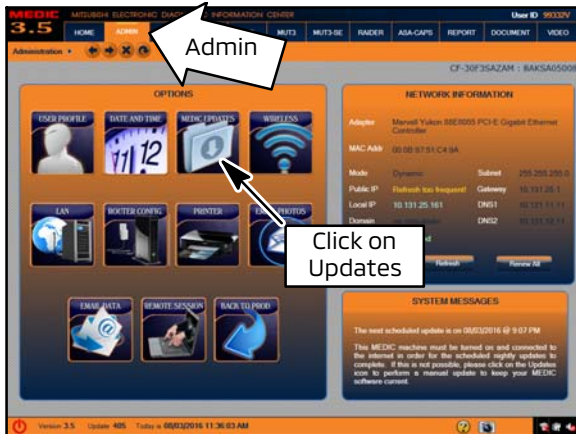
3. Select the MEDIC 3.5/4 Admin tab and click on "Updates."

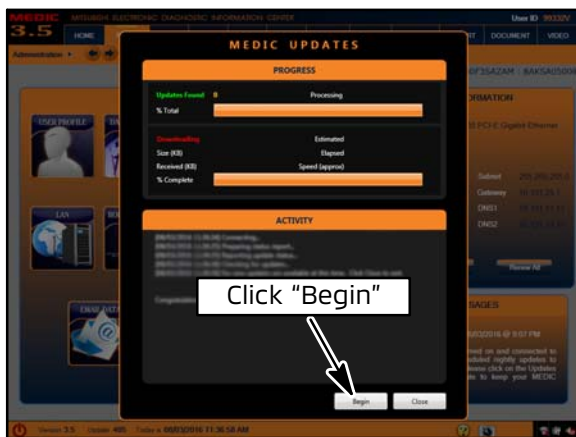
4. IF the MEDIC update screen advises updates are available, click the "Begin" button. After all updates are complete, **GO TO THE REPROGRAMMING PROCEDURE.**

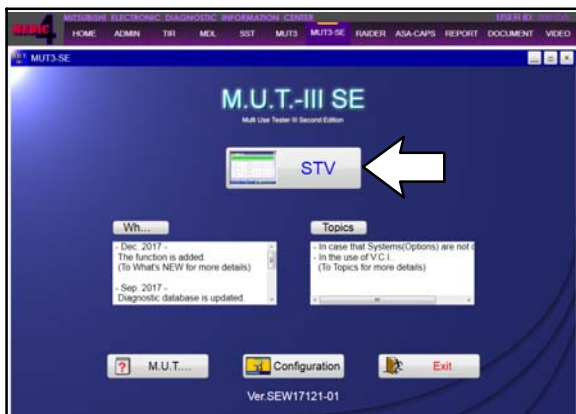
5. **STANDALONE MUT-III SCAN TOOL VIEWER (STV) ONLY: (MEDIC 3.5 USERS - GO TO THE REPROGRAMMING PROCEDURE).** Verify that your MUT3-SE has the most current version of the reprogramming database:
From the MUT3-SE Main Page:
a. Click "STV."

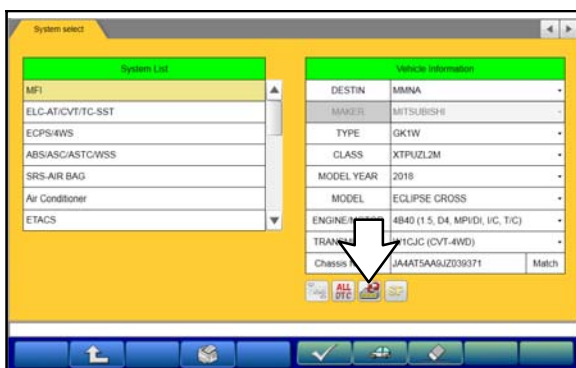
b. Click the "ECU Reprogramming" button.

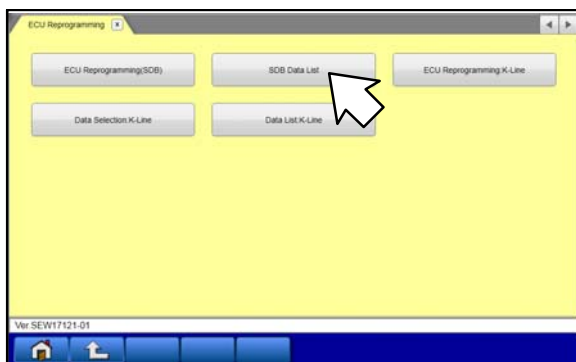
c. Click "SDB Data List."

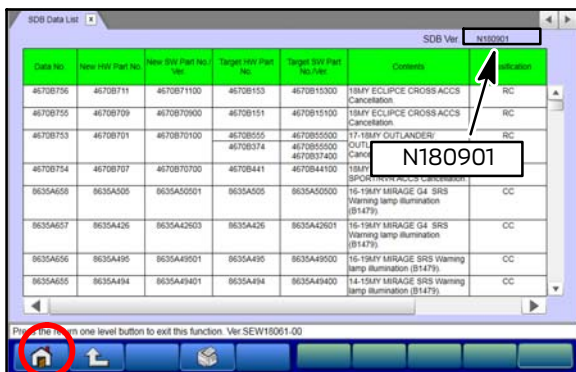
d. Confirm that the database number displayed in the upper right above the chart is **N180901 or higher**

- If the database number displayed on your MUT3-SE is **N180901** or higher, continue to the next section.
- If the reprogramming database number displayed on your MUT3-SE is **lower** than **N180901**, then the MUT3-SE database needs to be updated.

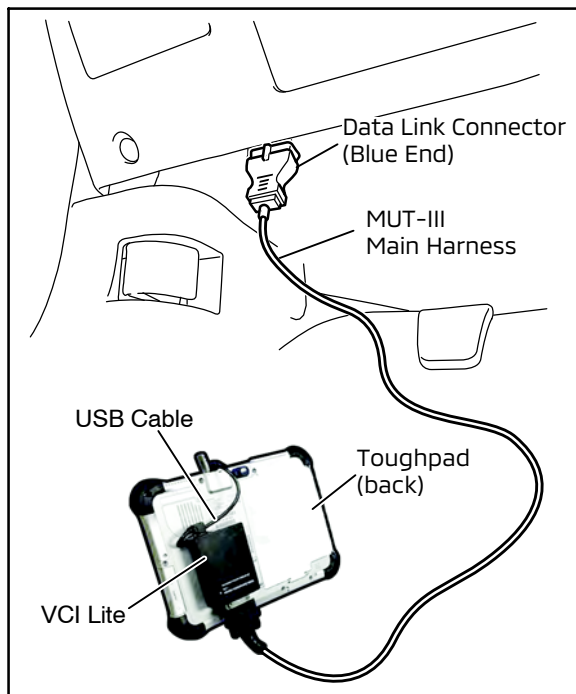
1. Connect the equipment as follows:

NOTE: VCI Lite and MEDIC 4.0 Toughpad shown for illustration purposes only.

- Turn the MEDIC PC/tablet on. If the battery indicator in the lower right hand corner of the screen does not show a full charge, it is recommended that either the battery be charged prior to beginning, or be used with the A/C power adaptor connected.
- Connect the USB cable to the VCI/VCI Lite.
- When the laptop/tablet displays the MUT-III main screen, connect the USB cable to the device.
- Connect the MUT-III main harness with the blue DLC connection to the VCI/VCI Lite.
- Connect the blue connection of the MUT-III main harness to the vehicle's data link connector.
- For VCI only (p/n MB991824): Turn the VCI power switch ON. Verify that the indicator lamp in the upper right corner of the screen is green.

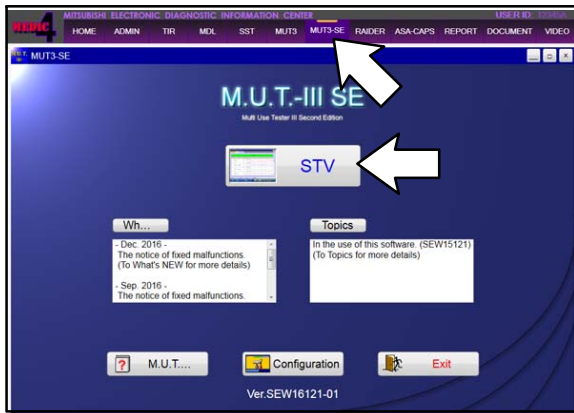
3. Using MEDIC, from the main page, click the "MUT3-SE" icon at the top center of the screen to open MUT-III SE.

Click the STV button.

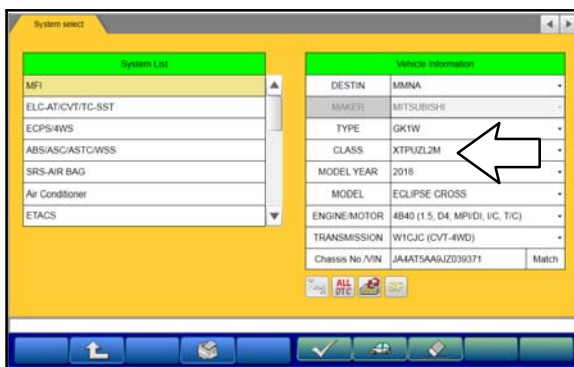
4. The System Select screen opens and populates with some basic information from the vehicle.

Look at the label on the passenger side B pillar to identify the appropriate class.

If necessary, select the correct class from the drop-down list.

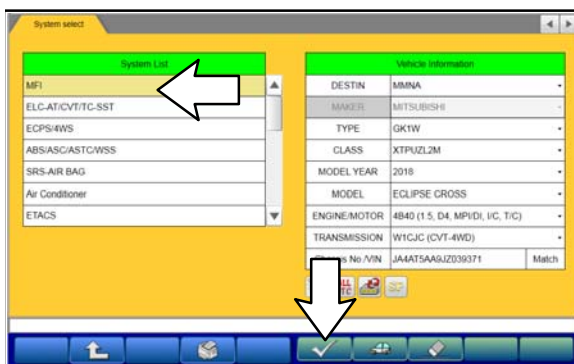
- a. Select "MFI" from the System List, then click on the check mark at the bottom of the screen.

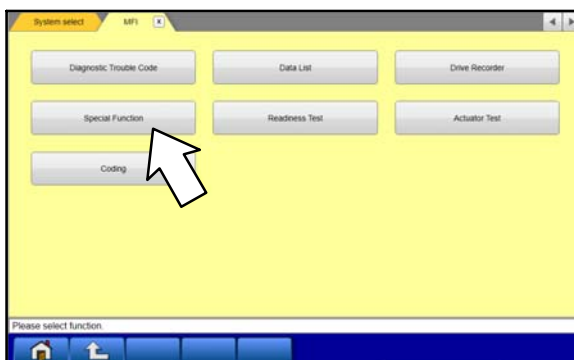
- b. Select "Special Function."

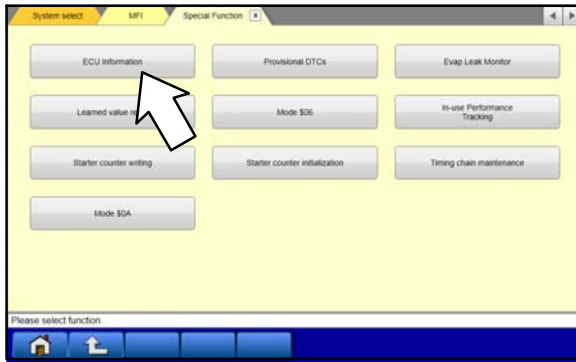
c. Select "ECU Information."

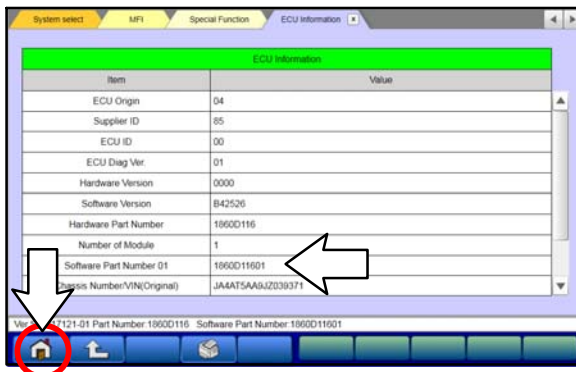
d. If the Software Part Number listed is **not** at the latest level (shown in the **"ECU Reprogramming Chart"** in this TSB), proceed with the next step. Click the Home button to return to the System Select screen.

If the Software Part Number **is** at the latest level, then reprogramming is not necessary.

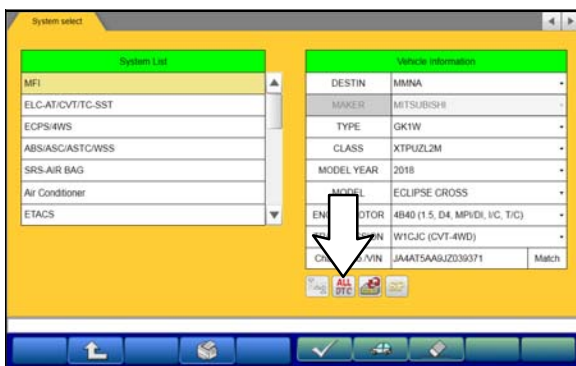
a. On the System Select screen click the "ALL DTC" button.

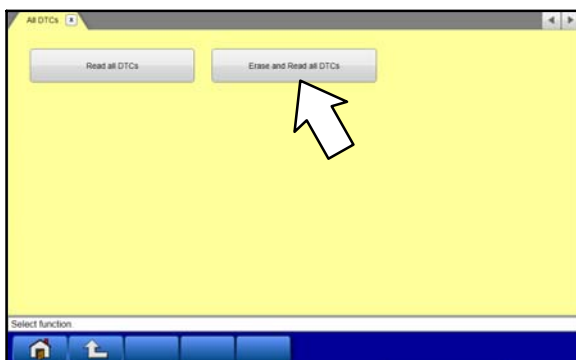
b. Select "Erase and Read All DTCs."

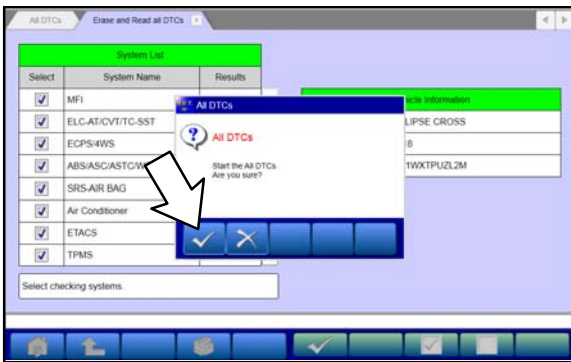
- c. A window will pop up asking you to confirm DTC erasing. Click the check mark in the dialog box for DTC erasing and reading to begin.

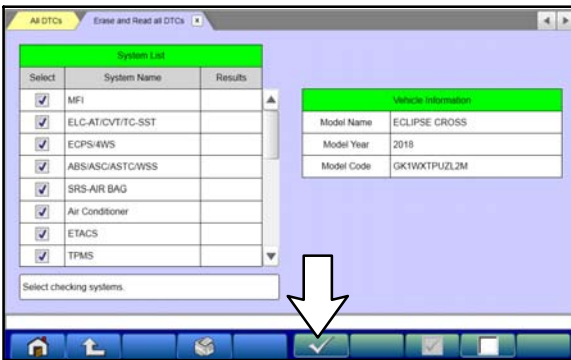
- d. The "System List" on the left side of the screen will have all selections checked. Do not change these selections.

- e. Click the check mark to continue.

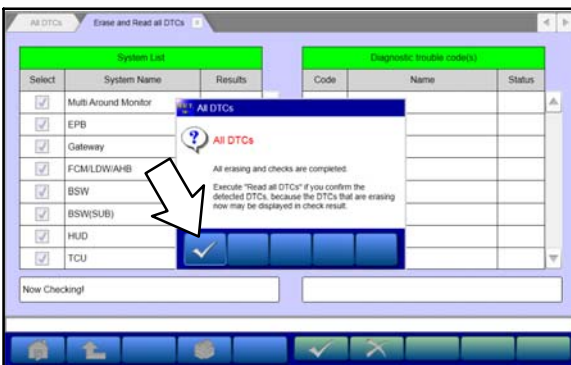
7. When DTC erasing is completed, click the check mark in the pop-up message that reads "All erasing and checks are completed."

- a. If any DTCs return after erasing is completed, click the check mark to clear the window. Diagnose and repair per the Service Manual.

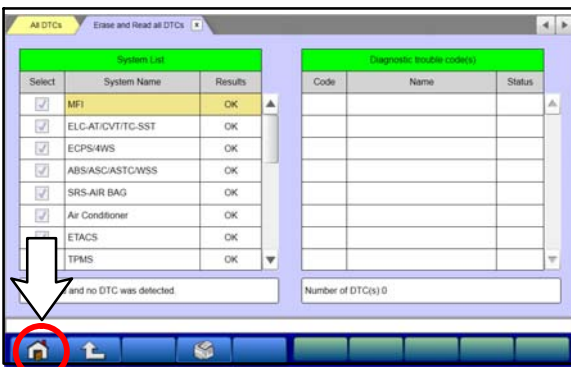
- b. If DTCs do not return, click the check mark to clear the window, then click the Home icon in the lower left to return to the System Select menu.

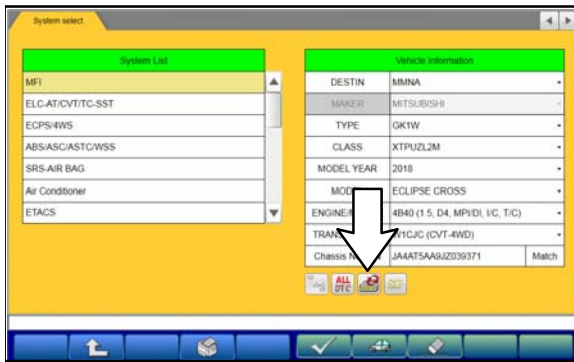
a. On the System Select page, click on the Reprogram button.

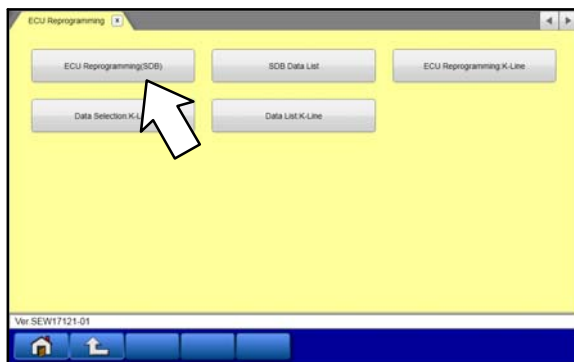
b. Select "ECU Reprogramming (SDB)."

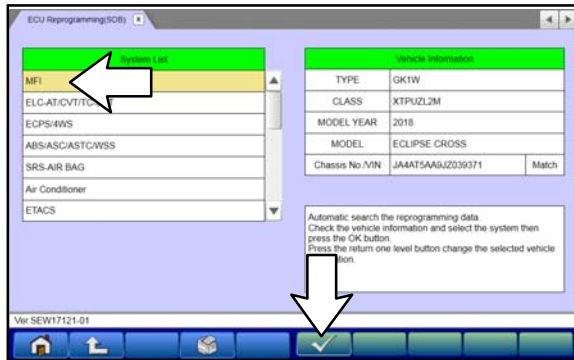
c. Select "MFI" in the System List, then click the check mark.

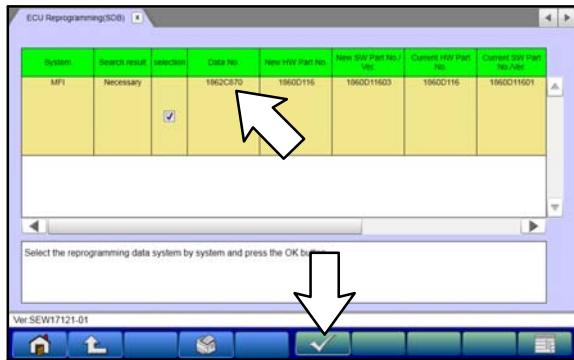
d. Verify that the correct data file listed in the table matches the one in the "ECU Reprogramming Chart."

e. Click the check mark at the bottom of the page to initiate reprogramming.

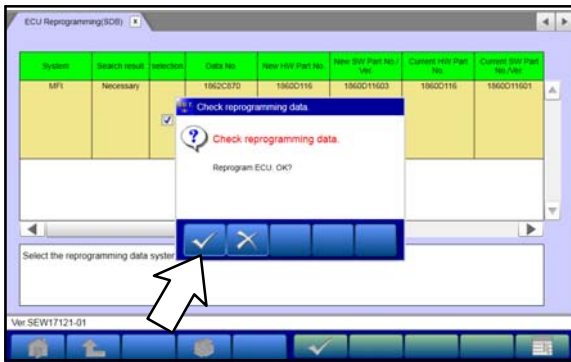
- f. Click the check mark in the "Check reprogramming data" dialog box.

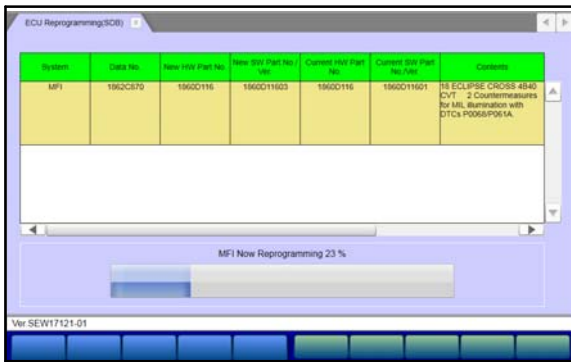
- g. Once the reprogramming is initiated, the screen shown will indicate the reprogramming progress.

NOTE: Do NOT disturb the cables or turn off the ignition during reprogramming.

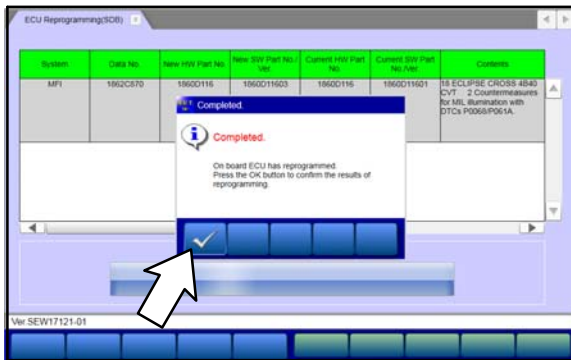
- h. Once reprogramming is completed, click the check mark in the "Completed" dialog box.

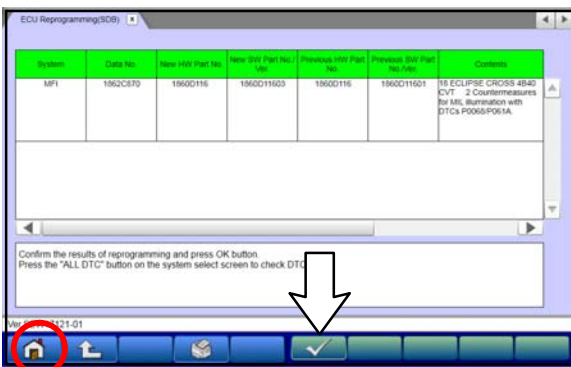
- i. Verify the correct information is listed in the table. Click the check mark at the bottom of the page, then click the Home button to return to the System Select screen.

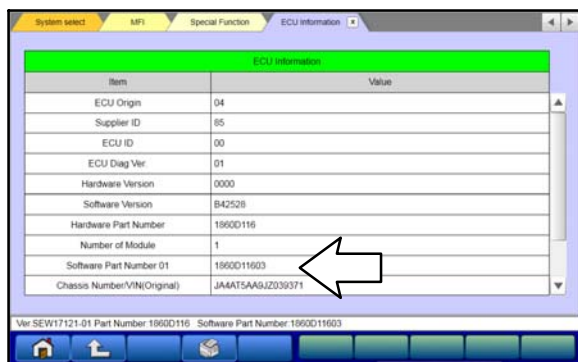
Confirm "Software Part Number" now matches the NEW one shown in the **"ECU Reprogramming Chart"** in this TSB.
