# QUALITY ACTION

## CAMPAIGN BULLETIN

### Electronic Control Module (ECM) Reprogram Dealer Inventory

Reference: PC663  
Date: October 26, 2018

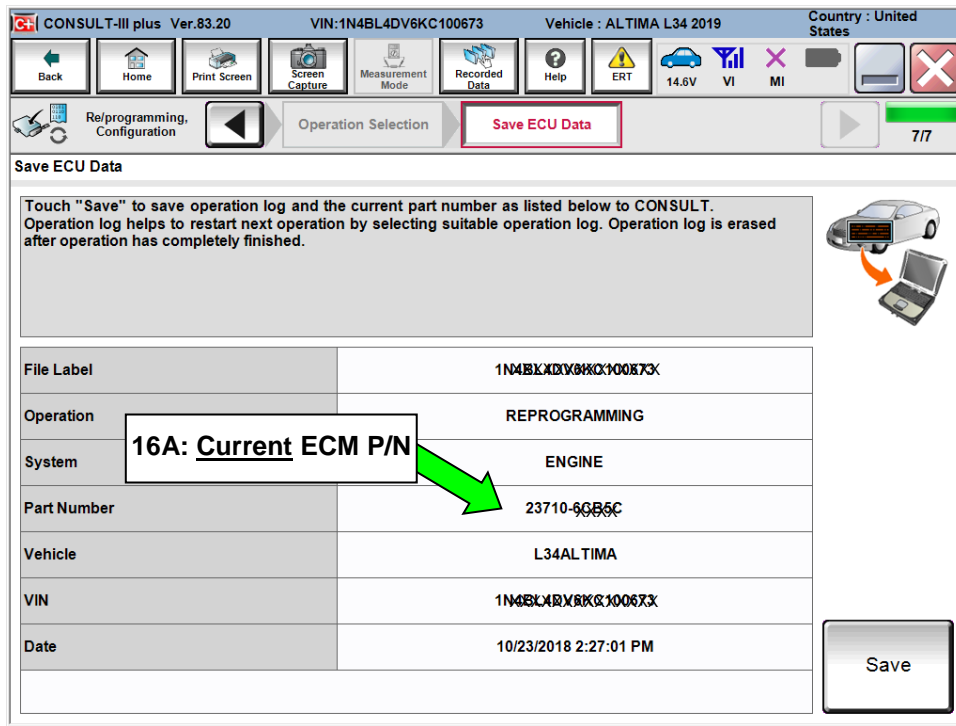
Figure 7

16. When you get to the screen shown in Figure 7, confirm this bulletin applies as follows.

A. Find the ECM **Part Number** and write it on the repair order.

**NOTE:** This is the current ECM Part Number (P/N).

B. Compare the P/N you wrote down to the numbers in the **Current ECM Part Number** column in **Table A**, below.

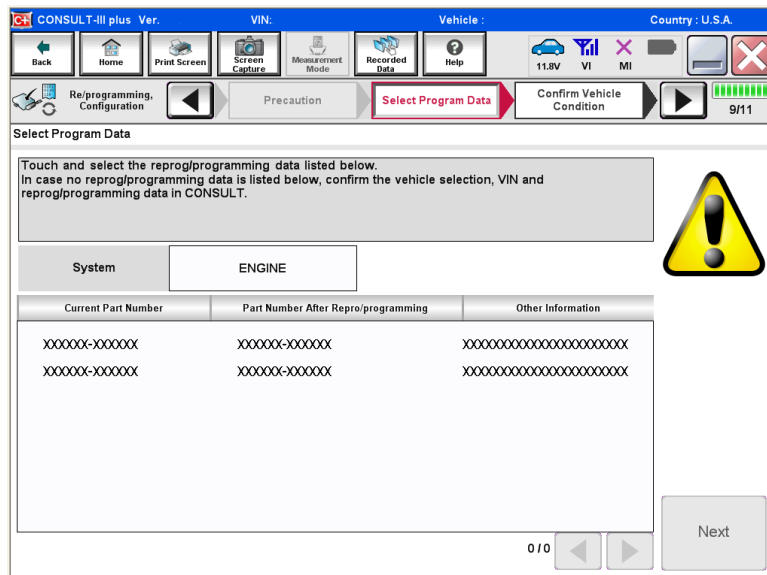
- In some cases, more than one new P/N for reprogramming is available.
  - In this case, the screen in Figure 10 displays.
  - Select and use the reprogramming option that **does not** have the message “Caution! Use ONLY with NTBXX-XXX”.
- If you get this screen and it is blank (no reprogramming listed), it means there is no reprogramming available for this vehicle). Refer to the CLAIMS INFORMATION and submit a claim using OP-CODE PC6631 (Does Not Require ECM Reprogram).

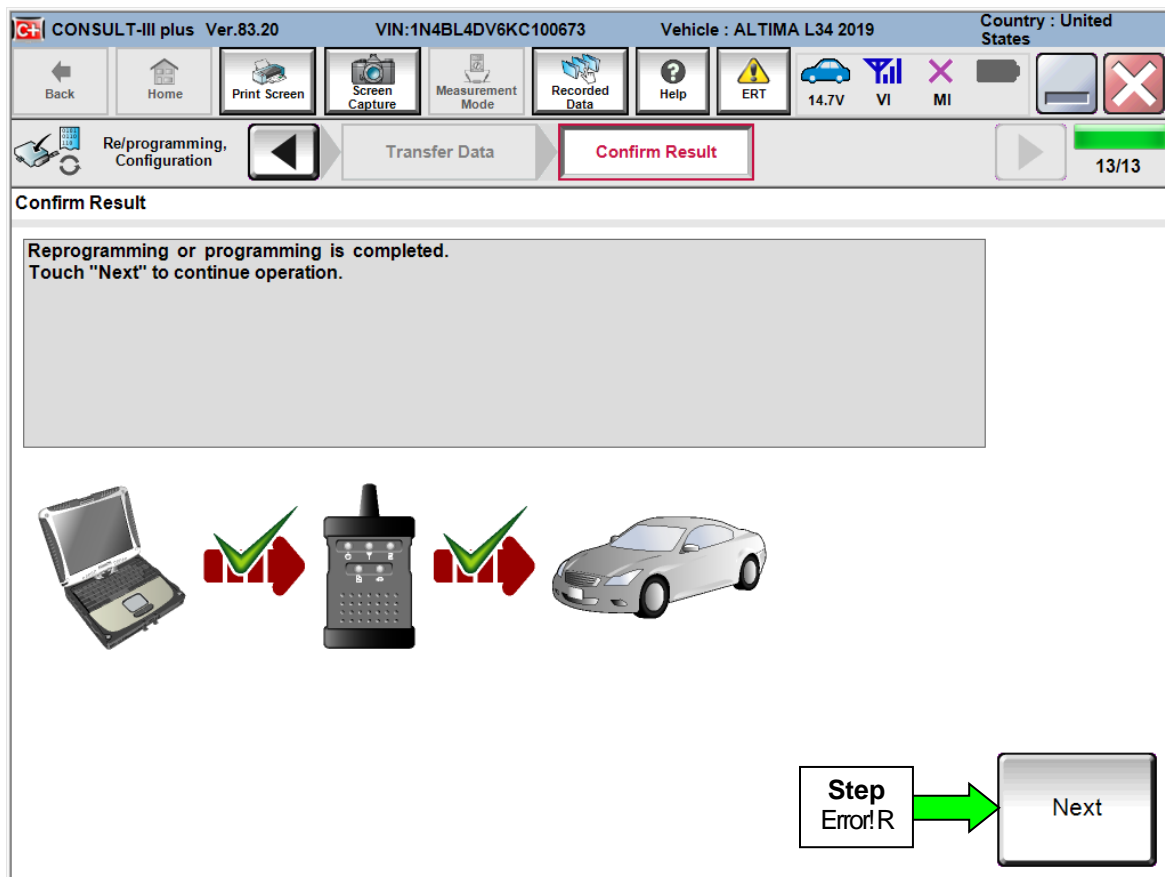
25. When the screen in Figure 14 displays, reprogramming is complete.

**NOTE:** If the screen in Figure 14 does not display (reprogramming does not complete), refer to the information on page 12.

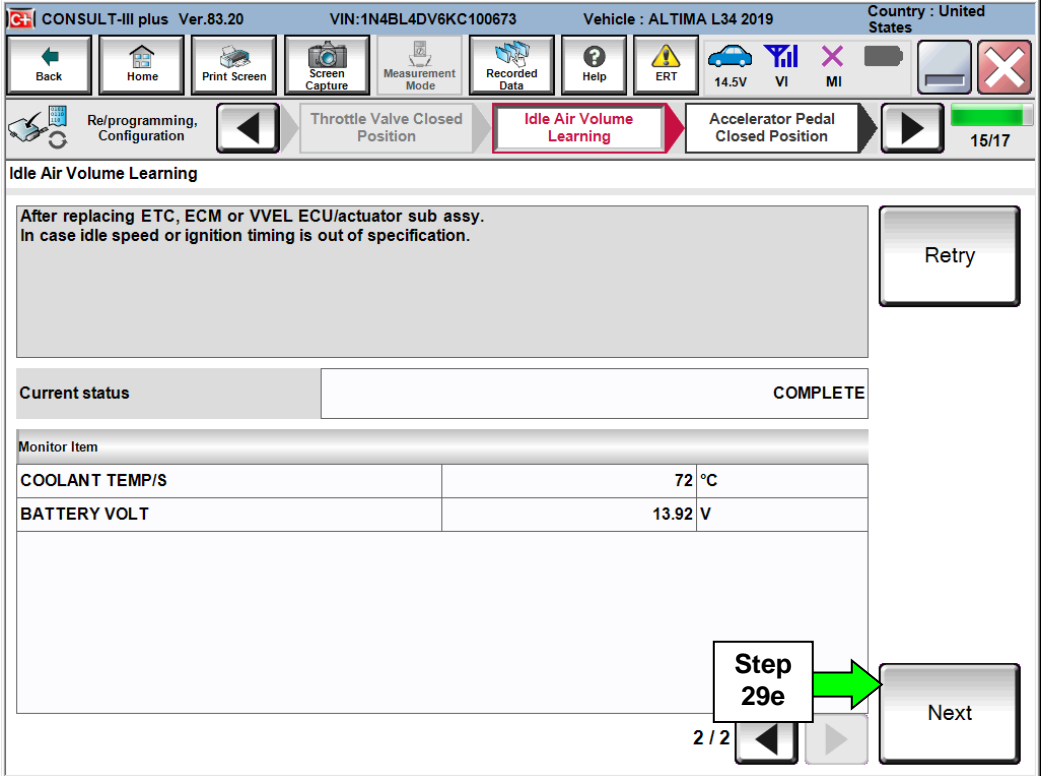
e. Select **Next**.

d. Wait for IAVL to complete (Screen in Figure 21 will be displayed).

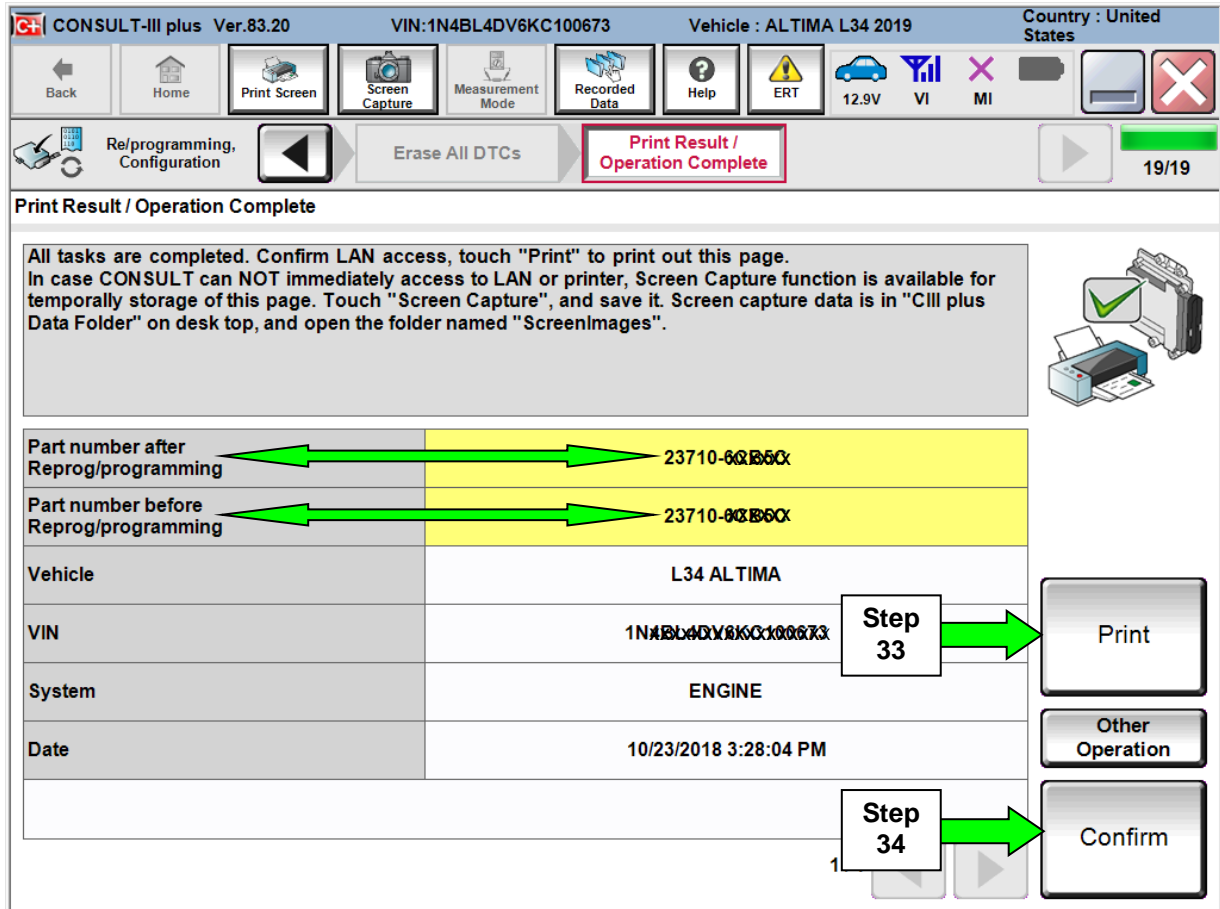
Figure 25

33. Print a copy of this screen (Figure 25) and attach it to the repair order.

**NOTE:** The before and after part numbers may be the same or different.
