WJ65 Re-programming PDK Control Unit (Workshop Campaign)

Vehicle Type: **Panamera (971)**

Subject: **PDK control unit**

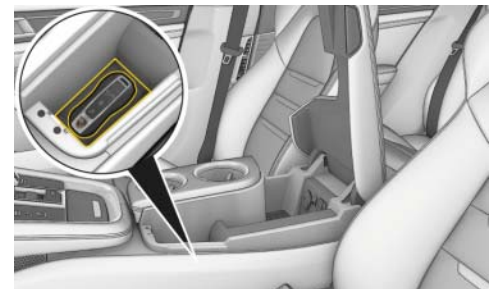
Driver's key in storage compartment

2 Place the driver's key with the back facing down in the front left storage compartment in the center console ⇒ *Driver's key in storage compartment*. This will guarantee an uninterrupted radio link between the vehicle and the driver's key.
