November 6, 2018

Version 1

2018 Odyssey: Bluetooth® HandsFreeLink® Will Freeze After Calls and Voice Tags Are Missing at Startup

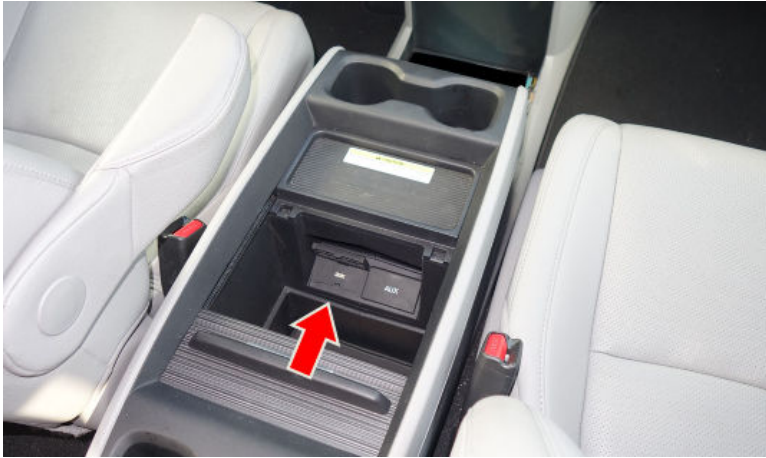
- Update the audio unit software by plugging in the USB drive into the USB port. The audio unit will automatically detect the USB drive tool and start the update process.

- Never disconnect the battery, turn the ignition to OFF, disconnect the USB drive tool, or press the **BACK** button while the update is in progress.

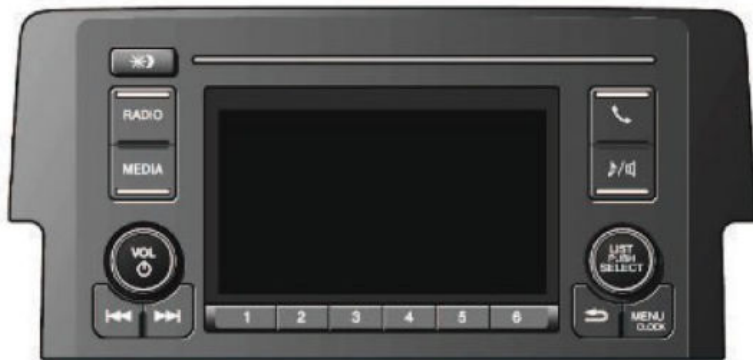
- The screen will go black and the buttons will begin blinking. The blinking will speed up every 10% of progress.
