## 2016-17 Pilot: Bluetooth® HandsFreeLink® Will Freeze After Calls and Voice Tags Are Missing at Startup.

### AFFECTED VEHICLES

Year	Model	Trim	VIN Range
2016-17	Pilot	LX	ALL

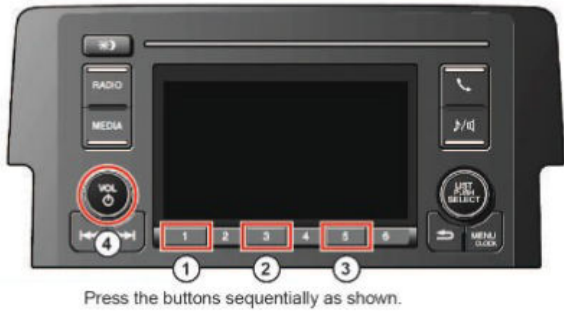
- With the audio unit turned off, press the buttons in sequential order as shown.

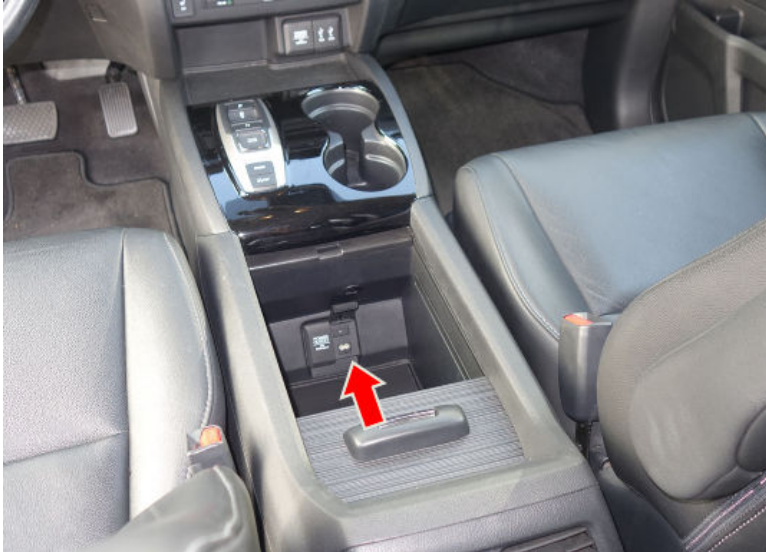
- 9. Update the audio unit software by plugging in the USB drive into the USB port. The audio unit will automatically detect the USB drive tool and start the update process.

- Never disconnect the battery, turn the ignition to OFF, disconnect the USB drive tool, or press the **BACK** button while the update is in progress.

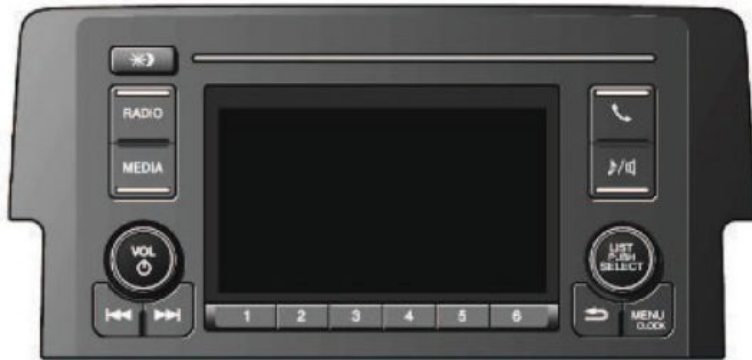
- The screen will go black and the buttons will begin blinking. The blinking will speed up every 10% of progress.

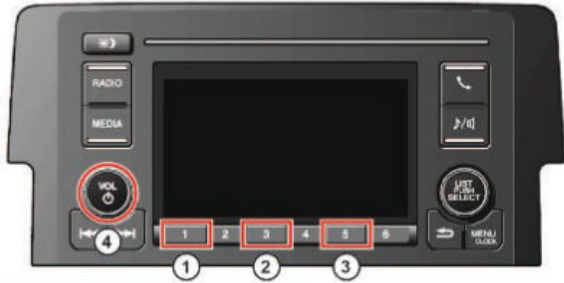
1. With the audio unit turned off, press the buttons in sequential order as shown.

Press the buttons sequentially as shown.
