## 2017 Ridgeline: Bluetooth® HandsFreeLink® Will Freeze After Calls and Voice Tags Are Missing at Startup

### AFFECTED VEHICLES

Year	Model	Trim	VIN Range
2017	Ridgeline	LX	ALL

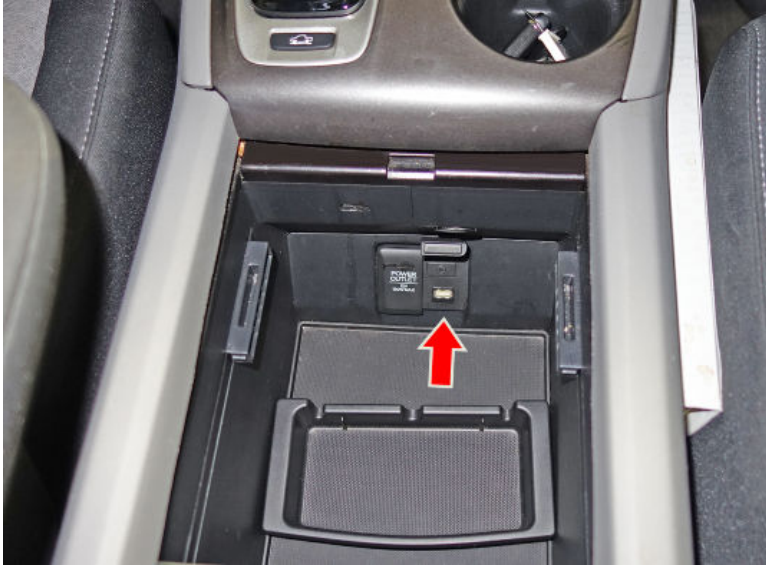
- Update the audio unit software by plugging in the USB drive into the USB port. The audio unit will automatically detect the USB drive tool and start the update process.

- Never disconnect the battery, turn the ignition to OFF, disconnect the USB drive tool, or press the **BACK** button while the update is in progress.

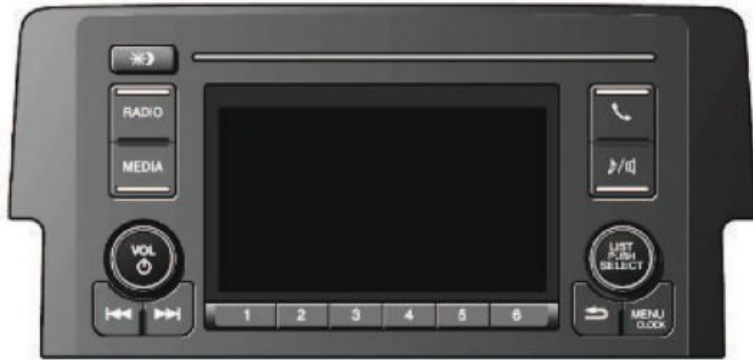
- The screen will go black and the buttons will begin blinking. The blinking will speed up every 10% of progress.
