# Technical Service Bulletin

## 45E3 UPDATE – Software Update Package (NVLW)

Model(s)	Year	VIN Range	Vehicle-Specific Equipment
Audi A4	2017	See Campaign/Action screen in Elsa	None

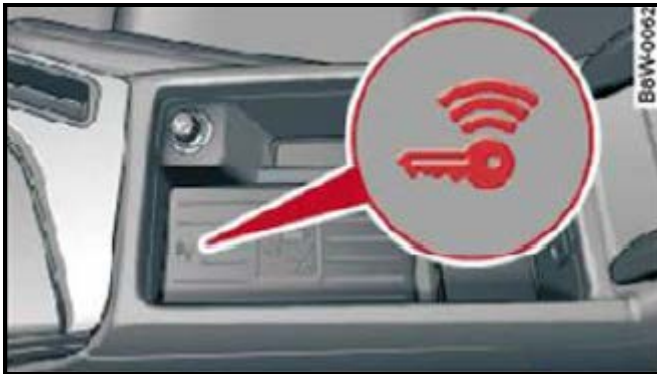
1. Place the vehicle key on the key symbol in the center console storage compartment and keep it there during the entire update process.

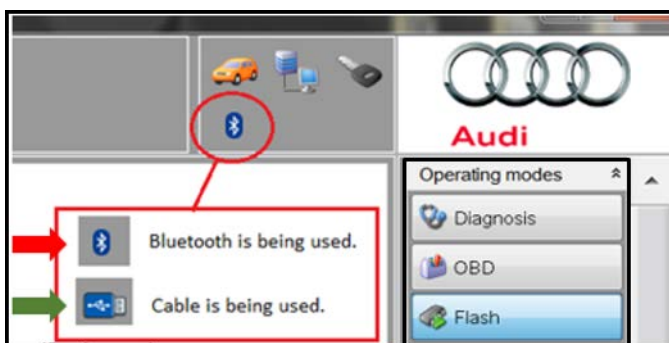
2. Follow all instructions in TSB 2011732: *00 Software Version Management (SVM), operating instructions*.
3. Attach an appropriate battery charger to the vehicle.
4. Attach the scan tool to the vehicle using an USB cable.
5. Confirm that the scan tool is communicating with the diagnostic head by USB <Green Arrow>. If the Bluetooth symbol is shown <Red Arrow> then disconnect the diagnostic head from the vehicle and then reattach the USB cable to the diagnostic head and then reattach to the vehicle.

6. Using **"Flash"**, perform the update using the SVM action code, **45E3A300**.

REVISION HISTORY		
Revision	Date	Purpose
1	November 22, 2016	Original publication
2	August 10, 2018	Updated photo in work instructions to reflect that the “Flash” operating mode must be used.
