Emissions Recall

Code: 23V1

Subject	3.0L TDI Engine Emissions System Modification
Release Date	July 26, 2018
Affected Vehicles	U.S.A.: 2011-2012 MY Volkswagen Touareg 3.0L TDI Generation 1.2 <i>Check Campaigns/Actions screen in Elsa on the day of repair to verify that a VIN qualifies for repair under this action. Elsa is the <u>only</u> valid campaign inquiry & verification source.</i> <ul style="list-style-type: none">✓ Campaign status must show "open."✓ If Elsa shows other open action(s), inform your customer so that the work can also be completed at the same time the vehicle is in the workshop for this campaign.
Problem Description	3.0 TDI vehicles were equipped with undisclosed Auxiliary Emission Control Devices which are not permitted by emissions regulations.
Corrective Action	Install updated engine control module (ECM) software, transmission control module (TCM) software and hardware to bring affected vehicles into regulatory compliance.

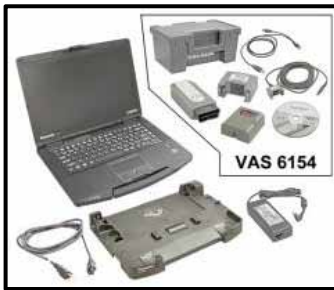
VAS6150X - Diagnostic Tester (or equivalent)
 VAS6154 - Vehicle Communication Interface (or equivalent)

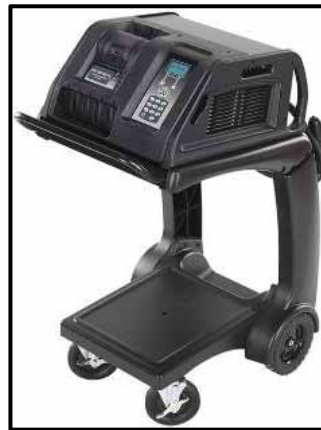
GRX3000VAS – Battery Tester/Charger (or equivalent)

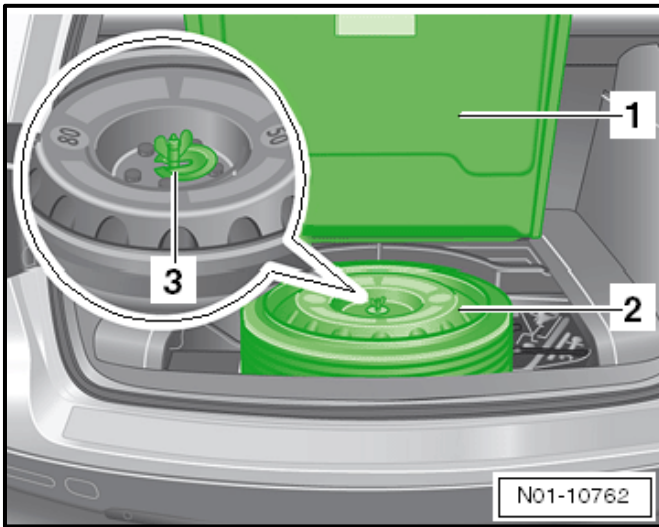
- Lift the rear compartment carpet <1> and slide it back.
- If equipped remove the spare tire <2> by removing the wing nut <3>.
- If equipped remove the foam piece <3>.

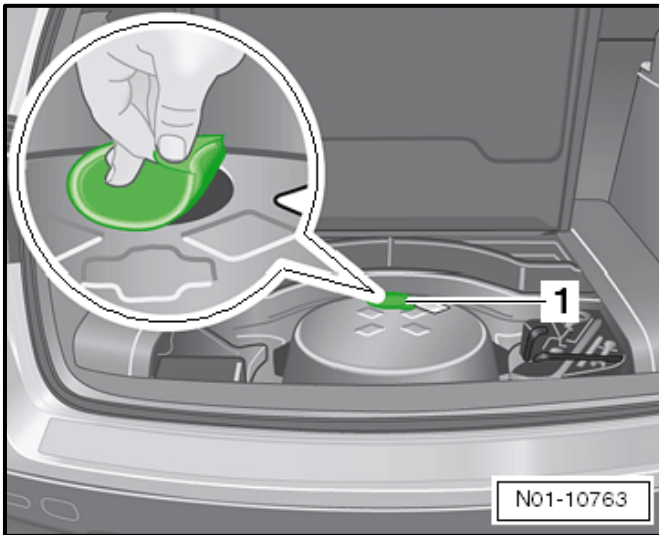
- Protect the hands when prying the plug out of the tank filler neck.
- Sharp-edged body components could cause injury.
- Remove the plug from the fuel tank filler neck <1>.

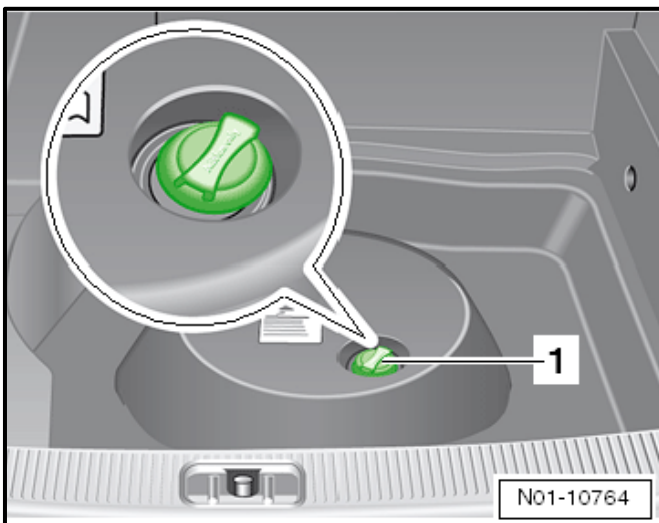
- Open the AdBlue filler cap <1> and fill the tank.

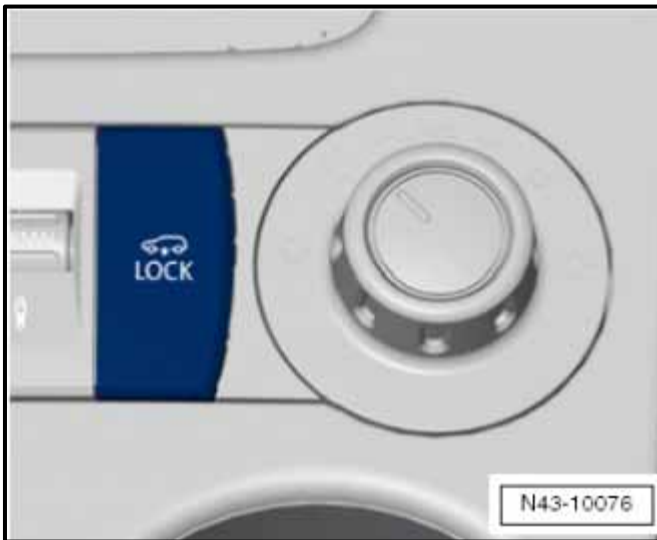
If equipped with air suspension:

- Switch the ignition on.
- Switch the electrical parking brake on.
- Press the **LOCK** button in the center console for 5 seconds.
 - The Vehicle Lift Mode is displayed in the Instrument cluster and the indicator lamp in the **LOCK** button flashes when vehicle is ready to lift.
- Turn off the ignition.

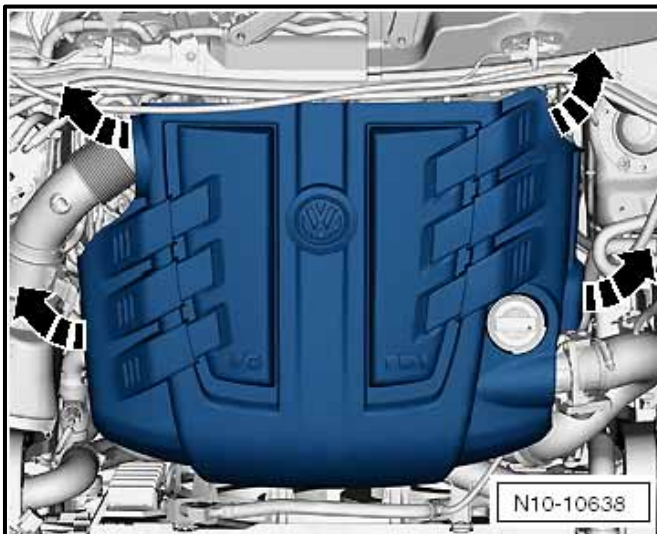
- Carefully pull the engine cover off the bolts one after the other in direction of <arrows>. Do not pull sharply on the engine cover or pull it to one side.

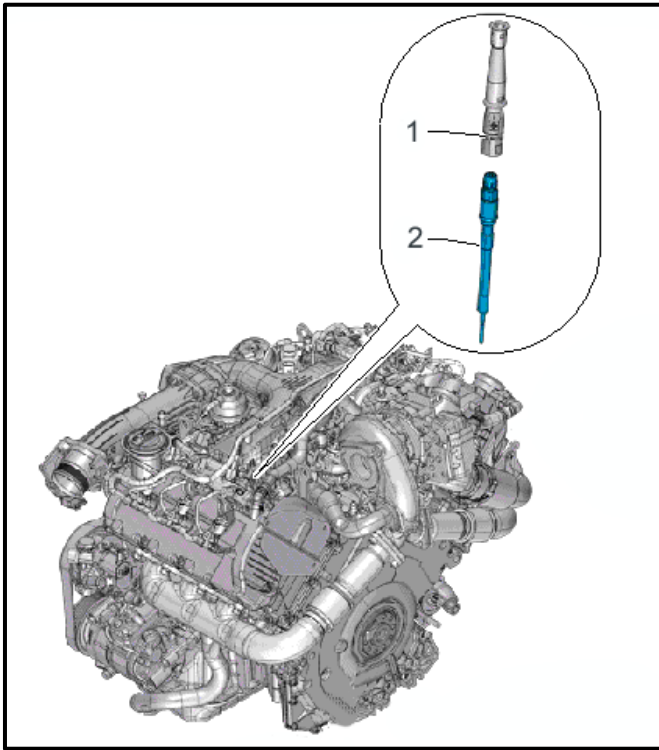
- Disconnect the glow plug connector <1> from Cylinder 2 and Cylinder 5 Glow Plug with Combustion Chamber Pressure Sensors (G678) <2>.
- Clean the glow plug ducts in the cylinder head (contaminants must not fall into the cylinder).

- Extract large contaminants with a vacuum cleaner.
 - Spray a brake cleaner or a suitable cleaner into the glow plug shaft, let it work and then use compressed air to remove it.
 - Then clean the glow plug duct with a rag dampened with oil.
- Loosen the Cylinder 2 and Cylinder 5 Glow Plug with Combustion Chamber Pressure Sensors (G678) <2> using Glow Plug Socket – VAS6454.
 - Carefully remove the Cylinder 2 and Cylinder 5 Glow Plug with Combustion Chamber Pressure Sensors (G678) by hand or with a hose without bending it.
 - Carefully install new Cylinder 2 and Cylinder 5 Glow Plug with Combustion Chamber Pressure Sensors (G678) <2> by hand or with a hose without bending them.

- Using Glow Plug Socket - VAS6454, tighten to 12 Nm.
- Reconnect the glow plug connectors <1> from Cylinder 2 Glow Plug with Combustion Chamber Pressure Sensors (G678) <2> and make sure they are secure.

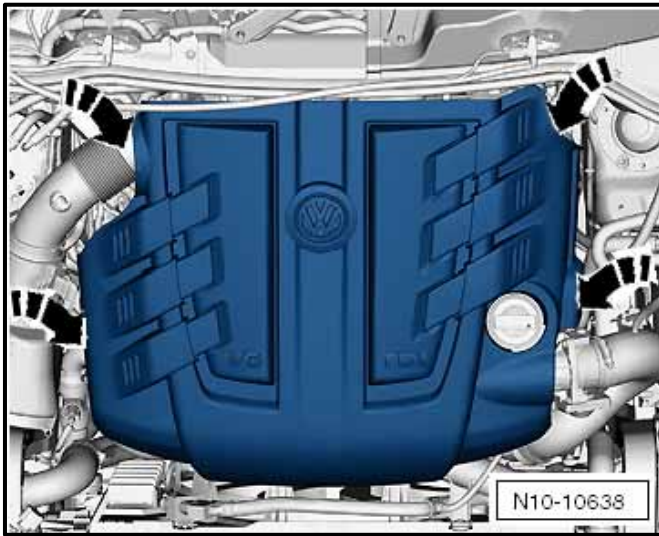
- Reinstall the engine cover by first pushing the cover with both hands into the rubber grommets in the rear and then into the rubber grommets in the front.

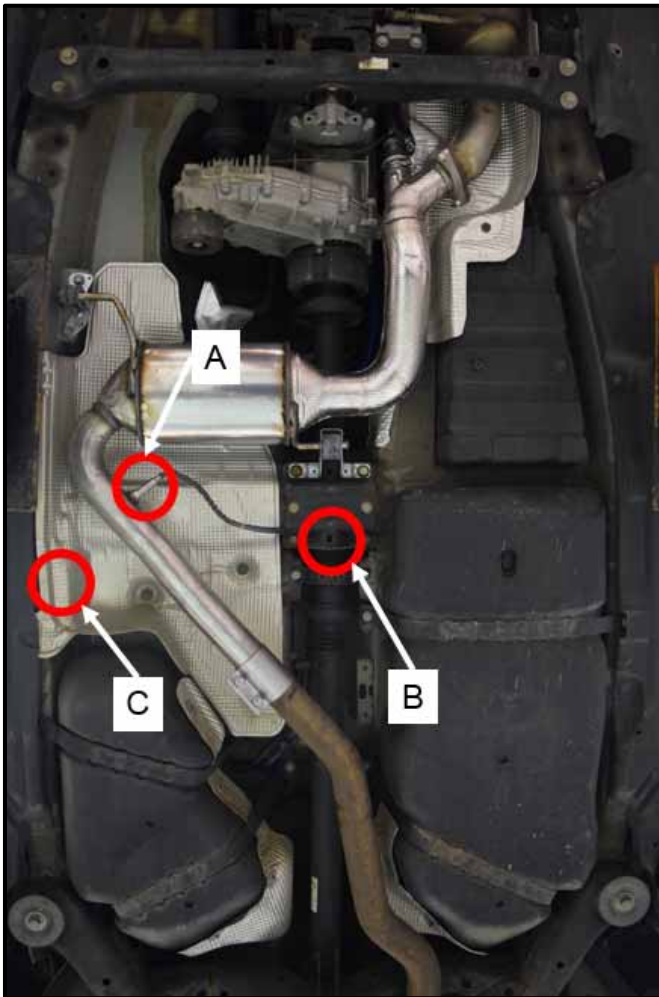
Figure <A>

Remove the NOx #2 sensor <1> from the catalyst pipe.

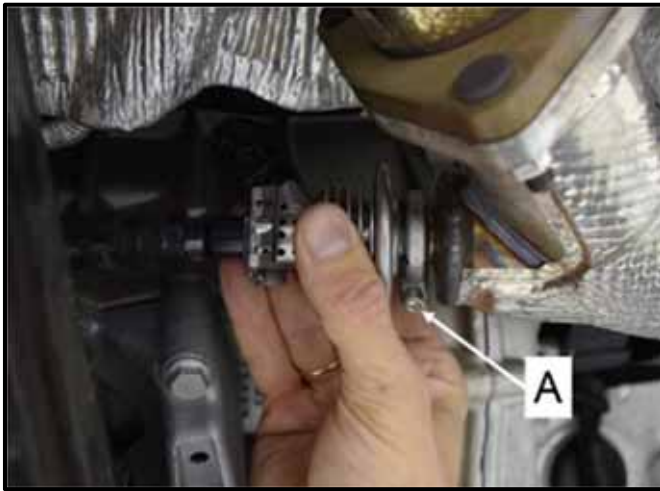
- Loosen the screw <A> and remove the clamp from the Reducing Agent Injector -N474-.
- Leave the electrical connector and the Reducing Agent Injector AdBlue feed line connected at this time. This will reduce the possibility of contaminating the electrical connection with AdBlue.
- Secure the Reducing Agent Injector out of the way with a tie strap (or equivalent).

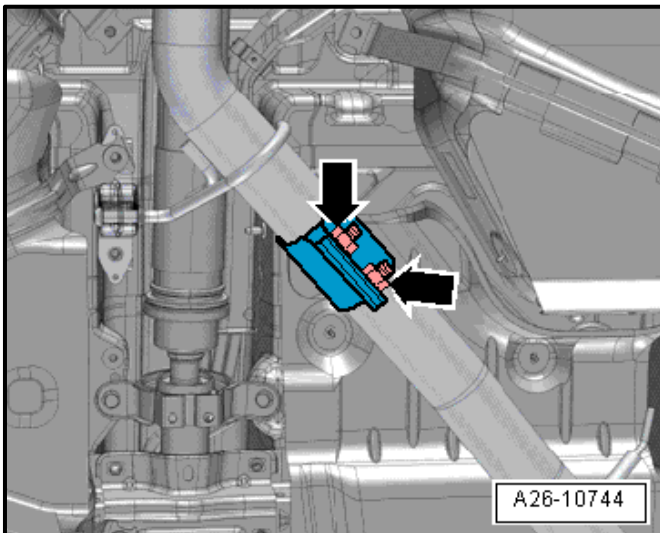
- Loosen the two nuts on the Dual Clamp <arrows> so the clamp can slide back and forth on the exhaust pipe.
- Leave the clamp in the installed position at this time. This will assist in holding the SCR Catalyst in place while removing the brackets in the next step.

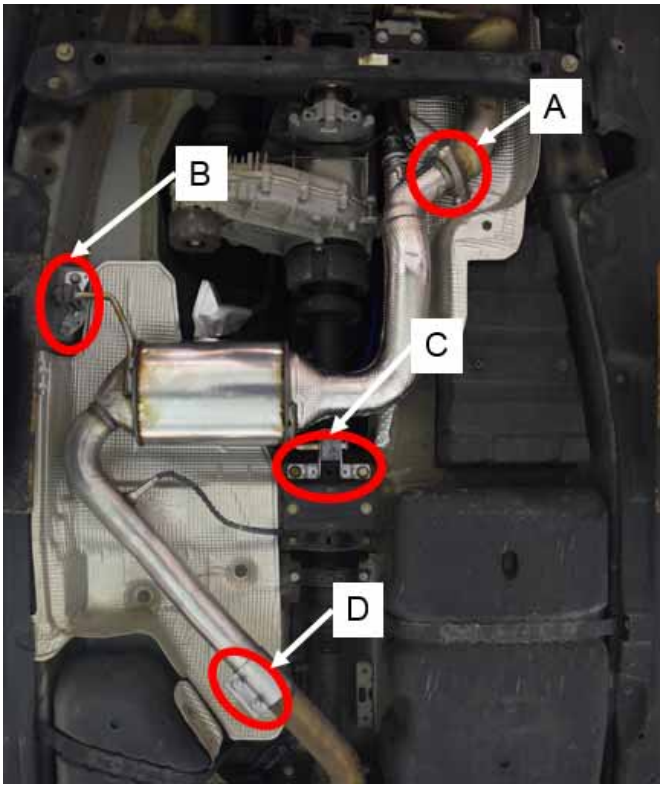
- With the assistance of a second technician, remove the three nuts <A> from the exhaust studs securing the SCR Catalyst to the Diesel Particulate Filter (DPF).
- Remove the bolts from SCR Catalyst brackets at locations <B and C> with assistance from second technician to support the SCR Catalyst while the brackets are removed.
- Slide the Dual Clamp <D> towards the rear of the vehicle, and with the assistance of a second technician, remove the SCR Catalyst from the vehicle.
- Remove the Dual Clamp <D> from the exhaust pipe and discard.

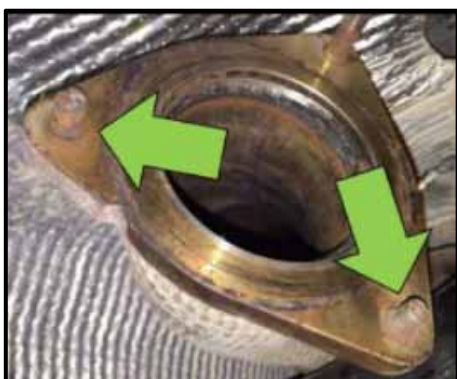
OTC 5057 Clevis Pin Press

- If stud replacement is necessary, **IT IS REQUIRED** to use a press tool such as the OTC 5057 clevis pin press (or equivalent), or other available screw or hydraulic type clevis/stud press tool to remove all necessary studs from the rear DPF flange.

- It is advised if one stud breaks that all three studs are pressed out and replaced with the bolts/nuts included in the parts kit.
 - Lubricate the OTC 5057 clevis/stud press tool threads and the press pin contact tip with hot bolt paste or anti-sieze lubricant before each use.

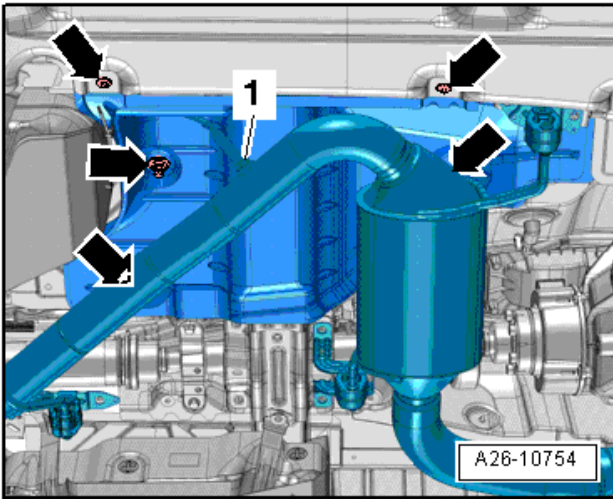
MY 2011 ONLY:

- Loosen the mounting elements <arrows> and move the heat shield to the left.

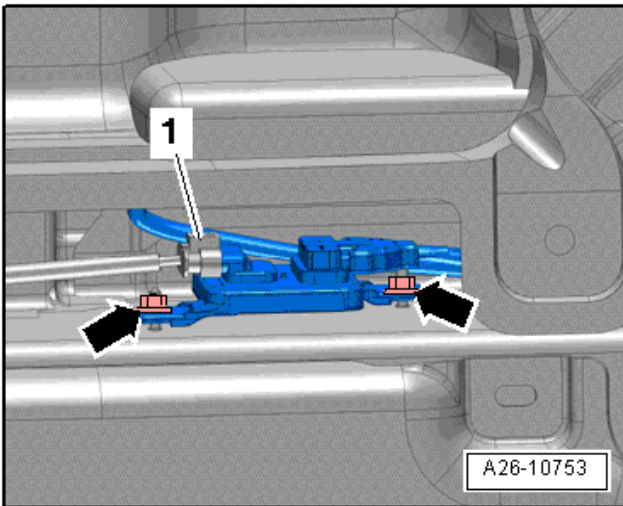
MY 2011 ONLY:

- Disconnect the electrical connector <1> from the NOx Sensor Control Module 2 -J881-.
- Remove the nuts <arrows> and remove the NOx Sensor Control Module 2 -J881- and NOx Sensor 2 -G687- as an assembly.

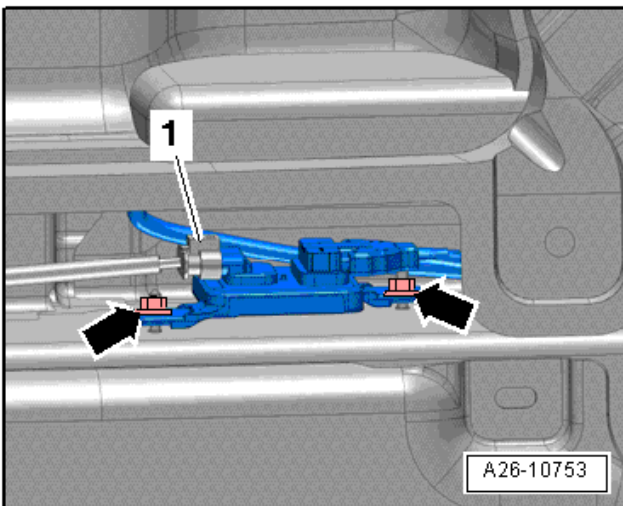
MY 2011 ONLY:

- Install new NOx sensor Control Module 2 -J881- and tighten the nuts <arrows> to 3.5 Nm.
- Connect the electrical connector <1>.

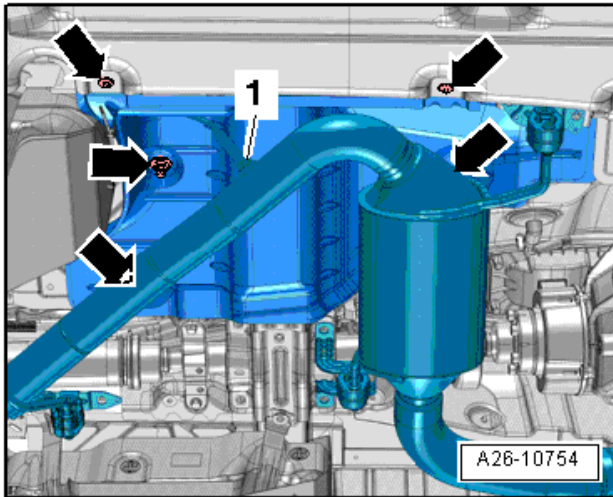
- Reinstall the heat shield and tighten the mounting elements <arrows>.

- Install the new (MY 2011) or original (MY 2012) NOx Sensor 2 -G687- <1> and tighten to 50 Nm.

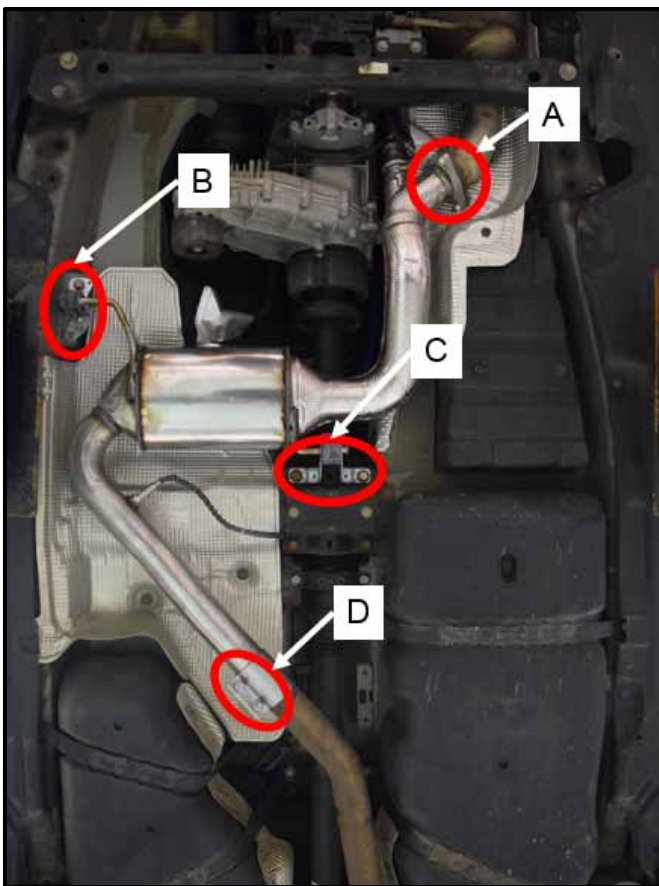
Coat the threads on the nuts and exhaust studs/bolts <A> with hot bolt paste prior to installation. Refer to the Parts Catalog.

- Install the new exhaust Dual Clamp onto the exhaust pipe at location <D> and slide the clamp to the rear of the vehicle, but do not tighten.
- With the assistance of a second technician, install the new SCR Catalyst with a new gasket between the SCR Catalyst and DPF <A>. Fit the SCR Catalyst onto the DPF flange studs/bolts and install new nuts and tighten to 23 Nm.
- Slide the Dual Clamp into the installed position on the SCR Catalyst, but do not tighten. This will assist in holding the SCR Catalyst in place while the exhaust system is properly tensioned.
- Install the bolts for the SCR Catalyst brackets <B and C> and tighten by hand.

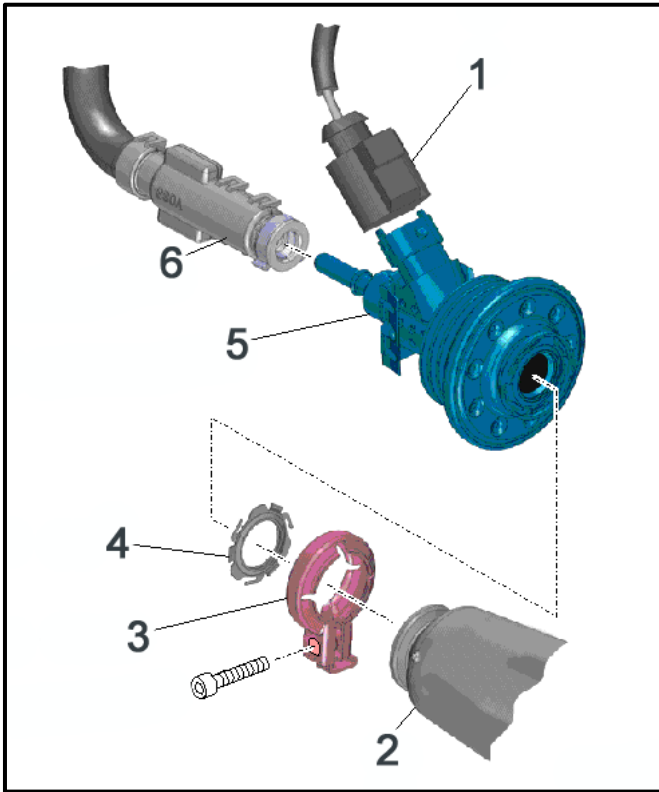
- Install the new Reducing Agent Injector -N474- <5> ensuring that the tabs in the Injector fit properly into the corresponding mounts in the SCR catalytic converter <2> (electric connector faces up).

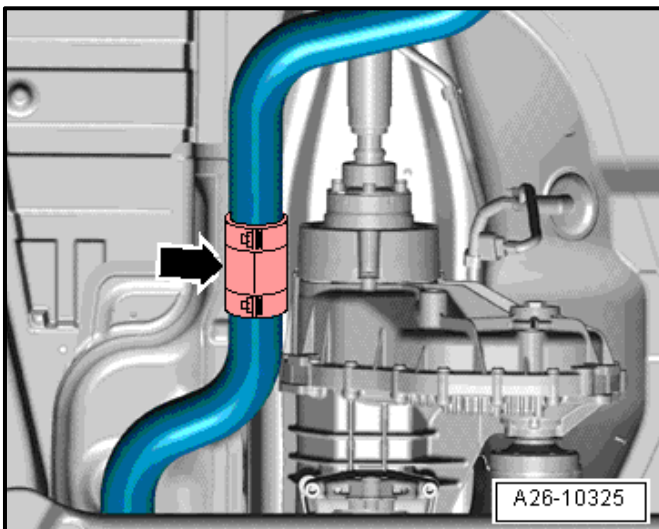
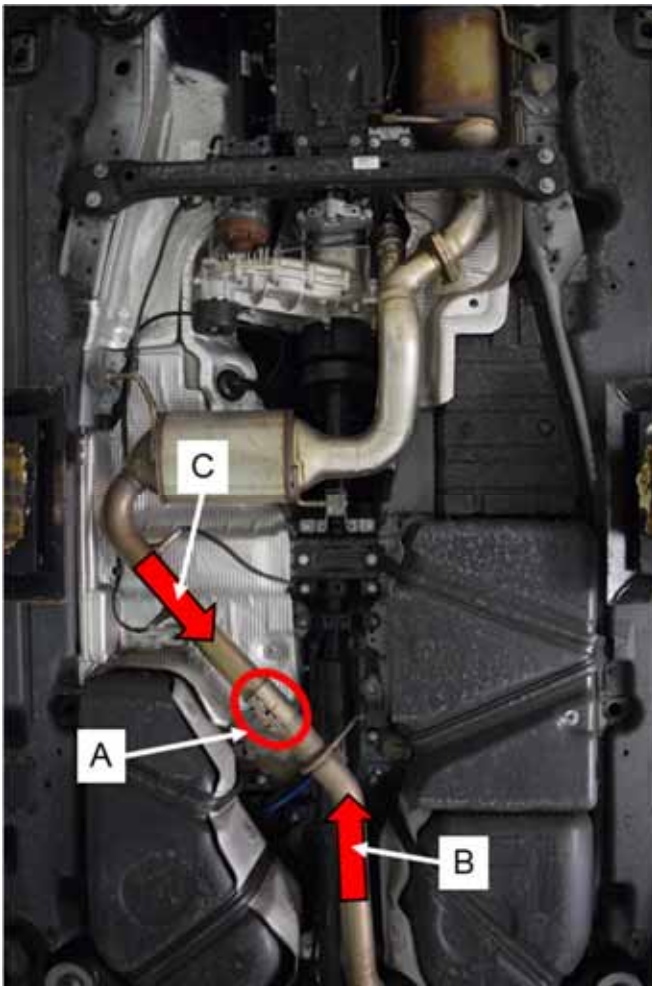
- Tighten the Dual Clamp <A> until there is a slight dragging resistance on both the SCR Catalyst pipe <arrow C> and the rear resonator/muffler pipe <arrow B>, but do not tighten so much that the pipes cannot slide in and out of the Dual Clamp <A>.
- Pretension the rear resonator/muffler hanging straps by pulling the rear resonator/muffler pipe towards the front of the vehicle <arrow B> and pulling the SCR Catalyst pipe towards the rear of the vehicle <arrow C>.

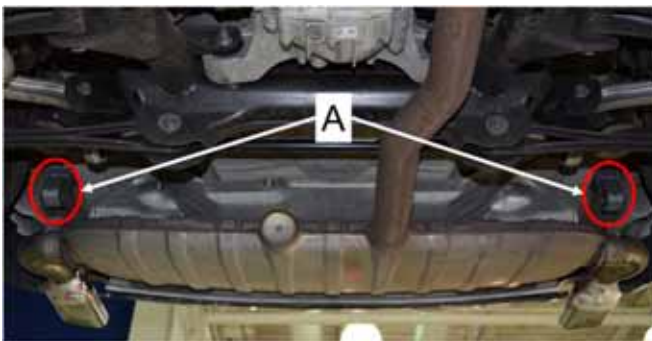
<A> = Rear Resonator Hanging Straps

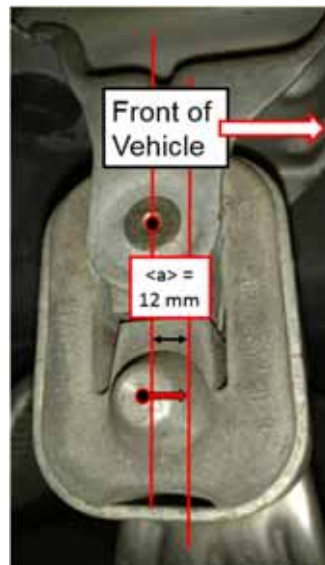
In order to reduce harmonic vibration, the rear muffler/resonator straps require 12 mm of forward tension, as shown in the sub-photo. Pull forward on the rear muffler/resonator pipe and insert the pipe deeper into the Dual Clamp until this dimension is achieved.

- Once the desired dimension of <a> = 12 mm is achieved, tighten the Dual Clamp to 23 Nm.

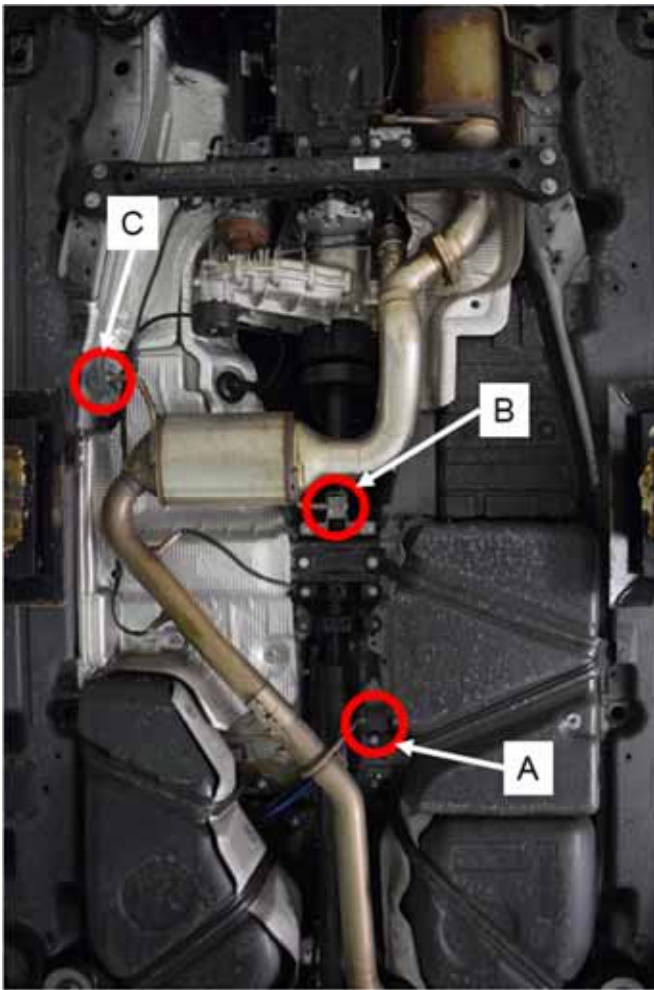
Figure <A>

If necessary, loosen the bolts at the forward resonator pipe hanging strap <A> and adjust the bracket until $\langle a \rangle = 4 \text{ mm}$ of forward tension.

- Tighten the two hanging strap bolts to 23 Nm.

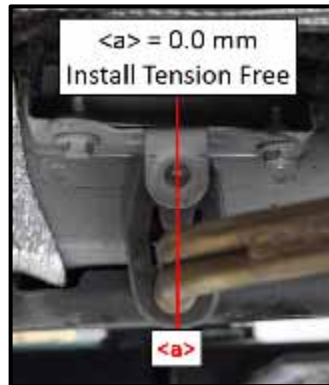
Figure <B and C>

Left and Right SCR hanging straps: $\langle a \rangle = 0.00 \text{ mm}$, install without tension.

If necessary, loosen the bolts at the left and right SCR Cat hanging straps <B and C> and adjust the brackets until $\langle a \rangle = 0.00 \text{ mm}$. The SCR Catalyst hanging straps are installed tension free.

- Tighten the two hanging strap bracket bolts to 60 Nm.
- Tighten the two hanging strap bracket bolts <C> to 23 Nm.

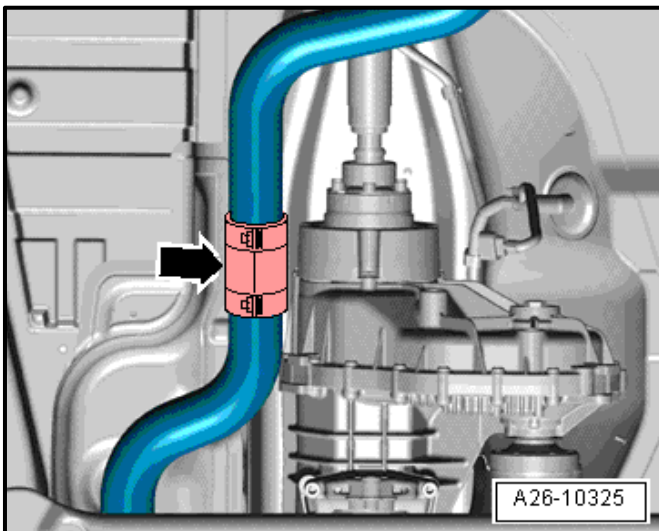
- Hold the exhaust system in this position and tighten the clamping sleeve screws evenly to 23 Nm.

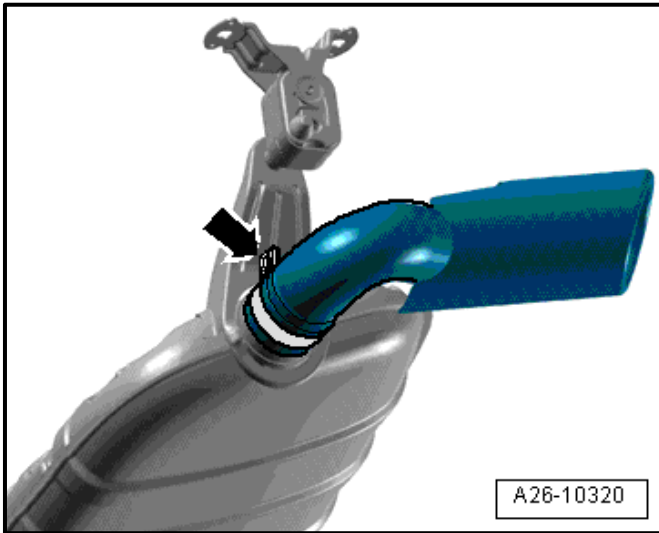
- Align the tailpipes by first loosening the screw-type clamp <arrow> on the tail pipes.

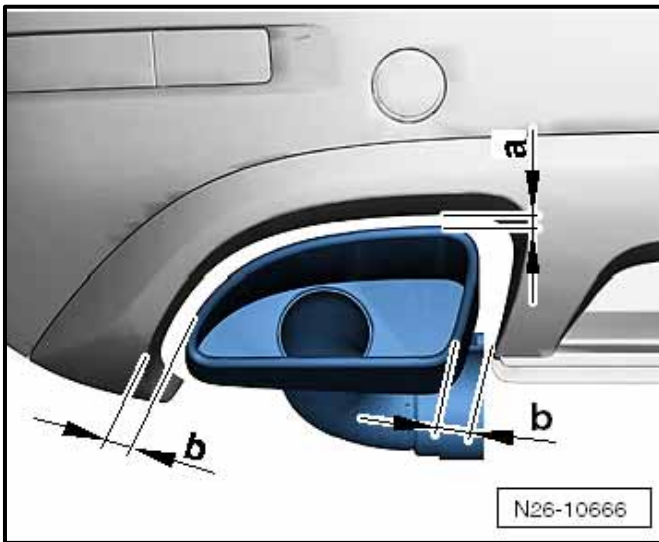
- Adjust the tailpipes to the specifications below.
 - Dimension <a> = 20 mm minimum.
 - Dimension = align evenly.

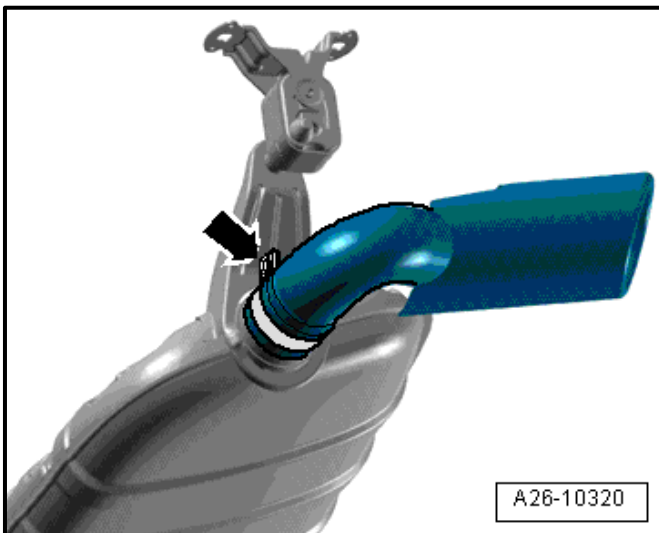
- Tighten the screw-type clamps <arrow> to 60 Nm.

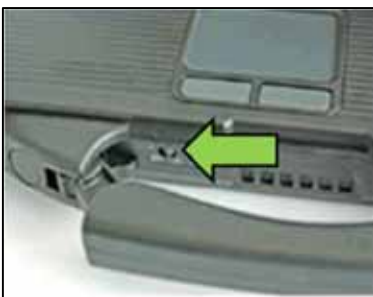
VAS 6150 & VAS 6150A
(Front panel behind handle)

- Performing a software update using a Bluetooth connection increases the risk of losing connection during the update, which could result in damage to the control module. It also greatly increases the time required to perform the update. Requests for additional time or parts will be denied if the GFF log shows the update was performed using Bluetooth.
- ✓ **The Bluetooth function of the scan tool is physically switched off <see pictures below>.**

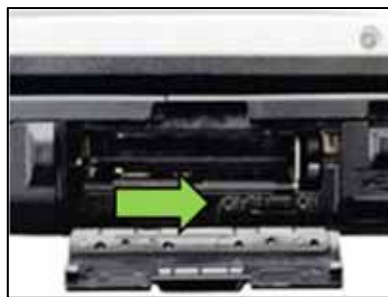
VAS 6150B
(Right side behind WIRELESS door)

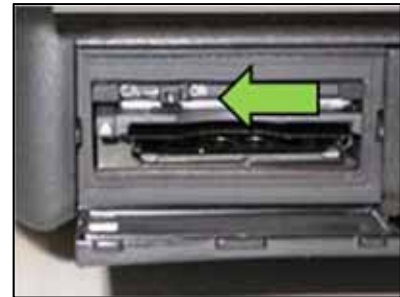
VAS 6150C
(Left side behind SC/EX door)

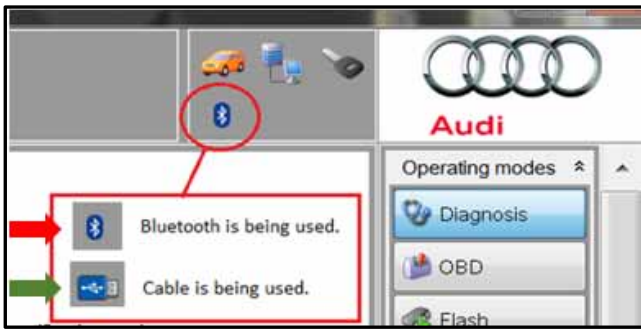
- Confirm that scan tool is communicating with the diagnostic head by USB <Green Arrow>.
 - If the Bluetooth symbol is shown <Red Arrow> then disconnect the diagnostic head from the vehicle and reconnect the USB cable to the diagnostic head and then reattach to the vehicle.
- Upon ODIS startup, verify the “Diagnosis” operating mode is selected <as shown>.

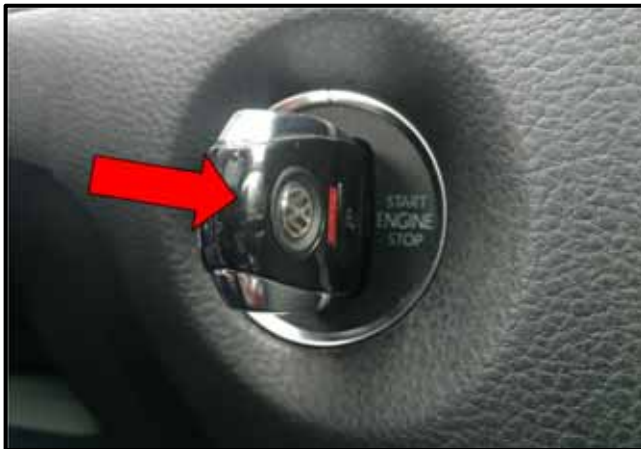
It is **REQUIRED** to insert the key into the reader coil <arrow>, or place the key in the closest proximity possible to the reader coil throughout the flash process.

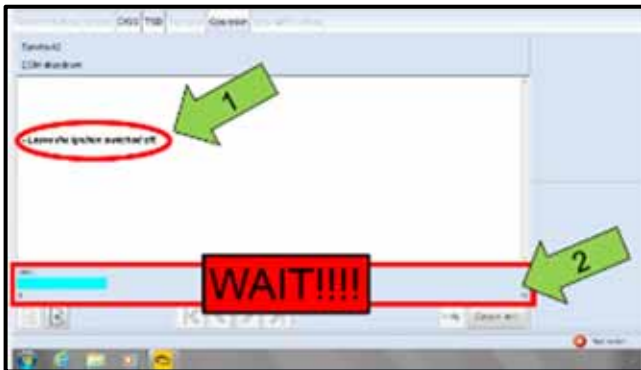
- It is **IMPERATIVE** that **ALL** of the ignition cycle on/off delay requests are fulfilled in their entirety during this flash process <arrow 1>.
- Failing to wait for the ignition on/off timing cycle to complete (progress bar and countdown timer <arrow 2>) before cycling the ignition on/off **MAY** damage a control module.
- Damage to control modules as a result of failing to wait the specified time displayed by the progress bar and countdown timer <arrow 2> are **NOT** covered under this action.

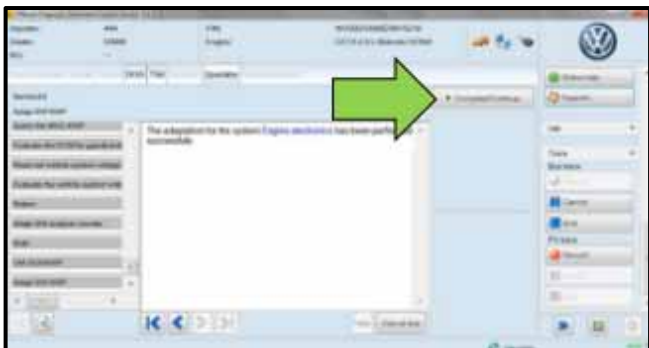
- When the SVM update is complete a confirmation message is displayed <as shown>.
- Select "Complete/Continue" <arrow>.

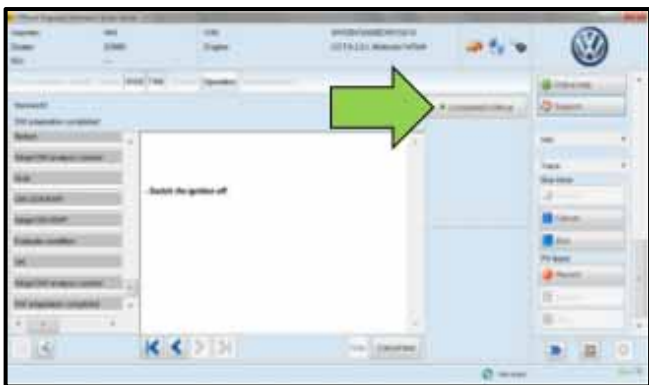
- Switch the ignition off, then select "Complete/Continue" <arrow>.

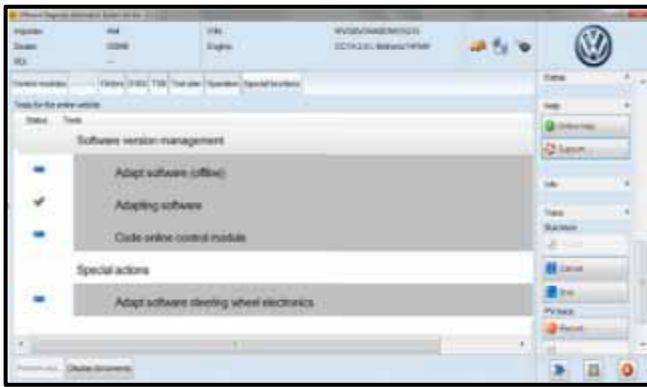
- The green check mark indicates the test plan was successfully carried out.

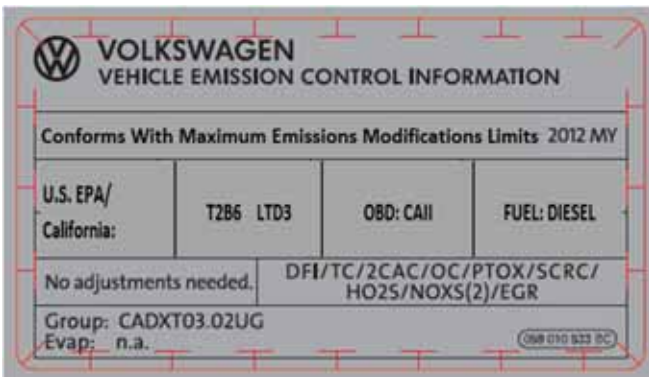
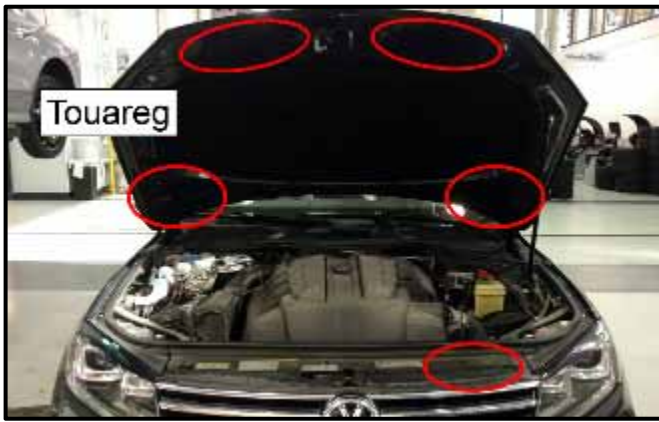
Install Supplemental Vehicle Emissions Control Information Label

- Open the hood.
- Clean the surface where the label is to be installed <circle>.
- Install the supplemental Vehicle Emissions Control Information (VECI) label **059 010 533 BA** or **059 010 533 BC** (based on vehicle model year) according to the chart below, onto the underside of the hood or onto the core support as shown. The Supplemental Vehicle Emissions Control Information (VECI) label and TDI Recall Proof of Completion label should be placed next to each other so that a single photograph can capture both labels.
- Be certain the correct model year sticker is placed on the correct model year vehicle.

- The surface where the label is to be installed must be clean, dry, and free from oil residue prior to installing the label.
- Label must NOT cover any existing label(s).
- Label must be installed in location shown.
- Photo documentation of label installed is required.
