Engine Control Module (ECM) Software

U.S.A.: 2013-2017 MY Beetle Convertible, Beetle, Jetta and 2014-2017 MY Passat CANADA: 2013-2017 MY Beetle & Jetta and 2014-2017 MY Beetle Convertible & Passat

Current ECM software may cause unintended system faults. If present, these faults could lead to illumination of the malfunction indicator light (MIL). If the MIL is on, the vehicle will not pass an emissions inspection.

Update ECM software.

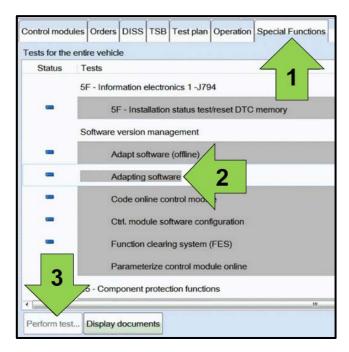
- Confirm that scan tool is communicating with the diagnostic head by USB <Green Arrow>.
 - If the Bluetooth symbol is shown <Red Arrow> then disconnect the diagnostic head from the vehicle and reconnect the USB cable to the diagnostic head and then reattach to the vehicle.
- Upon ODIS startup, verify the "Diagnosis" operating mode is selected <as shown>.
- Once the GFF scan is complete, select "Special functions" <arrow 1>, then "Adapting software" <arrow 2>, then select "Perform test" <arrow 3>.

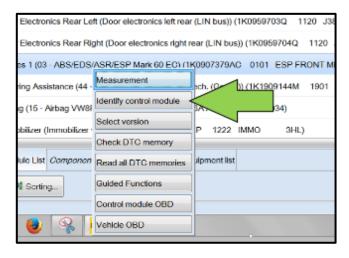
- It is <u>IMPERATIVE</u> that <u>ALL</u> of the ignition cycle on/off delay requests are fulfilled in their entirety during this flash process <arrow 1>.
- Failing to wait for the ignition on/off timing cycle to complete (progress bar and countdown timer <arrow 2>) before cycling the ignition on/off MAY damage a control module.
- Damage to control modules as a result of failing to wait the specified time displayed by the progress bar and countdown timer <arrow 2> are <u>NOT</u> covered under this action.
- After the software update is completed and before sending the GFF Log Online:
 - Select the "Control Module" tab.
 - Scroll down and right click on the module that was updated (0001).
 - Select "Identify Control Module" <arrow>.
