**Freightliner
Service Bulletin**

Important Information

Appearance Zones

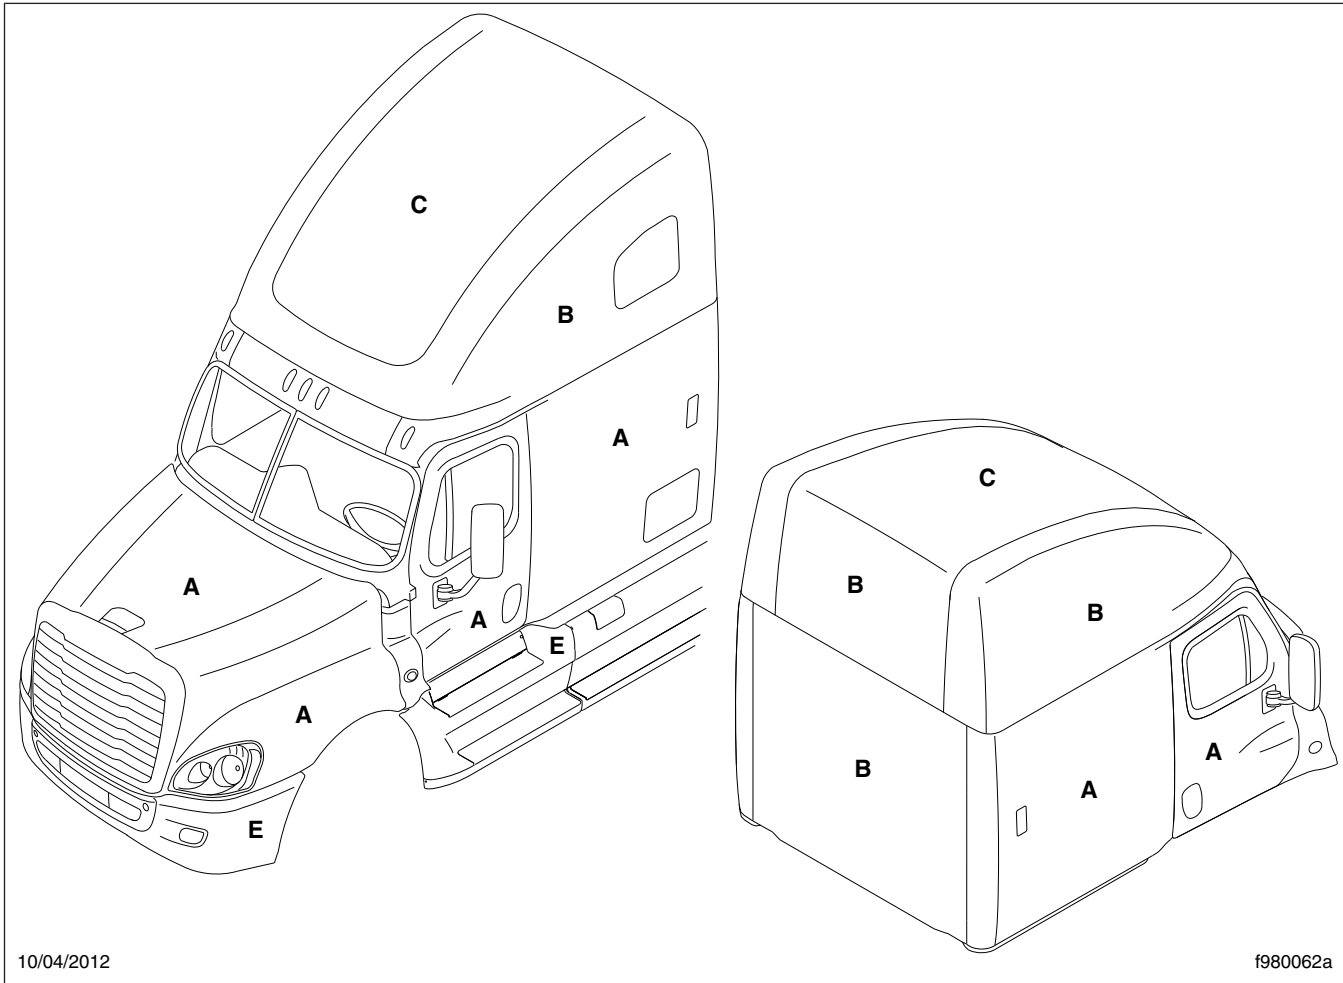
Fig. 1, Paint Appearance Zones (Typical)

Appearance Zones of a Cab and Hood	
Zone	Description
A	All Exterior Surfaces of the Cab, except the Back Panel and Roof Sections: Passenger, Baggage, and Access Doors (including exterior visible surfaces when door is closed), A-Pillar, Cab and Sleeper Side, B-Pillar, C-Pillar, Cowl Side, Lower Skirting, Cab Interior, Hood Top and Sides, Cowl Top, Fender, Upper and Lower Nose Skin, Center Nose Skin, Headlight Bucket, Sun Visor, non-textured Chassis Side Fairings and Bumpers, Forward Quarter-Fender, and Side Extenders (outboard side only)
B	Interior surfaces of Passenger, Baggage, and Access Doors, Back of Cab Panel, Raised Roof Side, Mid-Roof Side, Raised Roof Back Panel and Raised Roof below Skylight, M2 Access Panel, Side Extenders (inboard side only), and Trim Tabs
C	Flat Roof, Mid-Roof Top, Raised Roof Cap Above Skylight, "B" Side Surfaces (underside or inside) of Fairing Fuel Door, Sun Visor, and Roof Fairing

All vehicles are divided into various appearance zones, with specific requirements for each zone. See [Fig. 1](#) and [Table 1](#).
