HYUNDAI <small>c</small> Technical Service Bulletin	GROUP CAMPAIGN	NUMBER 18-01-027-1
	DATE NOVEMBER 2018	MODEL(S) SONATA (LF) SANTA FE SPORT (AN)
SUBJECT: ECM & CLUSTER UPDATE – ENGINE MONITORING LOGIC PRODUCT IMPROVEMENT (SERVICE CAMPAIGN 953)

Description: Hyundai is conducting a product improvement campaign to enhance the knock sensor software to detect abnormal engine bearing noise before potentially severe engine damage occurs. If abnormal engine bearing noise is detected, the Malfunction Indicator Lamp (MIL) will blink continuously, a chime will sound, and the vehicle will be placed in Limp Home Mode allowing the customer to drive to the nearest Hyundai dealer for diagnosis and repair. In addition, DTC P132600 will be recorded in the ECM. The vehicle can continue to be operated for a limited time in Limp Home Mode, but it will accelerate slower and have a reduced maximum speed. Engine RPMs will be limited to approximately 1800-2000 RPM.

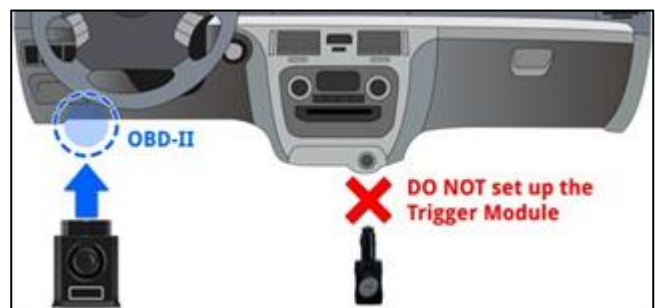
1. Connect the VCI-II into the vehicle's DLC connector under the driver side instrument panel.

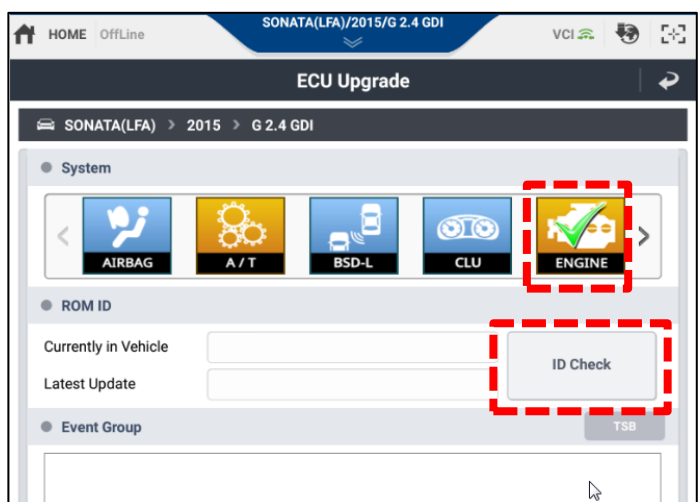
4. Under **System**, select **Engine** to update the engine ECM. Then select **ID Check** to search for available updates.

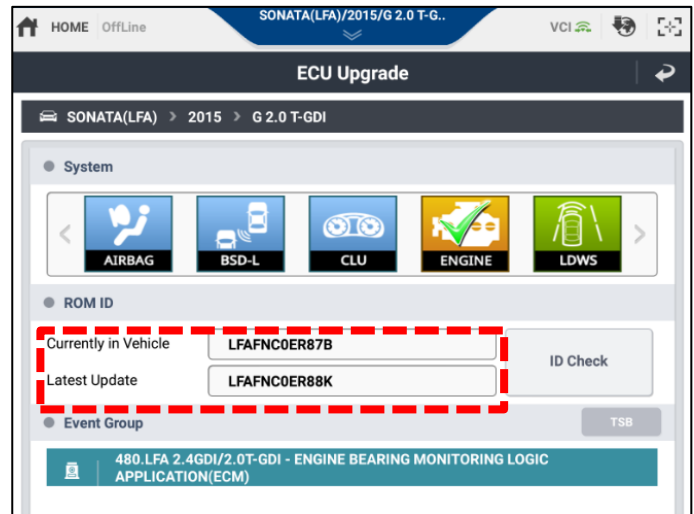
5. Confirm the ROM IDs match those in the ROM Information table for the vehicle specification. Select the event under **Event Group** and then select **Upgrade** to start the update.

The update is performed in two parts. Follow the prompts on the GDS to complete the update.

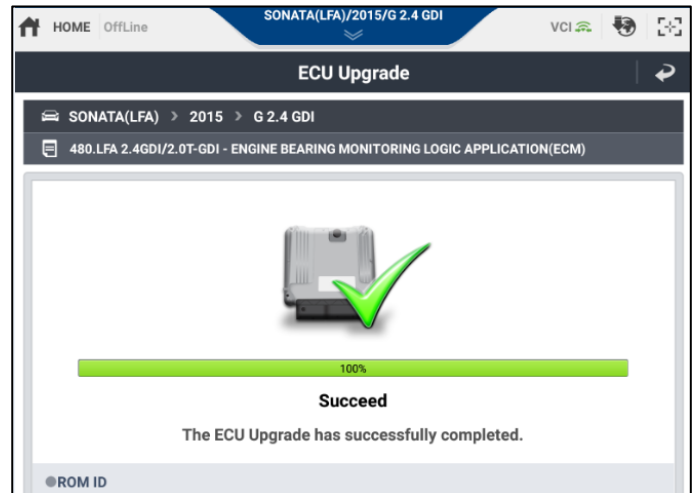
6. Once the update is performed successfully, select **OK** to continue. When prompted to run a fault code search, select **Yes** to check for DTCs. Clear all DTCs if any are stored.

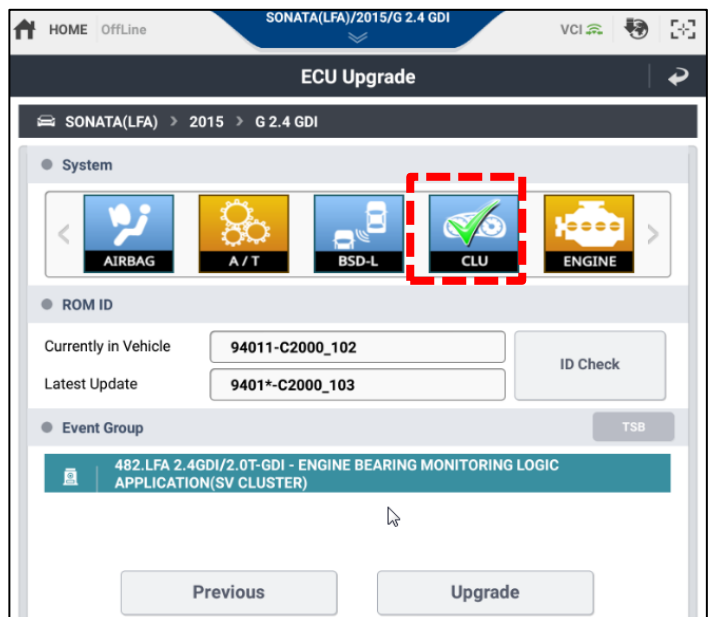
7. Next update the cluster software starting with the process outlined in Step 3. Under **System** in the **ECU Upgrade** menu, select **CLU** to update the cluster.

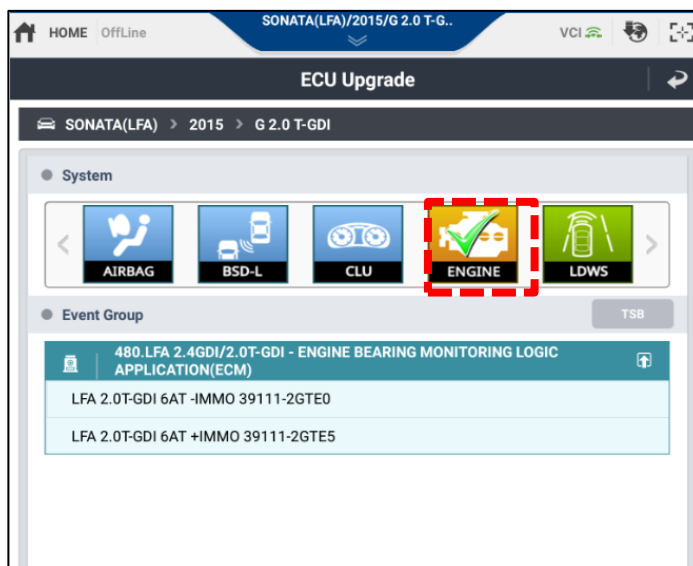
2. Under **System**, select **Engine** to update the engine ECM and **CLU** to update the cluster. Select the appropriate update by referencing the ROM ID Information and password tables. Select **Upgrade** and follow the prompts on the GDS to complete the update.
