Entune Audio Head Unit Software Update (Panasonic)

Service Category Audio/Visual/Telematics

Section Navigation/Multi Info Display

Introduction

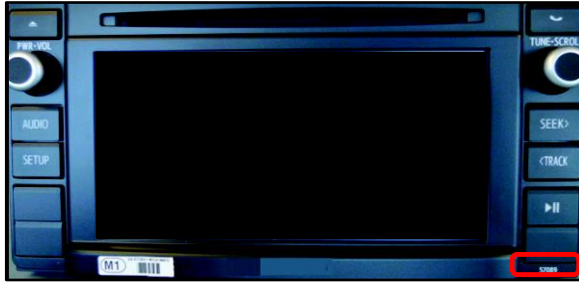
Figure 1. Avalon, Avalon HV, Highlander, Highlander HV, Prius, Prius V, Sienna, Sequoia, Tacoma, and Tundra

1. Confirm the audio system type by checking the faceplate ID printed on the bottom-right or bottom-center of the head unit. See Table 1 for the applicable model faceplate ID number.

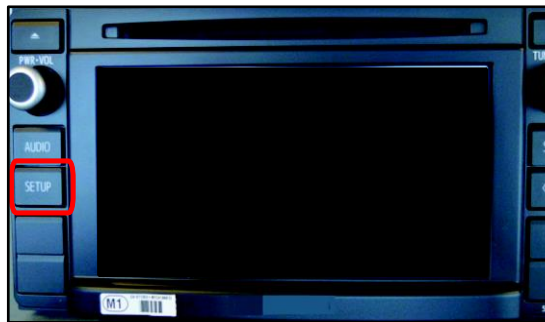
Figure 3. Tacoma, Prius, Prius V

2. Start the engine.
3. Insert the USB flash drive with the downloaded multimedia update file into the vehicle's USB port.
4. Go to the Setup screen.
 - A. For Entune™ Audio: Press the Setup button on the panel.

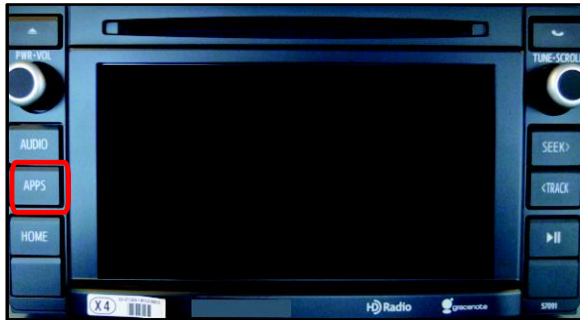
Figure 5. 4Runner, Avalon, Avalon HV, Highlander, Highlander HV, Prius, Prius V, Sienna, Sequoia, and Tacoma

- B. For Entune™ Audio Plus and Entune™ Premium Audio: Press the Apps button on the panel.

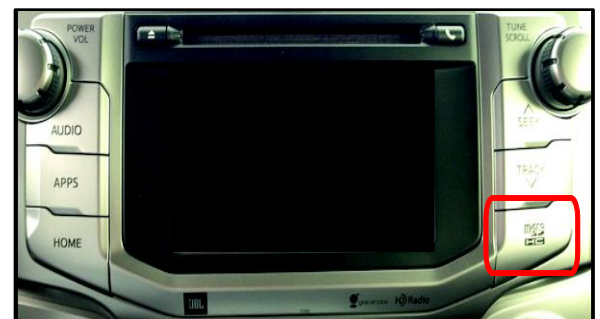
Figure 17.

- If the update fails and the error message “New software is not compatible with the system” displays, cycle the ignition OFF, remove the map micro SD card from the head unit, then repeat steps 3 – 12.
- A software update error is more likely to occur in areas with more traffic information.

Once the update is completed, reinsert the map micro SD card into the head unit, cycle the ignition OFF, then continue to step 13.

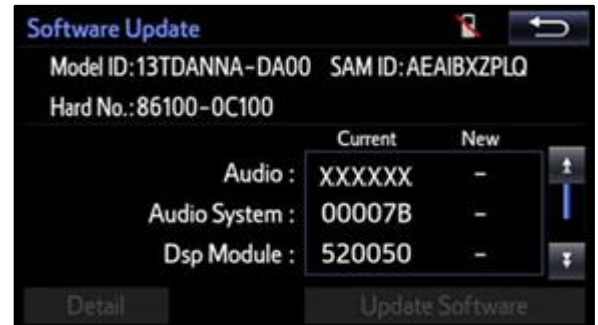
Figure 19.

- Perform steps 3 – 7 of the Software Update Procedure to re-enter the Software Update screen.
- Verify that the software information is updated on the Software Update screen. See Table 3 for the current software version.
