EMISSIONS RECALL

**CONVENTIONAL DCU AND ECU SOFTWARE
UPDATE**

**CAMPAIGN NO: AABF0
DATE: 11-27-2018
REFERENCE: QA-181120-N1**

SUBJECT VEHICLES: 19MY Conventional Trucks equipped with a J08 engine

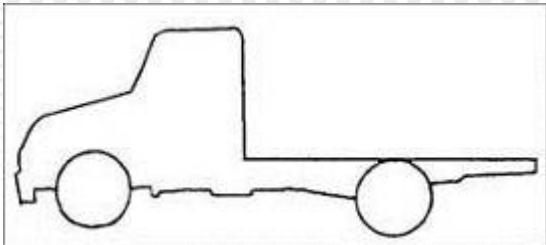
1. Park the vehicle on a flat, level and solid surface.

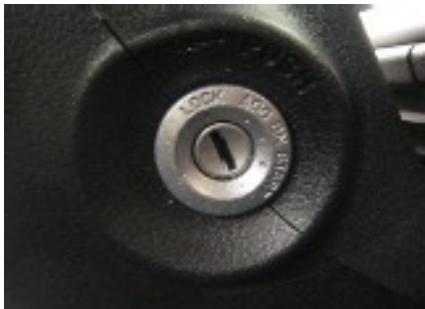
2. Confirm the engine is stopped, the ignition switch is in the off (LOCK) position, and the key is removed.

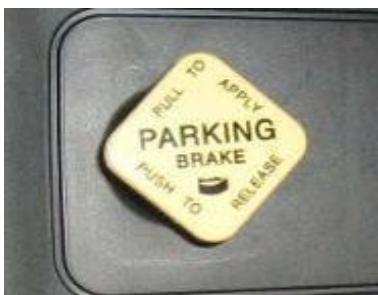
3. Apply the parking brake.

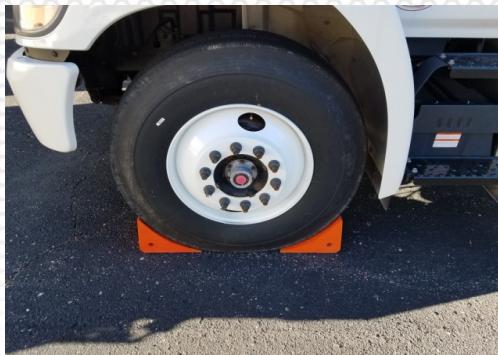
4. Chock all of the wheels.

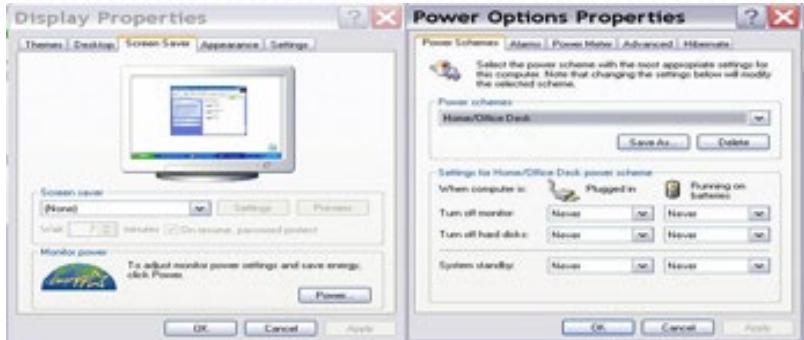
1. Screen saver
2. Energy saving features
 - a. Monitor
 - b. Hard disks
 - c. System standby

NOTICE: The illustrations above depict what you will see on your computer screen with regard to the features which must be disabled. The location on the screen of the features to be disabled will vary, however, based upon the operating software. Consult your IT (Information Technology) department as required.

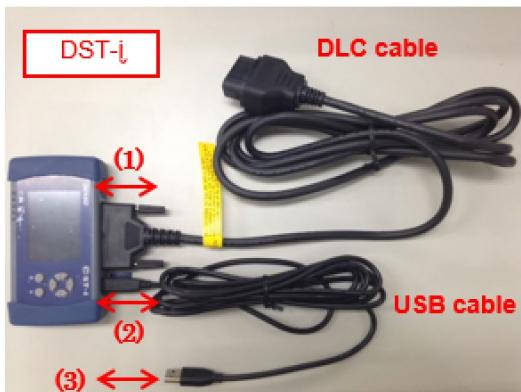
To assemble the interface cable, perform the following steps.

- (1) Connect the DLC (Diagnostic Link Connector) cable to the interface.
- (2) Connect the USB Cable to the interface.
- (3) Connect the USB connector to the USB port on your computer.

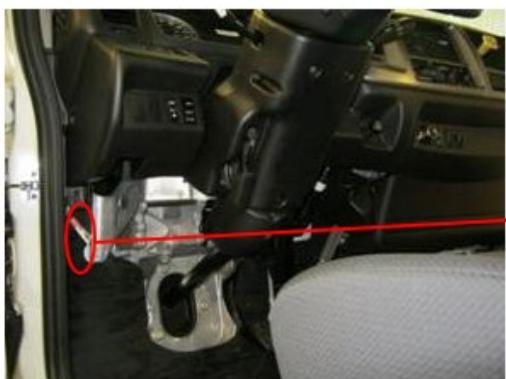
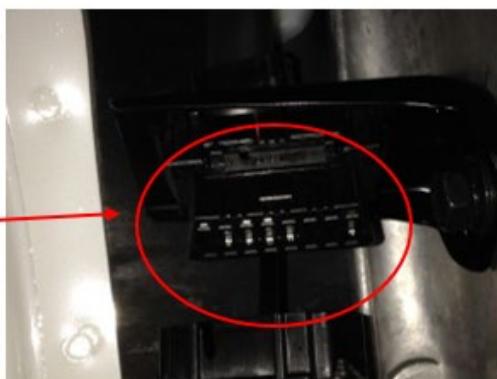
2. Connect the DLC cable to the vehicle's DLC connector. The DLC connector is found under the dash on the left side of the steering column.

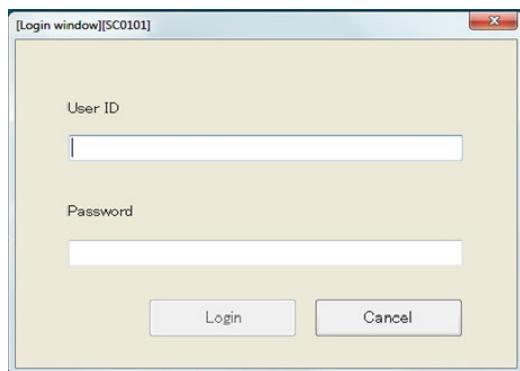
4. Hino DX2 will prompt you for a “User ID” and “Password”. Enter your User ID, and password and then select the “Login” icon. Verify that the DX2 has software version 1.1.18.16 or later.

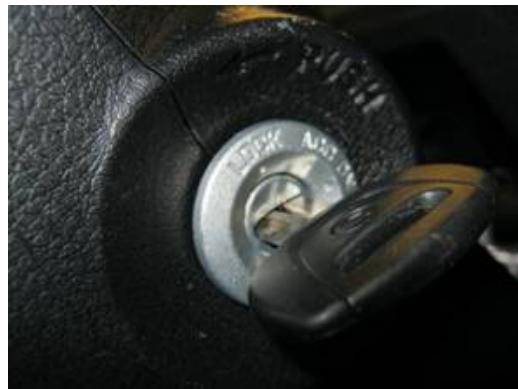
5. Insert the ignition key into the starter switch and turn the key to the “ON” position.

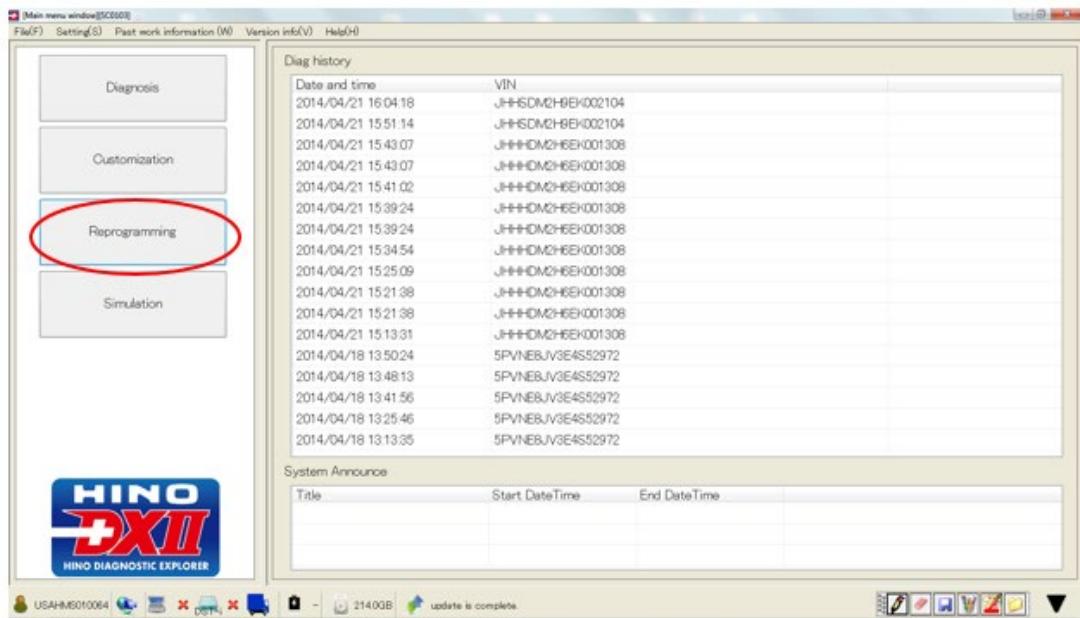
6. Select the “Reprogramming” icon.

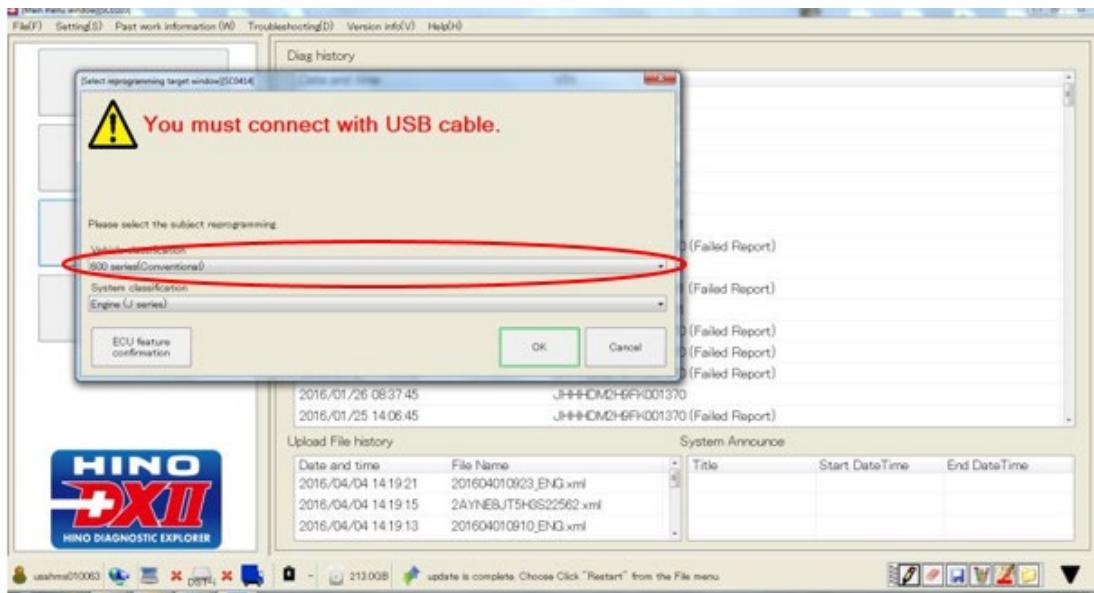
7. Select “600 Series” under the “Vehicle Classification” drop down menu.

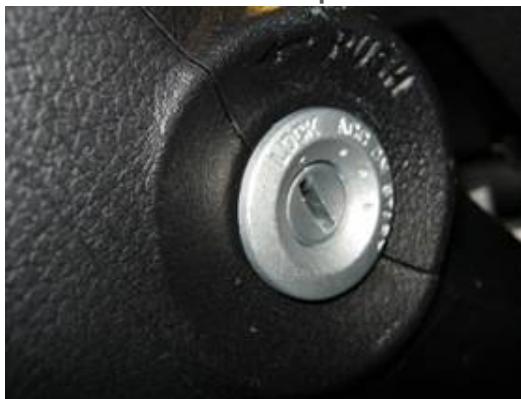
10. Once DCU reprogramming is complete, turn the starter switch to the “LOCK” position and remove the key for one minute.

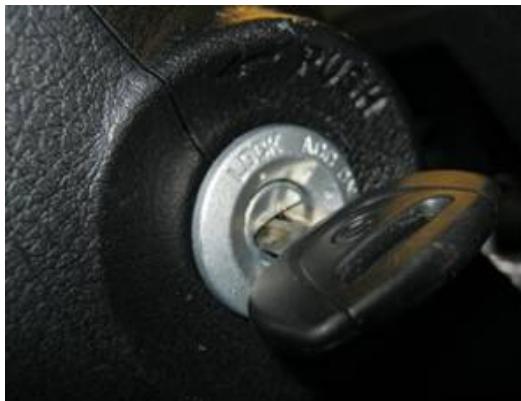
11. After waiting one minute, insert the ignition key into the starter switch and turn the key to the “ON” position.

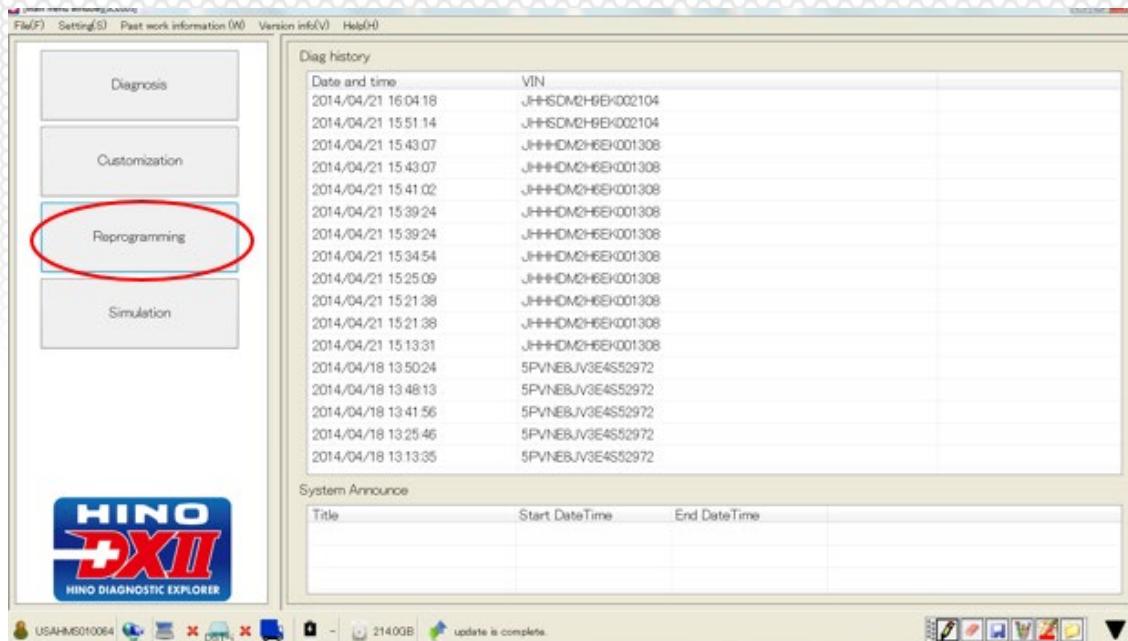
12. Again, select the “Reprogramming” icon.

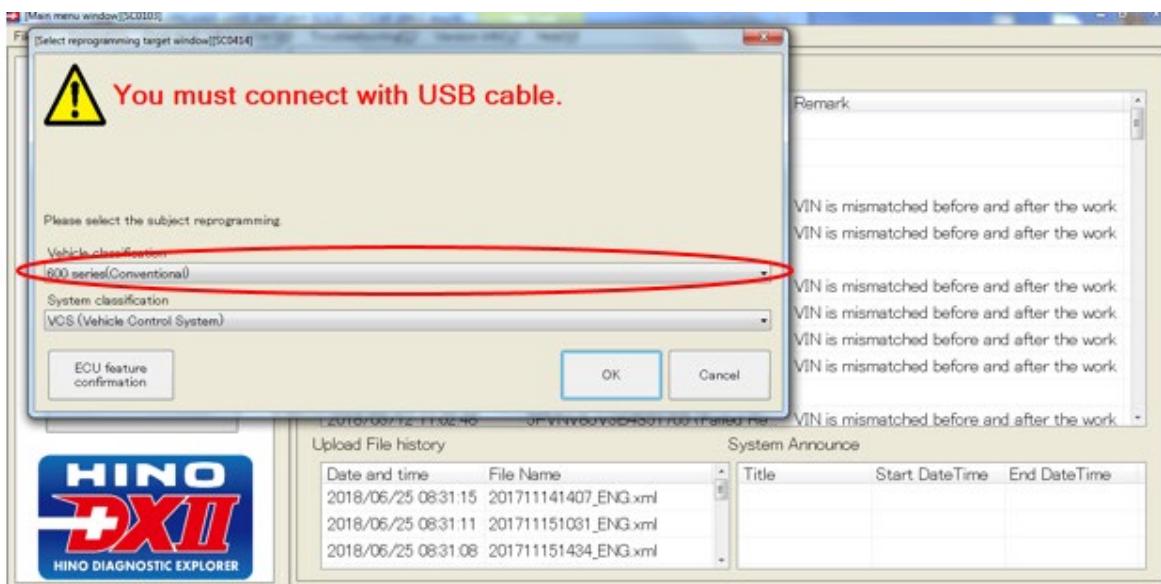
13. Select “600 Series” under the “Vehicle Classification” drop down menu.

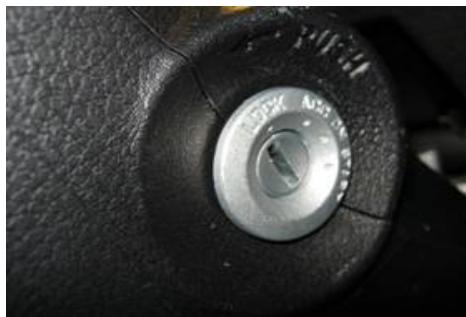
16. Once ECU reprogramming is complete, turn the starter switch to the “LOCK” position and remove the key for one minute.

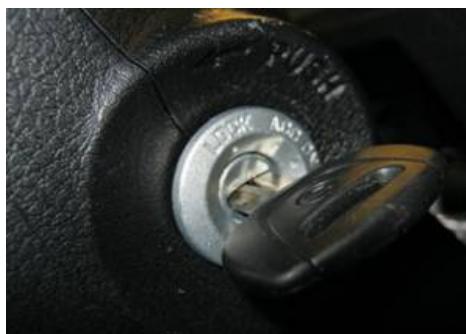
17. After waiting one minute, insert the ignition key into the starter switch and turn the key to the “ON” position.

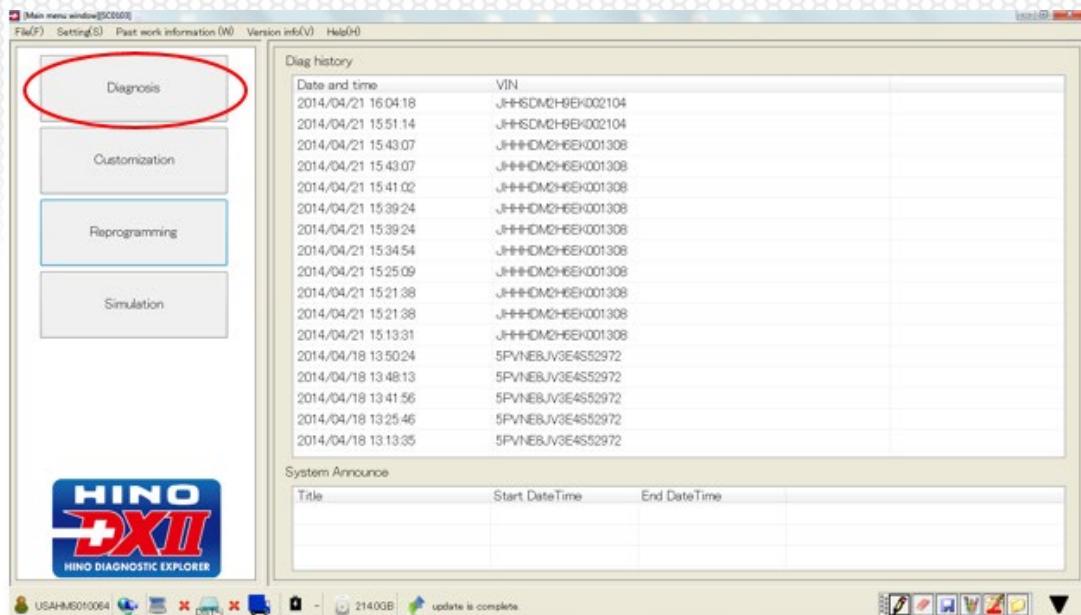
18. During ECU software reprogramming, other DTC's may have been set. These DTC's will need to be cleared prior to completing this campaign. Select the "Diagnosis" icon.

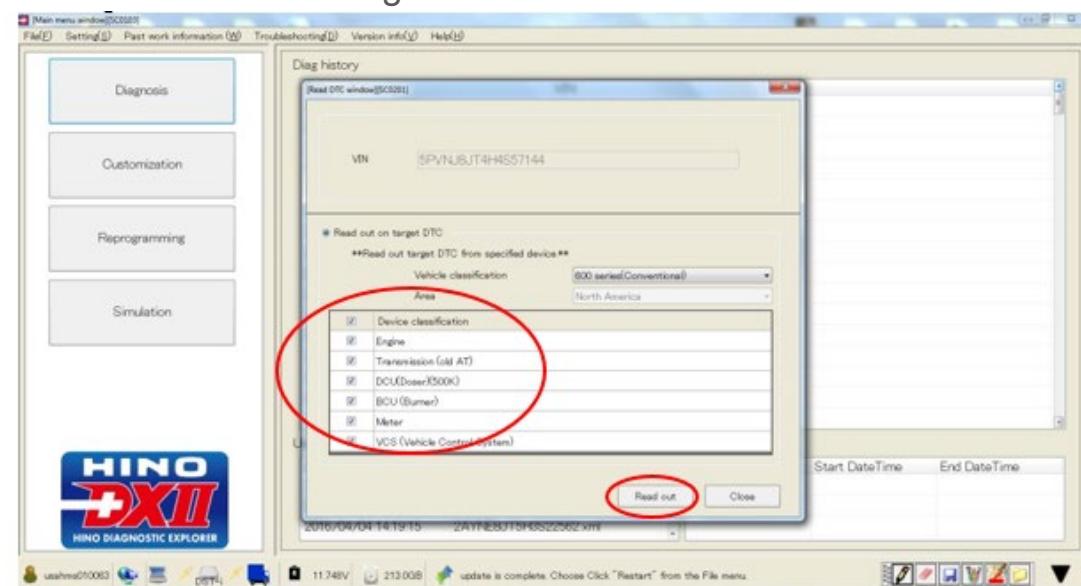
19. Check mark the "Device Classification". This should automatically check mark the remaining devices. Select the "Read Out" icon.

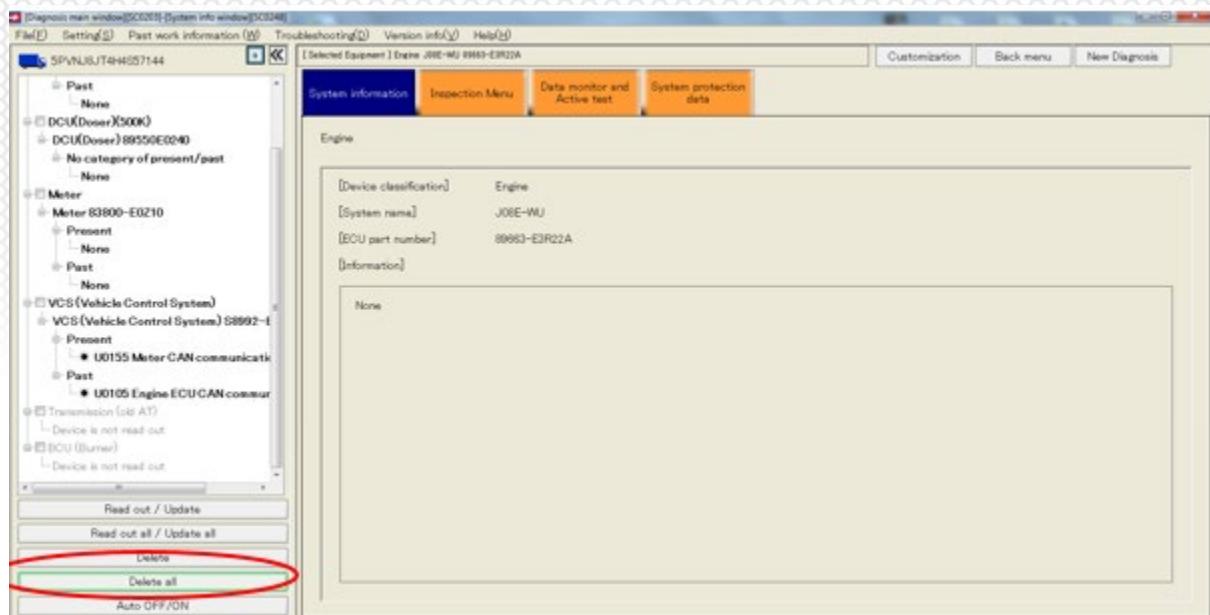
20. Select the “Delete All” icon.

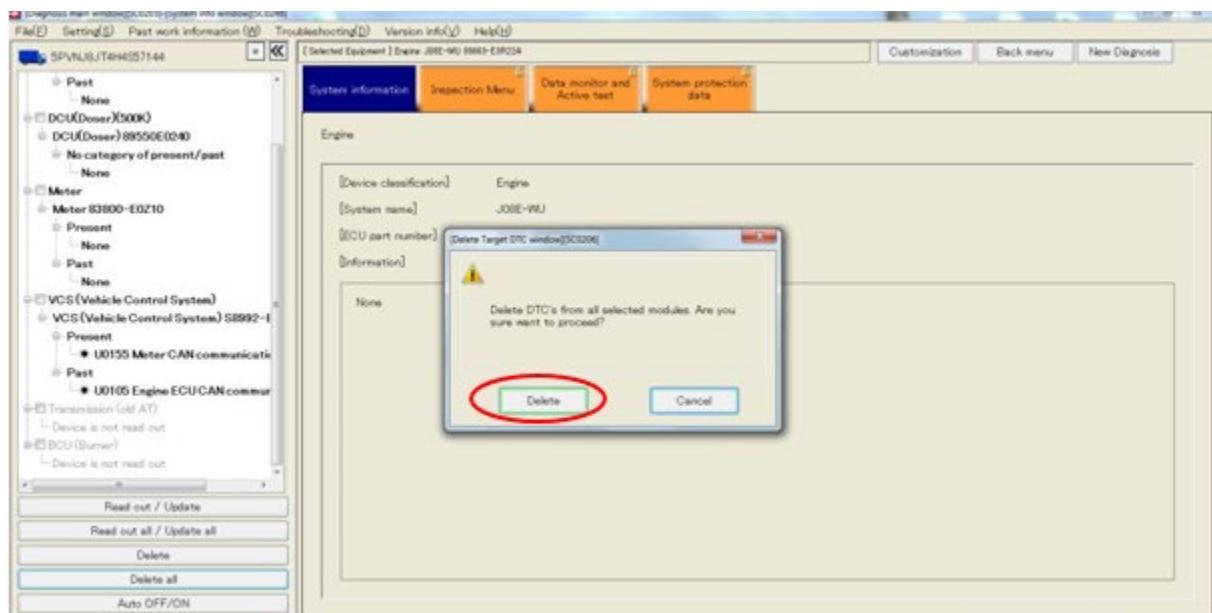
21. Select the “Delete” icon.

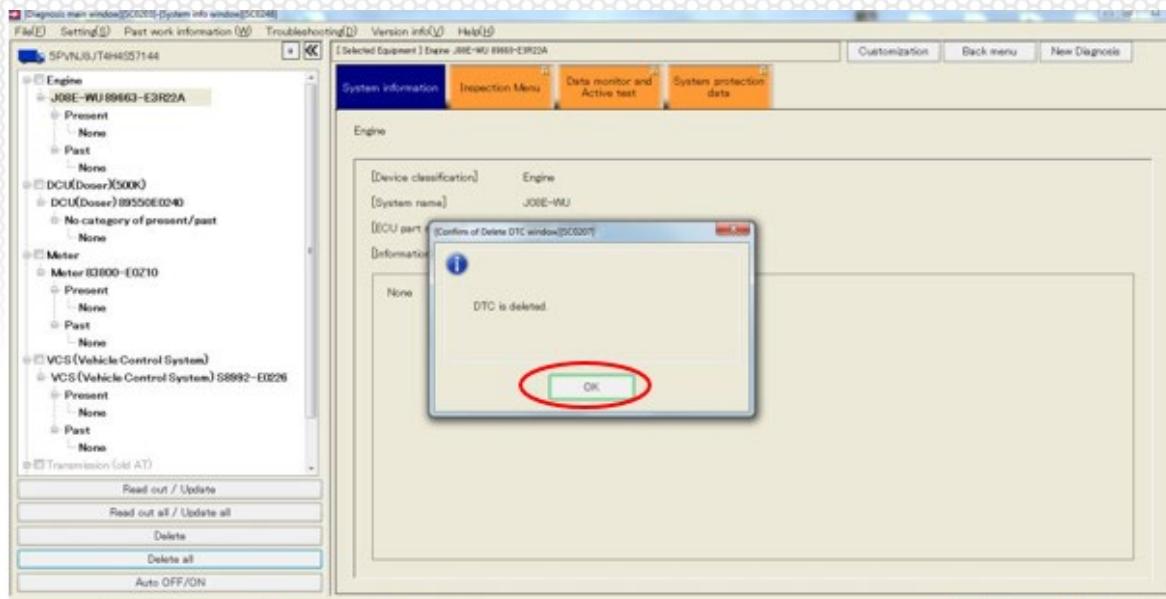
22. Select the “OK” icon.

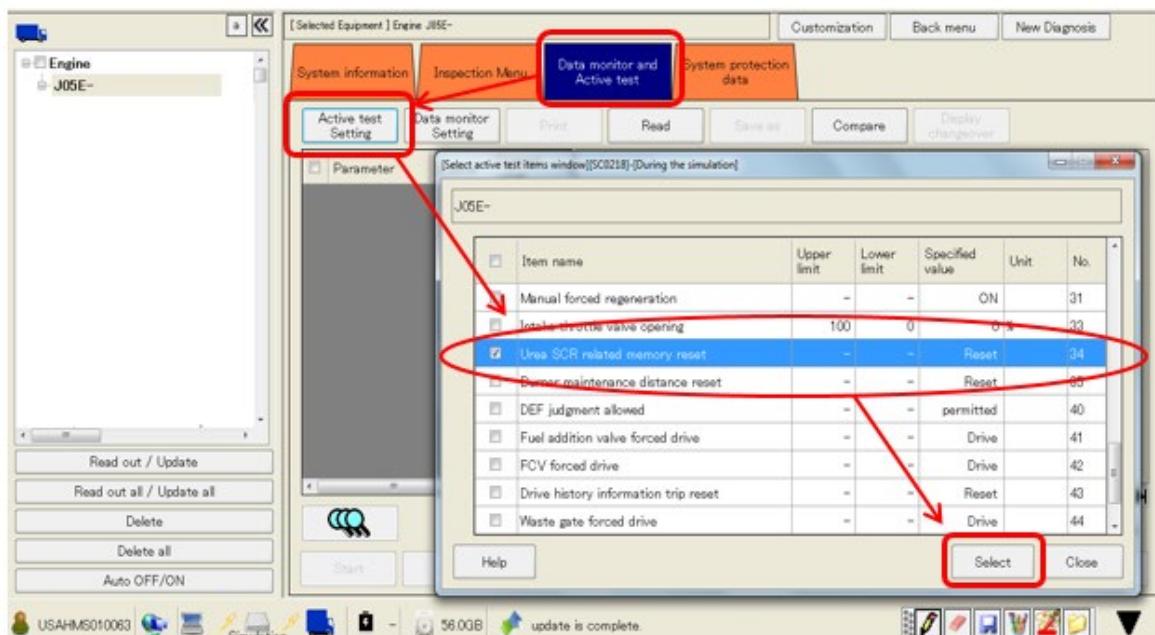
23. From the Engine ECU Data Monitor and Active Test menu, select Active Test Setting>Urea SCR Related Memory Reset> then follow the prompts to complete the reset.

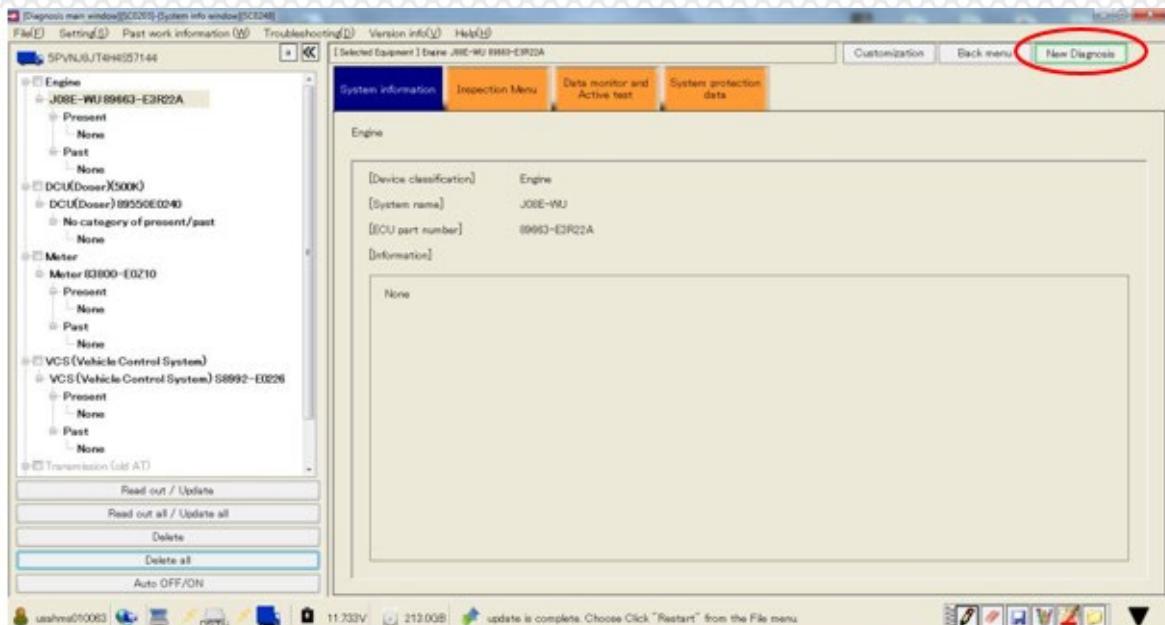
24. Select the “New Diagnosis” icon.

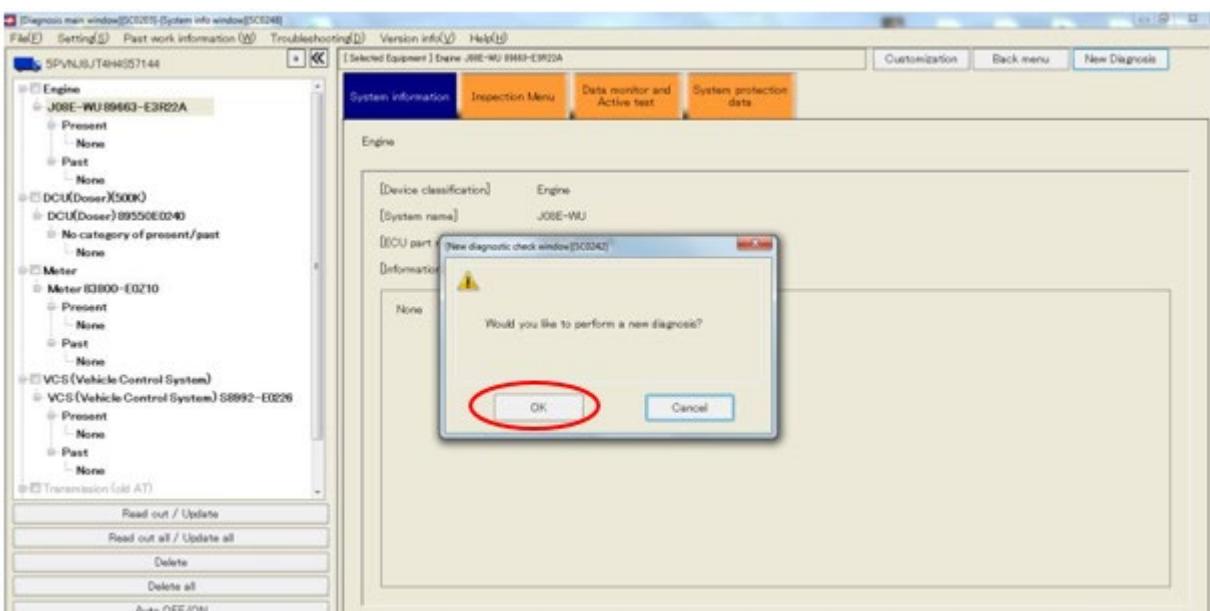
25. Select the “OK” icon.

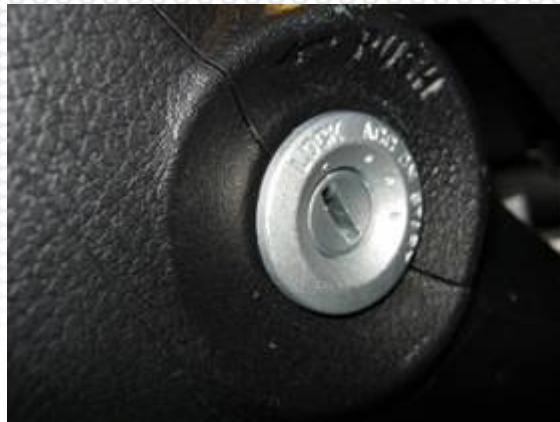
26. Turn the starter switch to the “LOCK” position and remove the key.

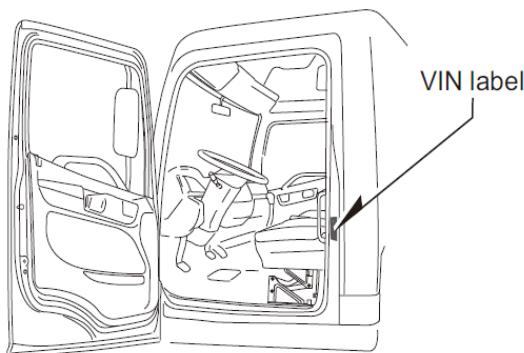
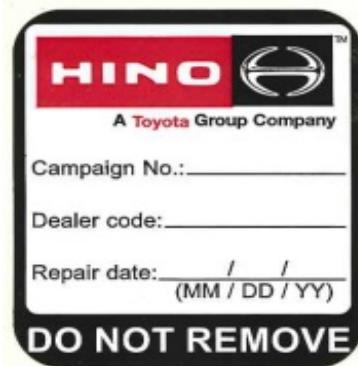
Once all above steps in this recall procedure have been completed, apply a recall label to the left door jamb above the VIN label. Fill in the Campaign No, Dealer code, and Repair date. Proceed to the Final Inspection Procedure, below.
