Service

Category Vehicle Interior

Section Interior Panels/Trim Market USA

Instrument Panel Trim Reflection

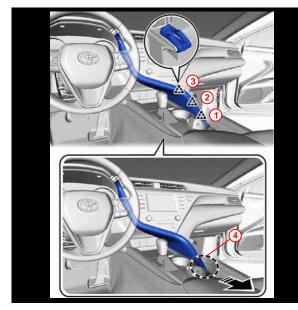
Figure 5.

B. Disengage the three clips as shown in the figure.

1-3	Dis engagement Order
4	Hand Placement Location

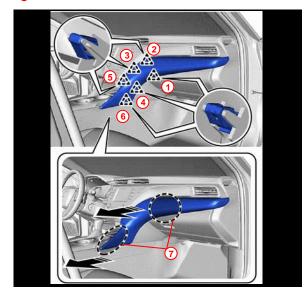
Figure 8.

B. Disengage the six clips as shown in the figure to remove the No. 2 instrument panel garnish sub-assembly.

1 – 6	Dis engagement Or der
7	Hand Placement Location

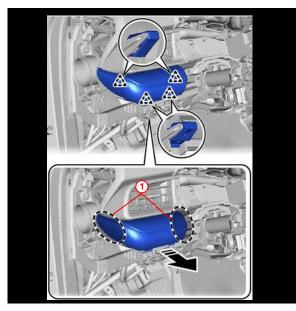
Figure 24.

12. Disengage the four clips as shown in the figure to remove the No. 1 instrument panel garnish sub-assembly.

Hand Placement Location

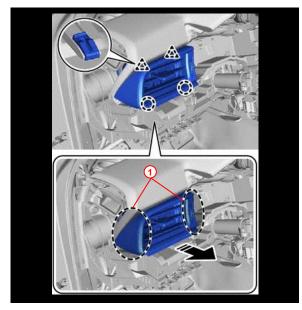
Figure 25.

13. Disengage the two clips and claws as shown in the figure to remove the No. 1 instrument panel register assembly.

Hand Placement Location
