GROUP	NUMBER	
CAMPAIGN	18-01-039	
DATE	MODEL(S)	
DECEMBER, 2018	ELANTRA (AD/ADa)

HEADLAMP REPLACEMENT AND AIMING ADJUSTMENT (SERVICE CAMPAIGN T3J)

Description: Some 2019 Elantra (AD/ADa) vehicles equipped with halogen headlights may experience intermittent operation of the high beam. This bulletin provides the service procedure to replace the left and right headlamp assemblies and perform aiming adjustments.

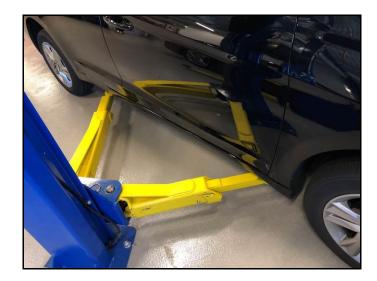
1. Align the vehicle onto the lift. Do not lift the vehicle up.

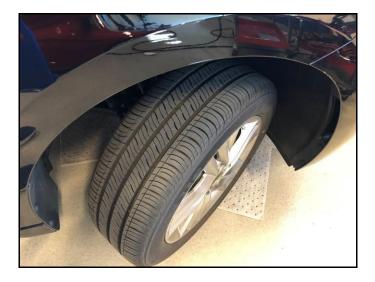
- 2. If applicable, record the customer's radio preset stations for AM/FM/XM.
- 3. Turn the wheel fully to the left or the right.

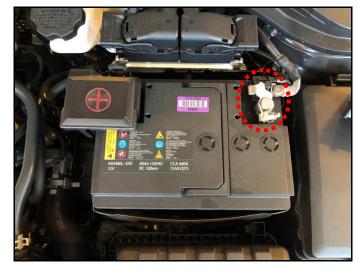
4. Open the hood and disconnect the negative (-) cable on the battery.

Negative battery terminal tightening torque: 3.0~4.4 lb-ft (4.0~6.0 Nm, 0.4~0.6 kgf.m)

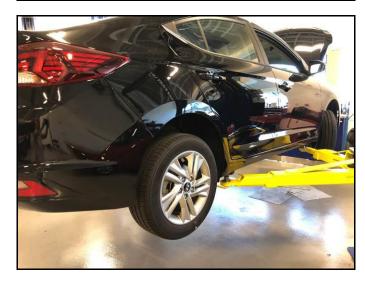
6. Lift the vehicle to comfortable working height.

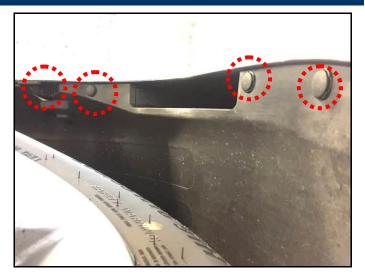
7. Remove one Phillips screw and three mounting clips from front inner fender liner.

Perform the procedure to both the driver and passenger side.

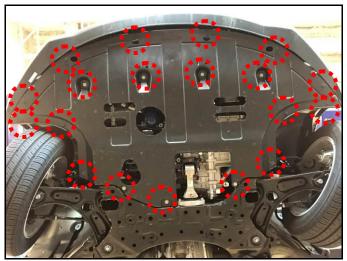
8. Remove the 12 mounting clips and seven 10mm bolts from the front under cover.

Tightening Torque for 10mm bolt: 2.9 ~ 4.3 lb-ft (3.9 ~ 5.9 Nm, 0.4 ~ 0.6 kgf.m)

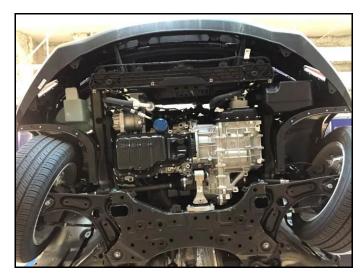
9. Remove the front under cover.

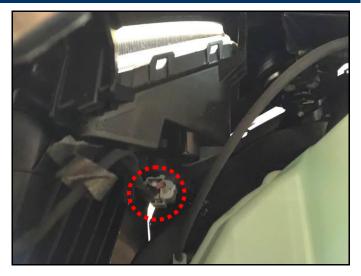
10. From under the vehicle, disconnect the driver and passenger turn signal light connectors.

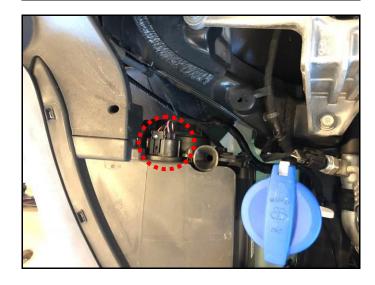
12. Disconnect the driver and passenger headlamp connectors.

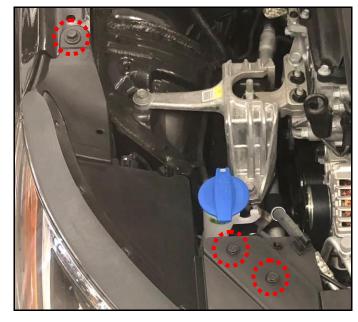
13. Remove the three headlamp mounting bolts.

Tightening Torque for 10mm bolt: 2.9 ~ 4.3 lb-ft (3.9 ~ 5.9 Nm, 0.4 ~ 0.6 kgf.m)

Tightening Torque for 12mm bolt: 5.1 ~ 8.0 lb-ft (6.9 ~ 10.8 Nm, 0.7 ~ 1.1 kgf.m)

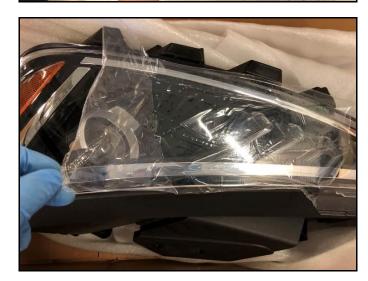
15. Remove the protective plastic film from the new headlamps.

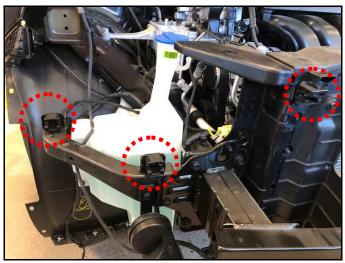
16. Install the new headlamp and reinstall all removed parts in reverse order.

When installing the driver and passenger headlamps, align the three headlamp tabs and hooks. Carefully push forward. Ensure the locking tabs are fully inserted into the hooks.

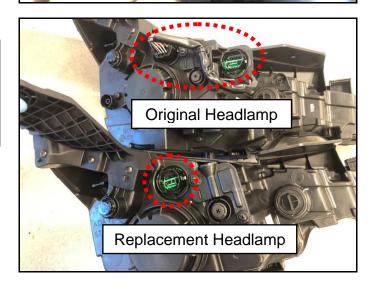
The driver side replacement headlamp assembly will not include the extension pigtail harness. The extension pigtail harness is not needed.

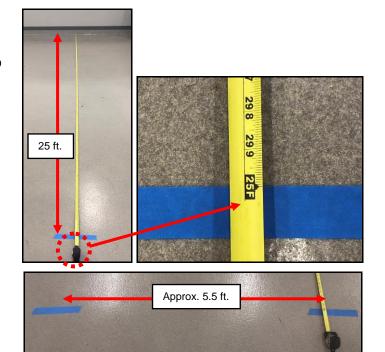
- 1. Park the vehicle on a flat surface in front of a screen or wall.
- 2. Check the front and rear tires pressure to ensure it is inflated to the correct pressure (36psi).
 - Adjust the tire pressure by inflating or deflating as necessary.
- Measure 25 ft. from the wall and place two pieces of masking tape or two marks approximately 5.5 ft. apart from each other onto the floor.

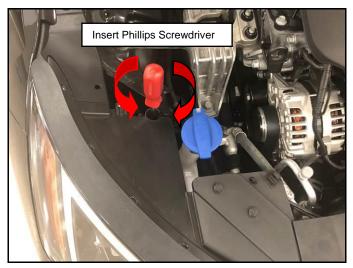
7. Insert a Phillips screwdriver into the adjusting hole and turn it clockwise or counterclockwise.

Turning the screwdriver clockwise will bring the beam upward and counterclockwise will bring the beam downward.

Perform the headlamp beam adjustment with no one sitting in the driver or passenger seat.

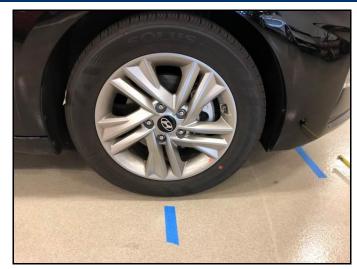
For ease of adjustment for another Elantra (AD/ADa), make a mark or tape on the floor using the alignment of the wheel center cap.

It is easier to align the wheel center cap than center point of the headlamp light bulb.

Mark both sides of the vehicle as shown in the picture to the right.
