# HYUNDAI

## Technical Service Bulletin

**SUBJECT:** HEATER PERFORMANCE IMPROVEMENT ECU UPDATE

This bulletin provides information on certain 2017-2018 model year Elantra (AD/ADA) 2.0L vehicles to update the ECM (Engine Control Module), update the HVAC ECU, and to update the engine coolant temperature gauge of the Instrument Cluster for improving heater performance.

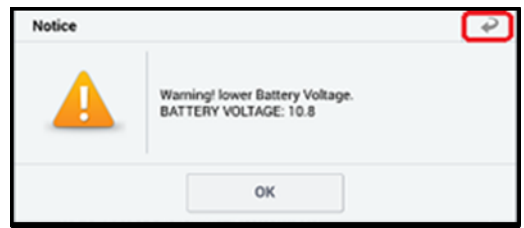
**GDS Vehicle Battery Voltage Warning:**

If voltage is below 12 volts as per the GDS warning, then select **Back** and run the engine at least 15 minutes to reach an adequate battery state of charge to prevent ECU Update failure. Cycle the ignition **OFF/ON** before retrying ECU update again.
