GROUP <b>Product Improvement</b>	MODEL <b>See Model List on Page 1</b>
	NUMBER <b>1802 (Rev 3, 12/04/2018)</b>	DATE <b>July 2018</b>
<b>PRODUCT IMPROVEMENT CAMPAIGN</b>		
<b>SUBJECT:</b> KNOCK SENSOR DETECTION SYSTEM - ECU LOGIC IMPROVEMENT (PI1802)

This bulletin provides information related to a software update to the Engine Control Unit (ECU) to install the Knock Sensor Detection System (KSDS) in order to protect the engine from excessive connecting rod bearing damage. This update is for:

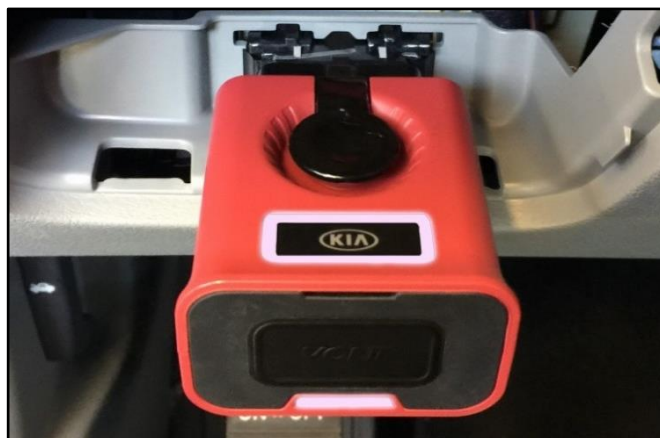
2. With the ignition ON, turn ON the KDS tablet. Select **KDS** from the home screen.

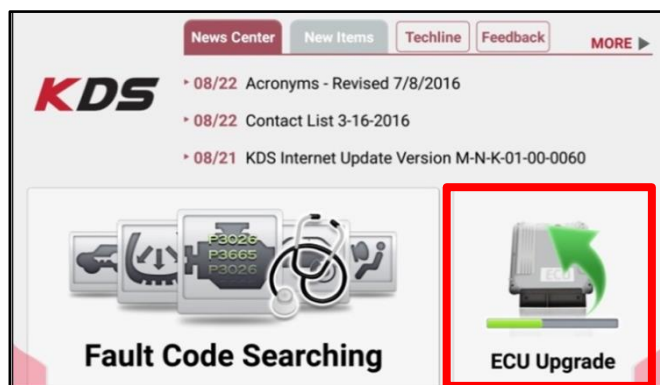
5. The KDS will check the server for recently uploaded Events and then automatically download **Upgrade Event #374 (XMa), #375 (TF), #376 (SL), #377 (QF), #392 (UMa), #393 (JF/JFa), or #394 (16MY SL).**
