NUMBER
1802 (Rev 5, 12/20/2018)

PRODUCT IMPROVEMENT CAMPAIGN

SUBJECT: **KNOCK SENSOR DETECTION SYSTEM - ECU
LOGIC IMPROVEMENT (PI1802)**

This bulletin provides information related to a software update to the Engine Control Unit (ECU) to install the Knock Sensor Detection System (KSDS) in order to protect the engine from excessive connecting rod bearing damage. This update is for:

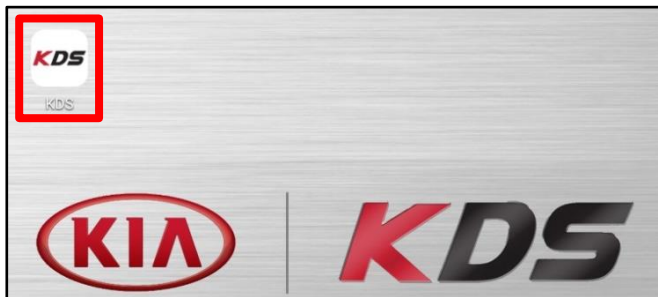
2. With the ignition ON, turn ON the KDS tablet. Select **KDS** from the home screen.
