Technical Service Bulletin

SUBJECT:		No: TSB-18-52B-003	
UPDATES TO SRS AIRBAG DIAGNOSTIC TROUBLE CODE PROCEDURES - SERVICE MANUAL REVISION		DATE: December 2018	
		MODEL: 2013-14 i-MiEV	
CIRCULATE TO:	<input type="checkbox"/> GENERAL MANAGER	<input checked="" type="checkbox"/> PARTS MANAGER	<input checked="" type="checkbox"/> TECHNICIAN
<input checked="" type="checkbox"/> SERVICE ADVISOR	<input checked="" type="checkbox"/> SERVICE MANAGER	<input type="checkbox"/> WARRANTY PROCESSOR	<input type="checkbox"/> SALES MANAGER

This TSB updates the Supplemental Restraint System (SRS) section of the affected Service Manuals to provide corrected diagnostic information for front and side impact sensors.

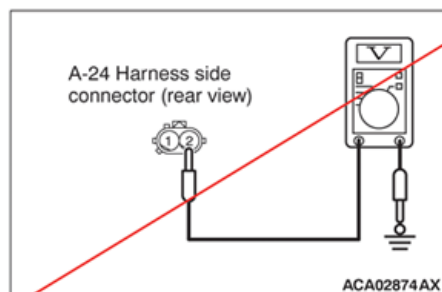
STEP 3. Check the front impact sensor (RH) power supply circuit. Measure the voltage at the front impact sensor (RH) connector A-24.

- (1) Disconnect the negative auxiliary battery terminal.
- (2) Disconnect front impact sensor (RH) connector A-24, and measure at the wiring harness side.
- (3) Connect the negative auxiliary battery terminal.
- (4) Turn the electric motor switch to the "ON" position.

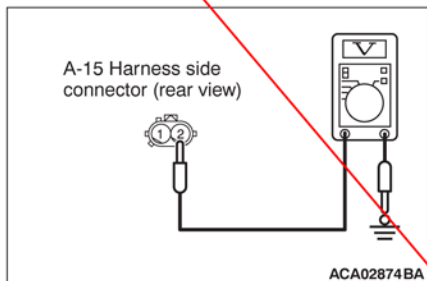
STEP 3. Check the front impact sensor (LH) power supply circuit. Measure the voltage at the front impact sensor (LH) connector A-15.

- (1) Disconnect the negative auxiliary battery terminal.
- (2) Disconnect front impact sensor (LH) connector A-15, and measure at the wiring harness side.
- (3) Connect the negative auxiliary battery terminal.
- (4) Turn the electric motor switch to the "ON" position.

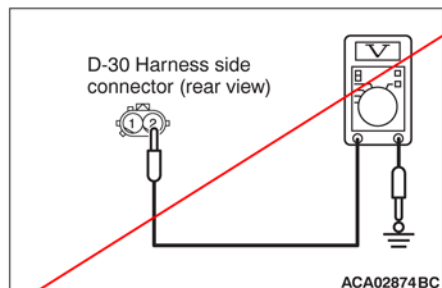
STEP 3. Check the side impact sensor (RH) power supply circuit. Measure the voltage at the side impact sensor (RH) connector C-30.

- (1) Disconnect the negative auxiliary battery terminal.
- (2) Disconnect side impact sensor (RH) connector C-30, and measure at the wiring harness side.
- (3) Connect the negative auxiliary battery terminal.
- (4) Turn the electric motor switch to the "ON" position.

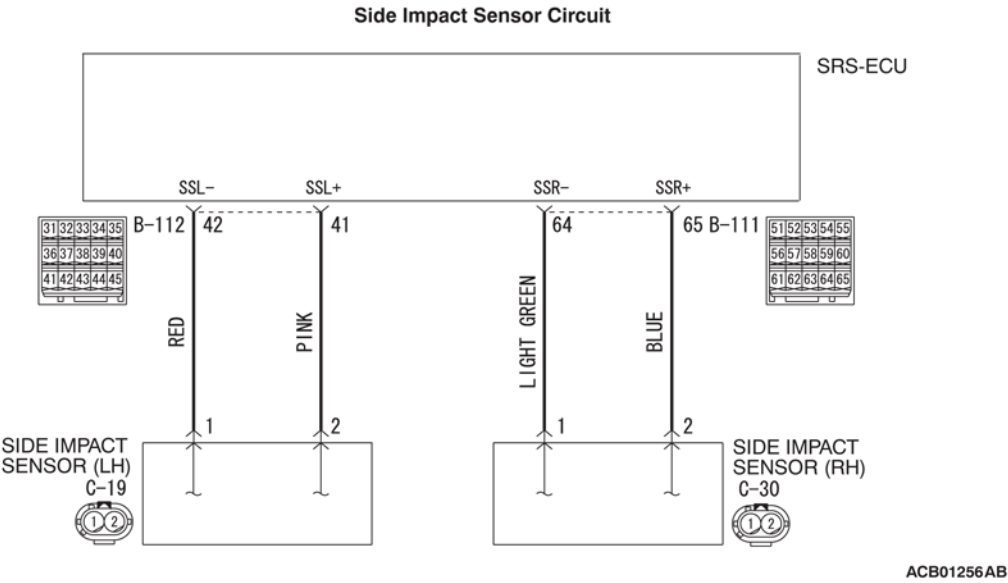
DTC B1428: Side Impact Sensor (RH) Communication Error
DTC B1429: Side Impact Sensor (RH) Communication Impossible

Please make the indicated changes to the 2013 (Canada only) and 2014 i-MiEV Service Manual, Group 52B - Supplemental Restraint System (SRS) -> SRS Air Bag Diagnosis -> Diagnostic Trouble Code Procedures <SRS-ECU>: Replace the Incorrect information with the Correct information for DTC B1428 and B1429, Diagnosis.

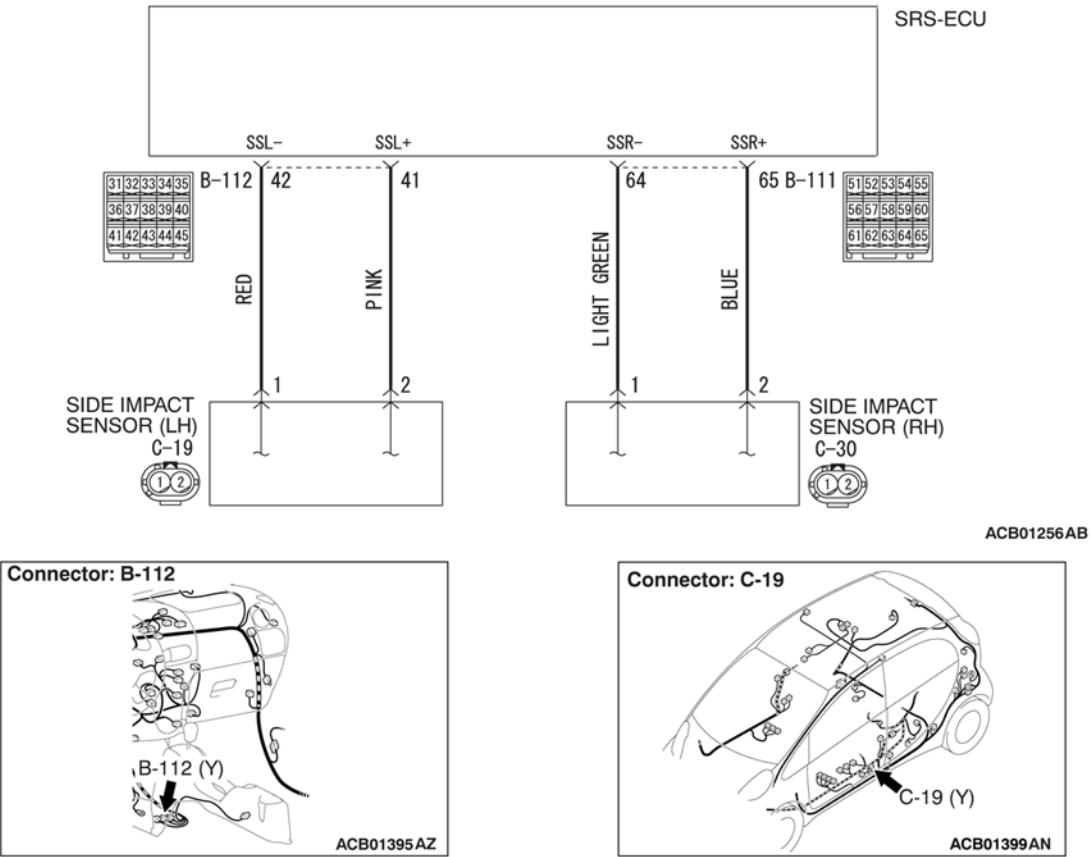
Side Impact Sensor Circuit

DTC B1438 Side Impact Sensor (LH) Communication Error
DTC B1439 Side Impact Sensor (LH) Communication Impossible

If the diagnostic trouble code B1438 or B1439 is set to SRS-ECU, be sure to diagnose the CAN bus line.
