# SERVICE BULLETIN

Classification: EL18-022	Reference: NTB18-081	Date: December 2, 2018
-----------------------------	-------------------------	---------------------------

## 2017-2018 PATHFINDER AND 2018 ARMADA; SOFTWARE UPDATES FOR INFOTAINMENT ISSUES

**APPLIED VEHICLES:** 2017-2018 Pathfinder (R52)  
2018 Armada (Y62)

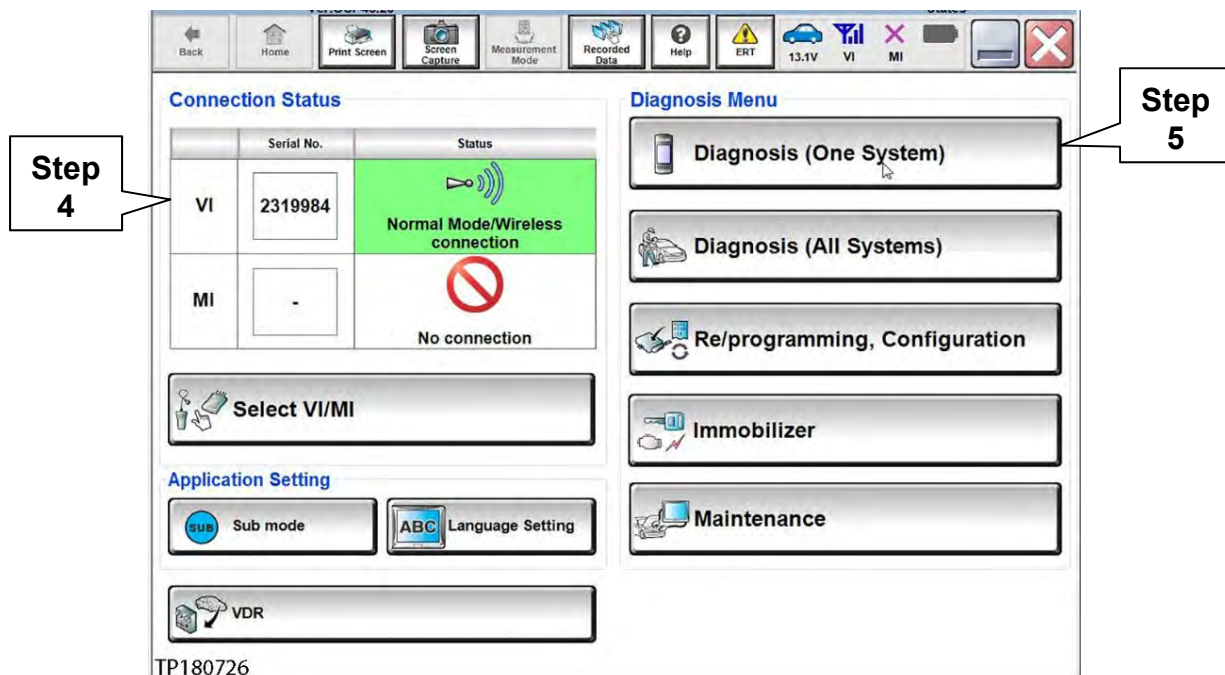
Figure 2

1. Connect the CONSULT PC and plus VI to the vehicle.
2. Start C-III plus.
3. Turn ON the ignition.
4. Wait for the plus VI to be recognized / connected.
  - The serial number will display when the plus VI is recognized / connected.
5. Select **Diagnosis (One System)**.

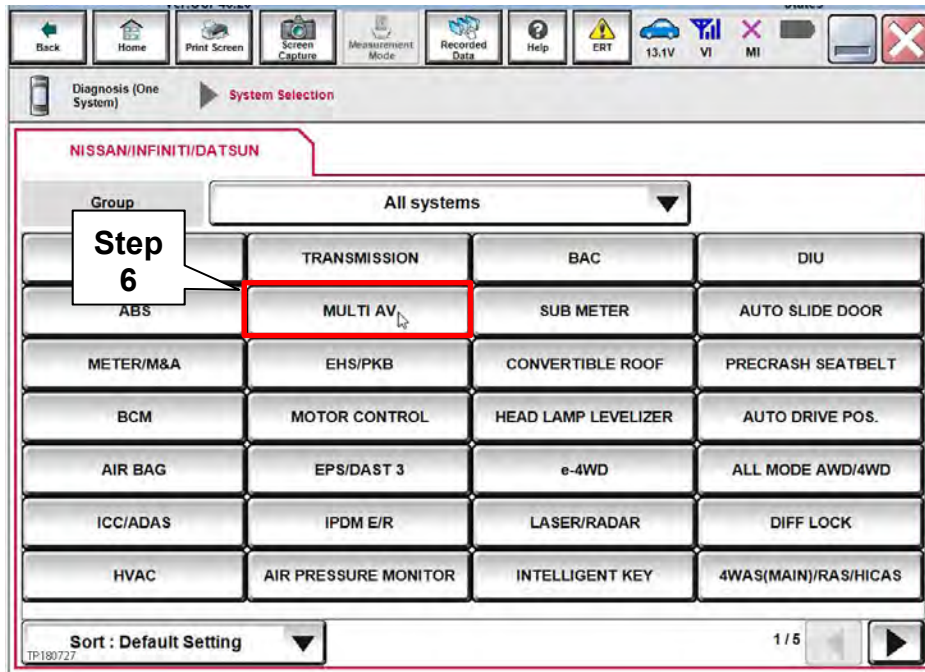
Figure 3

6. Select **MULTI AV**.

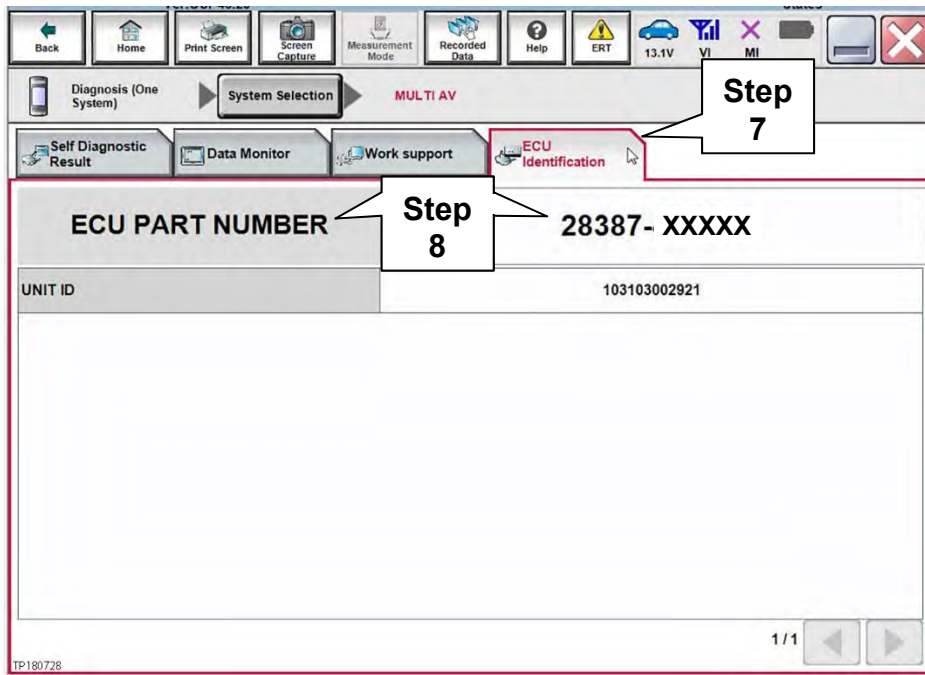
7. Select the **ECU Identification** tab.
8. When the screen in Figure 4 displays, confirm this bulletin applies as follows:
  - a. Write down the **ECU PART NUMBER** on the repair order.  
**NOTE:** This is the current DCU part number (P/N).

- b. Compare the P/N written down to the P/Ns in the **CURRENT DCU PART NUMBER** column in **Table A** below.
  - If there is a match, this bulletin applies. Go to the next page, **Update the Display Control Unit**.
  - If there is not a match, this bulletin does not apply. Refer to ASIST for further diagnosis.

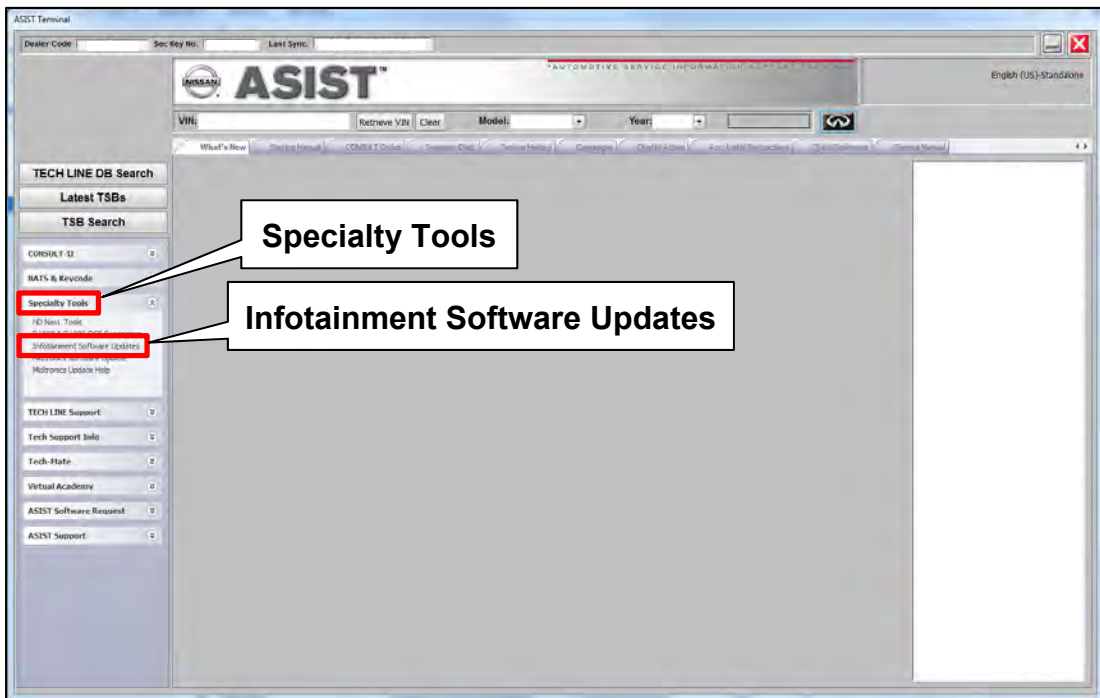
Figure 5

11. Select **Specialty Tools**, and then select **Infotainment Software Updates**.

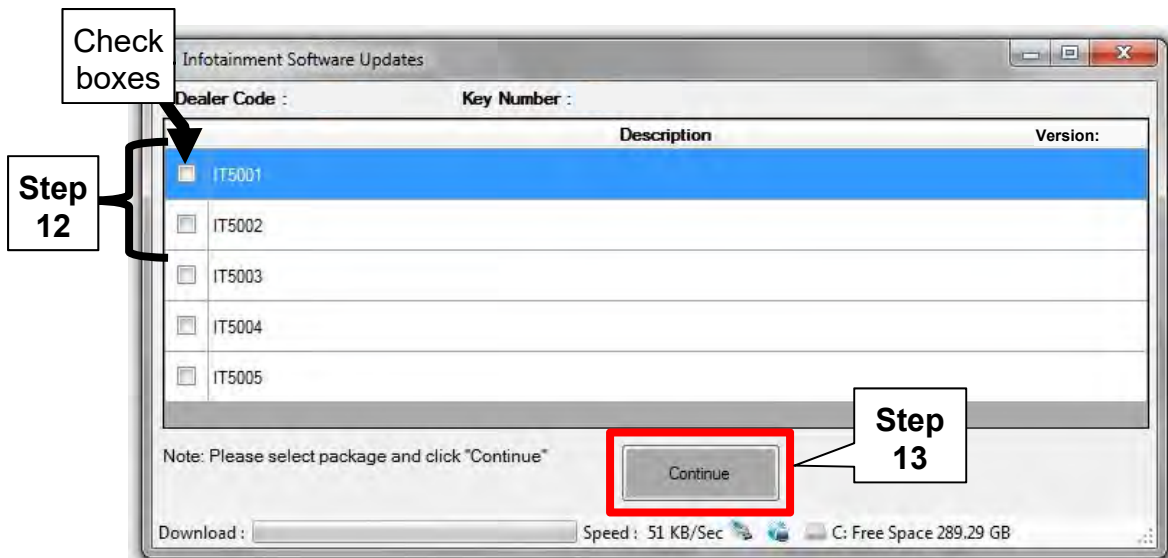
Figure 6

12. Select the check box next to the correct update software package based on **Table B** below (also refer to Figure 6).

13. After selecting the check box of the correct update software package, select **Continue**, and then wait for the download to complete.

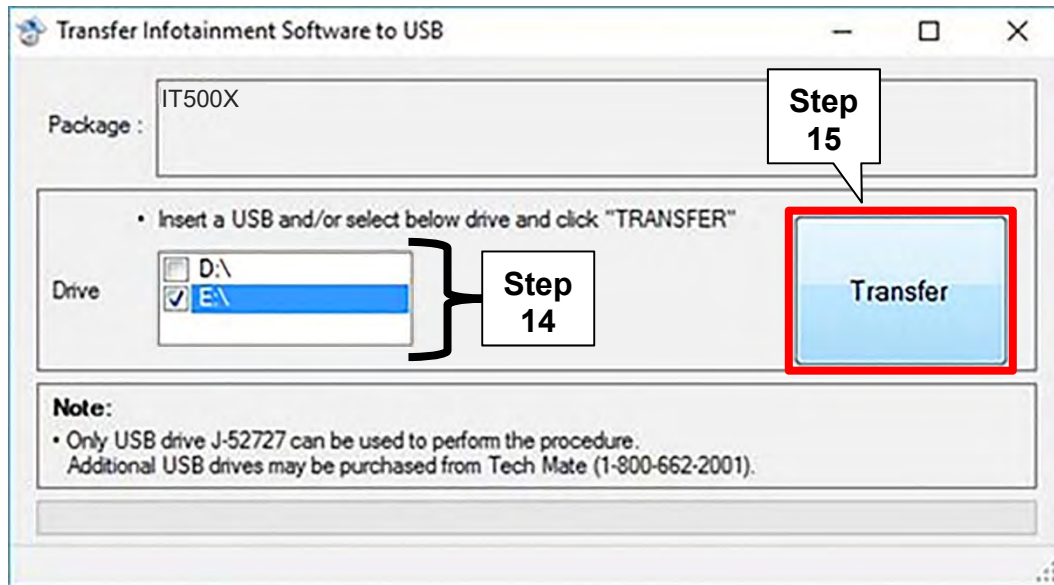
Figure 7

14. Once the download is complete, select the USB drive for update software package transfer.

- See example in Figure 7. The drive selection on your PC may be different.

15. Select **Transfer**, and then wait for the transfer to complete (see Figures 7 and 8).

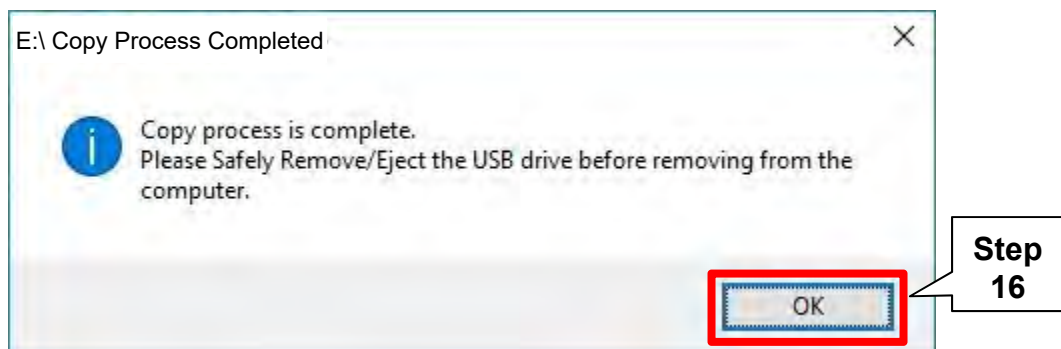
Figure 8

16. Select **OK**.

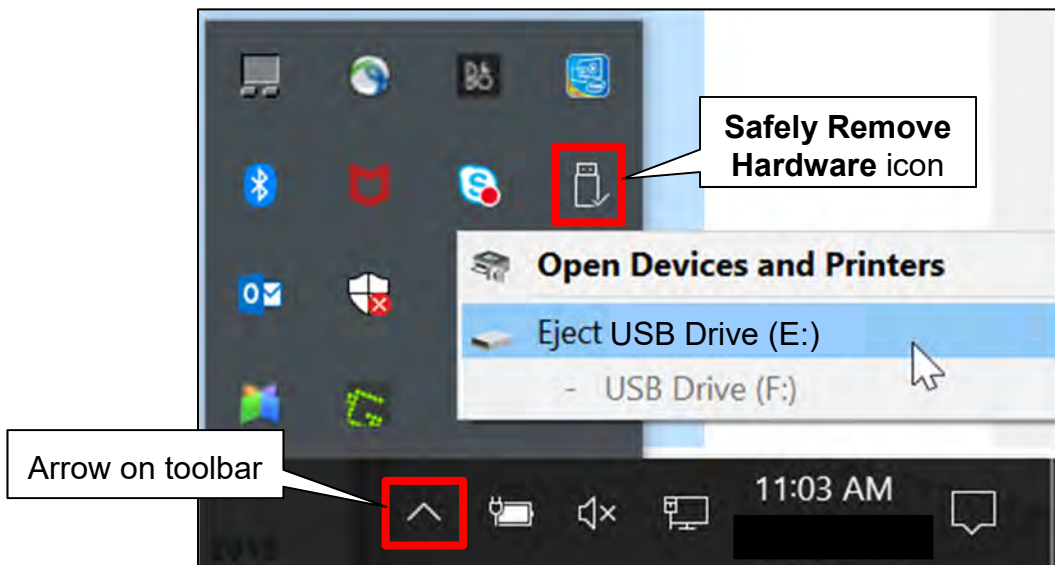
Figure 9

a. From the PC toolbar, select the **Safely Remove Hardware** icon.

- The icon is on the toolbar, or to be found after selecting the arrow.

b. Select the USB drive to be removed, and then remove the USB drive from the ASIST Station.

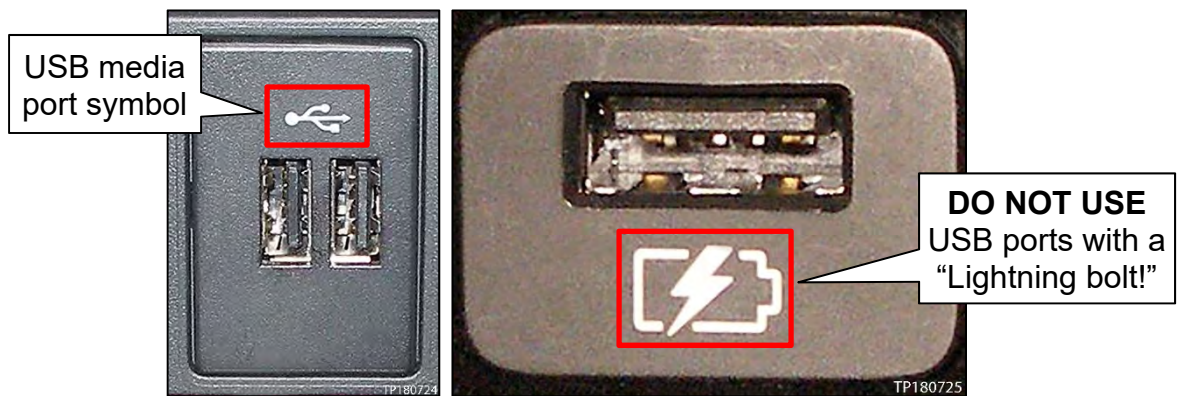
Figure 10

20. Connect the USB drive with update software package into the vehicle's USB media port.

**CAUTION:** Charging ports are marked in the vehicle with a “lightning bolt” symbol. Do not insert the USB drive into a charging port. If used, the update software and/or USB drive may become damaged. Only insert the USB drive in a USB media port.

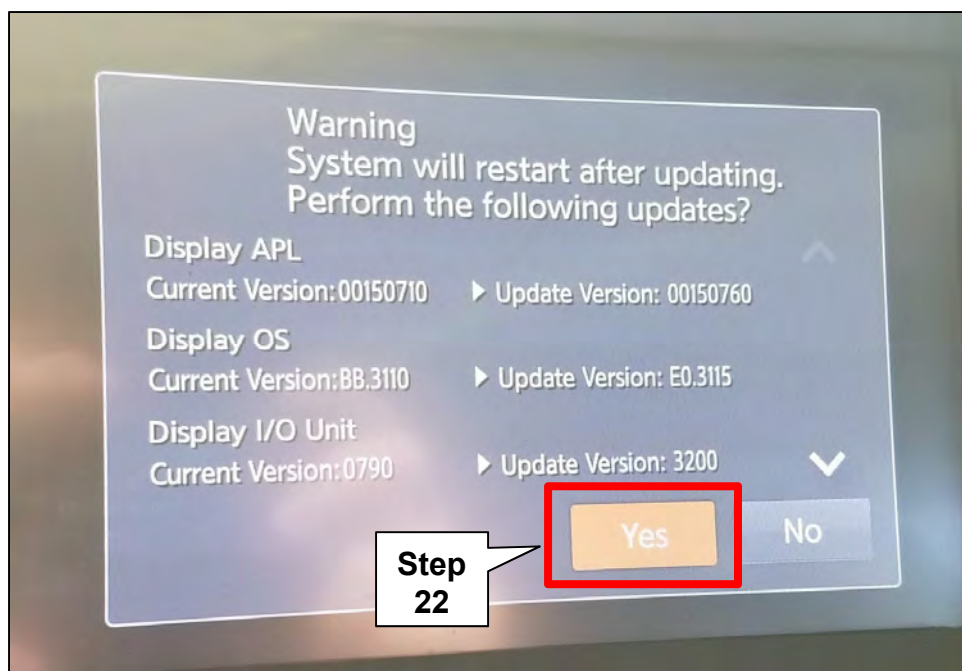
21. Wait approximately 10-30 seconds for the screen in Figure 11 to appear.

22. Select **Yes** to begin the software update.

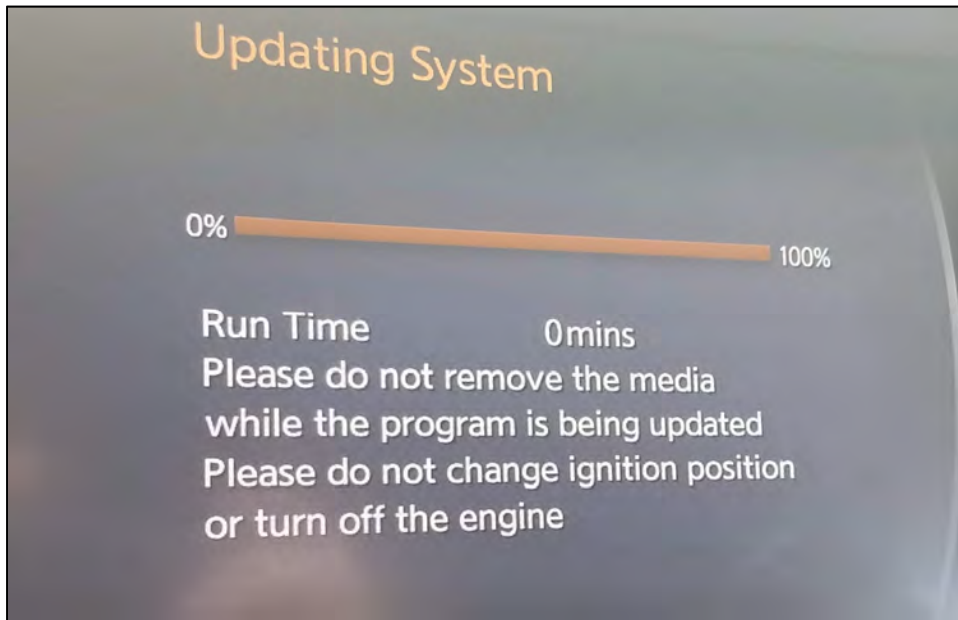
Figure 12

23. Wait for the update to complete.

- Follow the on-screen instructions while waiting.

**NOTE:** The update lasts 10-70 minutes.

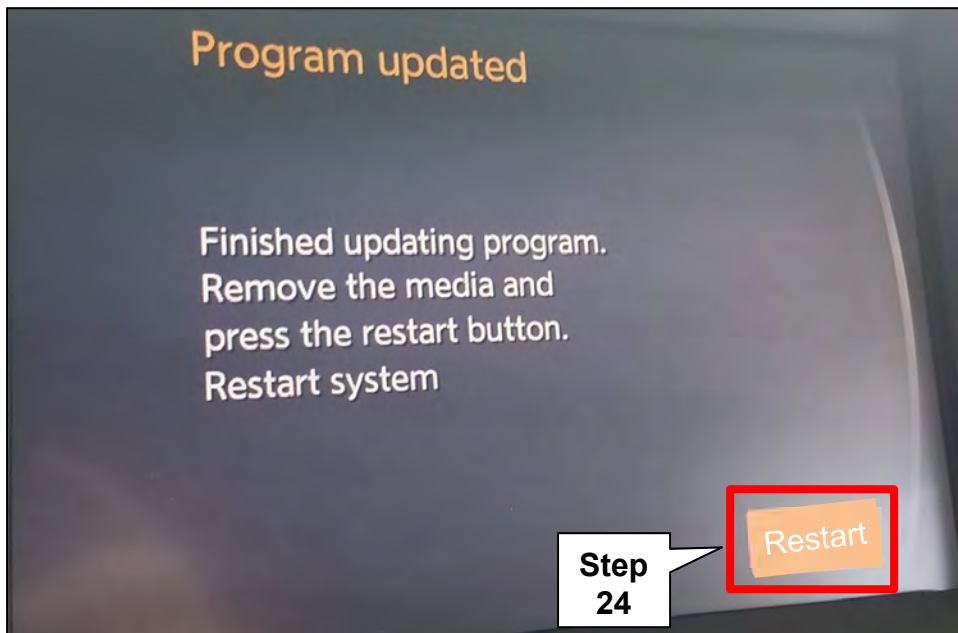
Figure 13

24. Once the update is complete, remove the USB drive, and then select **Restart**.
