SERVICE BULLETIN

APPLICABILITY: 2014-16MY Crosstrek Hybrid (HEV) **NUMBER:** 11-185-18
SUBJECT: DTC P0A7E: Reprogramming File Availability **DATE:** 11/27/18

INTRODUCTION:

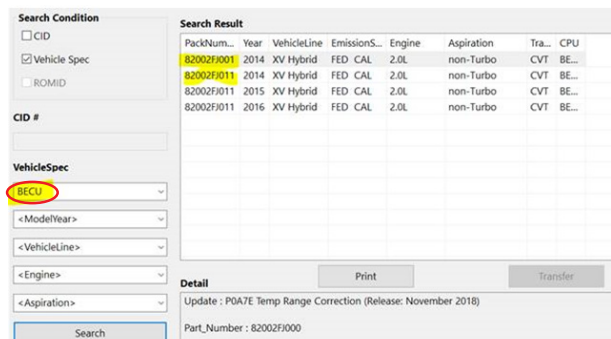
NOTE: FlashWrite currently displays the Battery Energy Control Unit as BECU when searching for available updates using Vehicle Spec as shown in the screen shot to the right.
