Field campaign

Topic	Rear Seat Entertainment - field update 2 (SC18/02) (ASW 09.16)
Market area	Bentley: worldwide (2WBE),Hongkong-Macau (5HK)
Brand	Bentley
Transaction No.	2048661/3
Campaign number	EA98
Note	
Type	Service Campaign
US code

Flying Spur

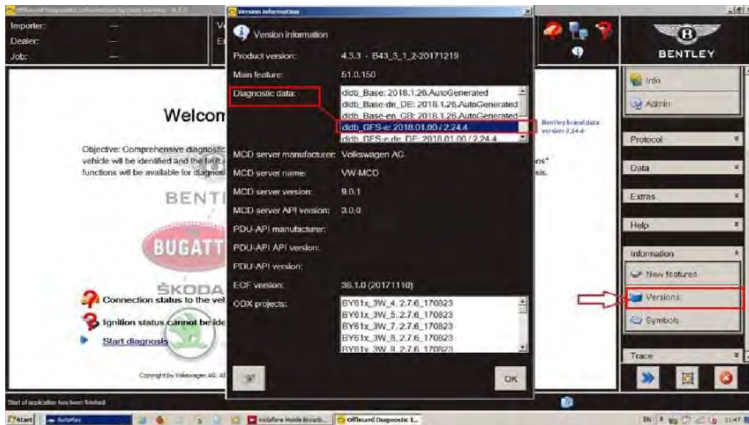
Figure 1a

Your Bentley diagnostic tester must be loaded with Bentley Brand Diagnostic Data Version (didb version) 2.24.4 or higher to perform this campaign (see Figure 1a)

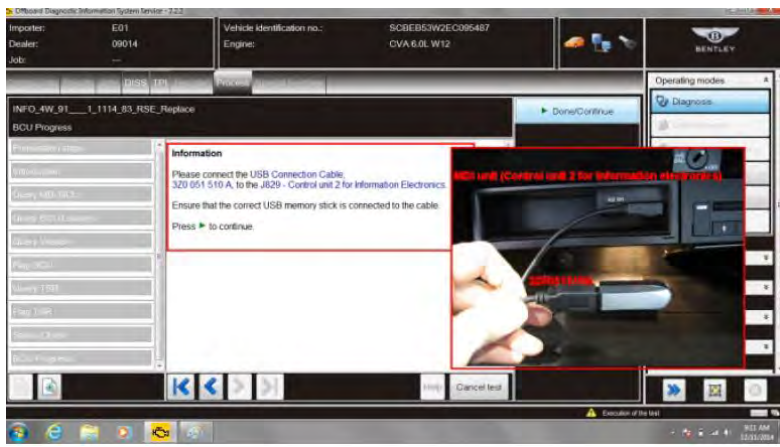
Figure 7

Figure 6
13. As requested connect the USB cable (part number 3Z0051510A) to the memory stick (part number WT10473) and connect that assembly to the MDI unit (Control unit 2 for Information Electronics) located in the glove box. Once connected select Continue (see Figure 7) once connected the update should begin within 5 seconds

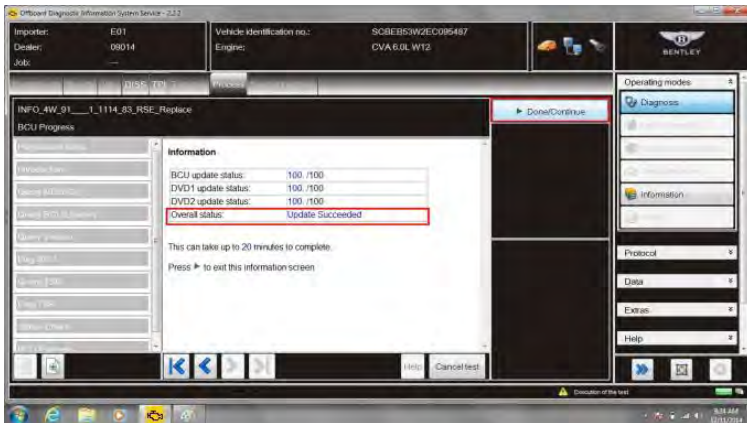
Figure 9

15. The process screen will display progress. This section of the download will take up to 20 minutes. When the *Overall status* shows *Update Succeeded* select Continue (see Figure 9)

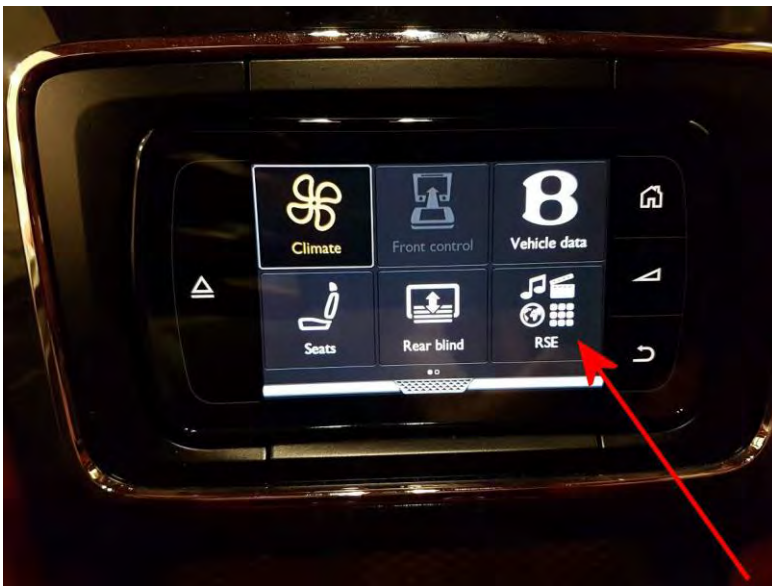
Figure 10

18. Once the RSE icon is visible on the TSR switch both screens on (See Figure 10)

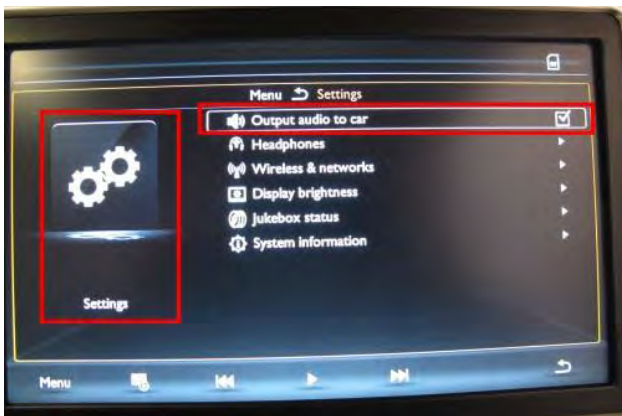
Figure 14

24. **Hint:** The additional function Output audio to car may be set to off in the settings menu check the tick box to enable this function (see Figure 14)

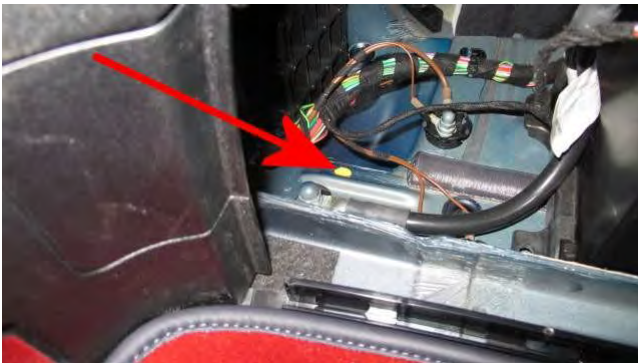
Figure 15

The presence of a yellow completion spot on the left hand side floor pan identifies this campaign has been performed (Figure 15)

If the vehicle is not already listed as repaired in the "Repair history" (Elsa pro), check for the presence of a yellow completion spot on the left hand side floor pan (Figure 15), should neither be evident carry out the required work in accordance with these instructions

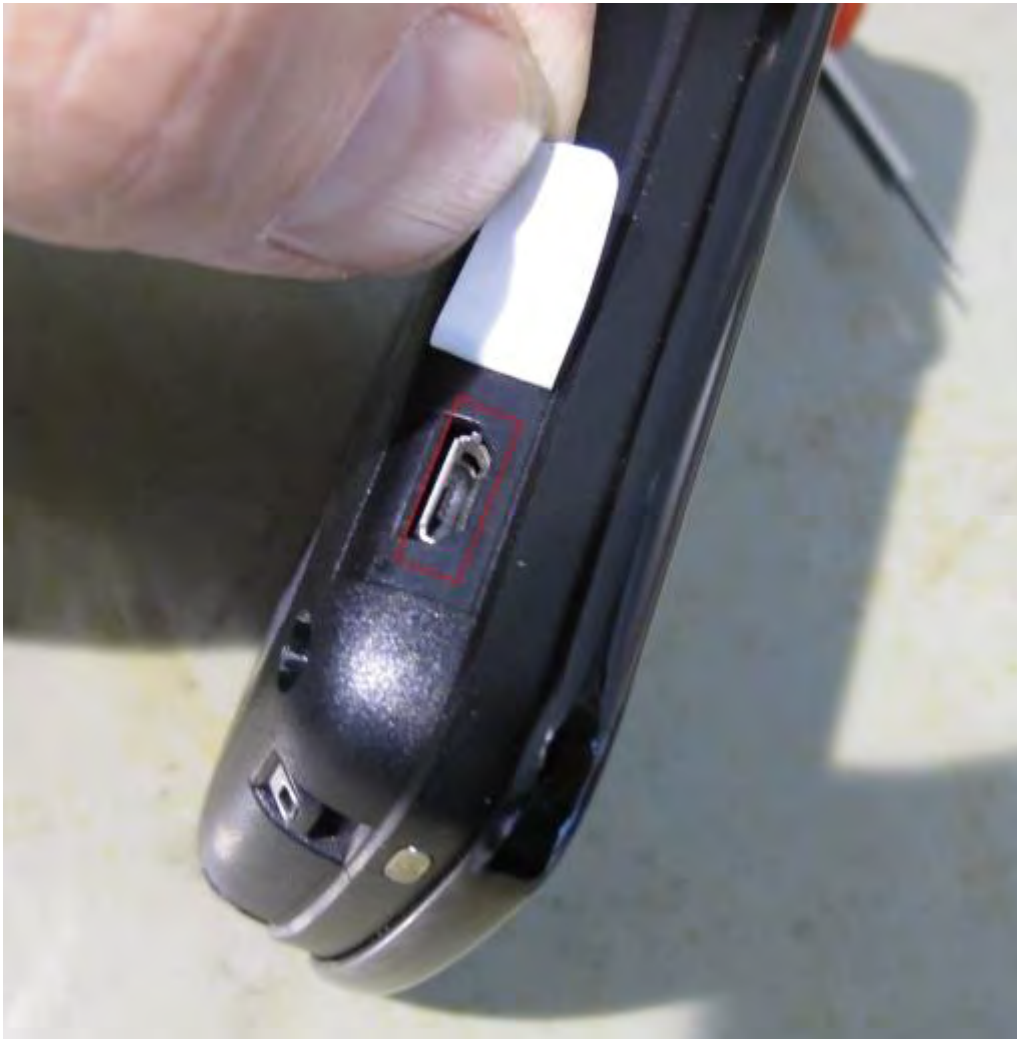
Figure 10

3. With the back removed from the TSR remove the tape covering the micro USB port (see Figure 10)

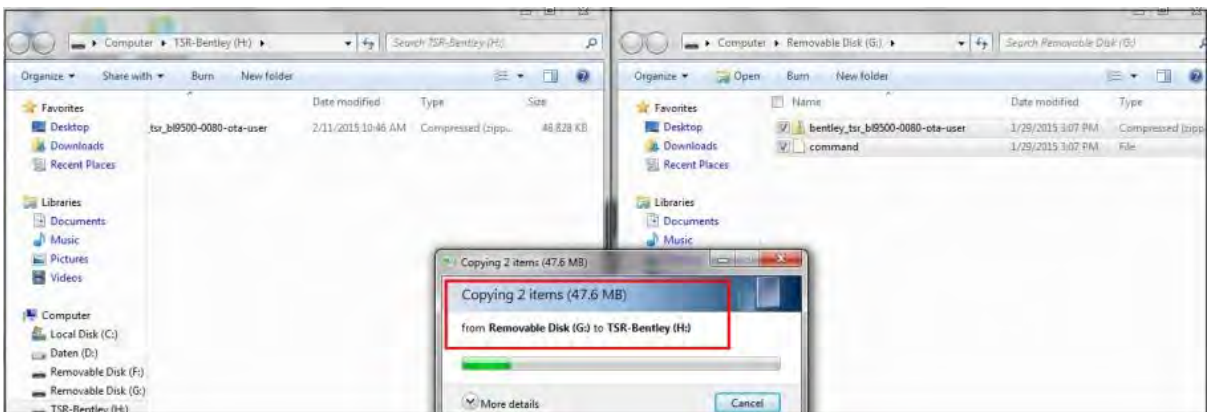
6. The Bentley diagnostic tool will display two *AutoPlay* windows, one for the memory stick and one for TSR-Bentley. Select *Open folder to view files* on both windows. Arrange the two open folders side by side on the *Desktop* in preparation to transfer files.
7. The memory stick (Removable Disk (?)) contains two files these two files require transferring to the TSR-Bentley. Transfer the two files, *drag and drop*, from the *Removable Disk (?)* to the *TSR-Bentley (?)*. (See Figure 12a,b and c)
8. Once transfer has taken place close down the two windows using the *Safely Remove Hardware and Eject Media Function*
9. Refit the tape over the micro USB port and refit the back onto the TSR. Avoid touching the *Cancel* button that will be displayed on the TSR (see Figure 13)

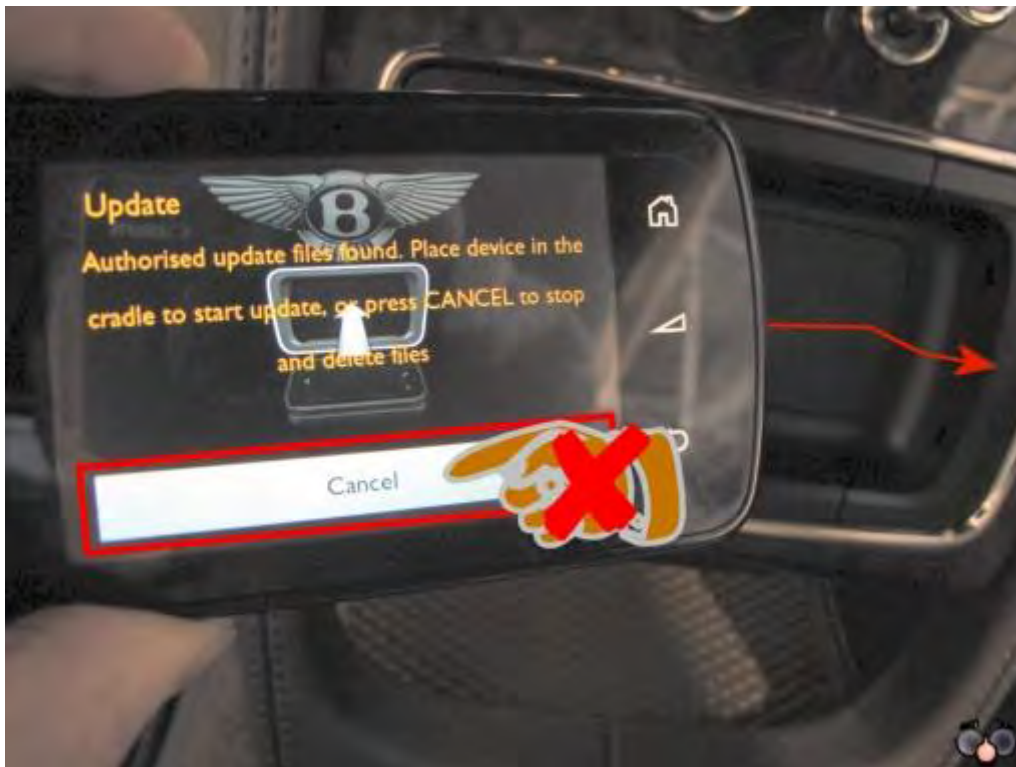
Figure 13

10. Once the TSR update is recognised as indicated on the TSR screen *Place device in the cradle to start update*. NOTE: When refitting the TSR into the cradle avoid touching the *Cancel* button (see Figure 13). If *Cancel* is inadvertently initiated then the process will have to be restarted from operation 2.

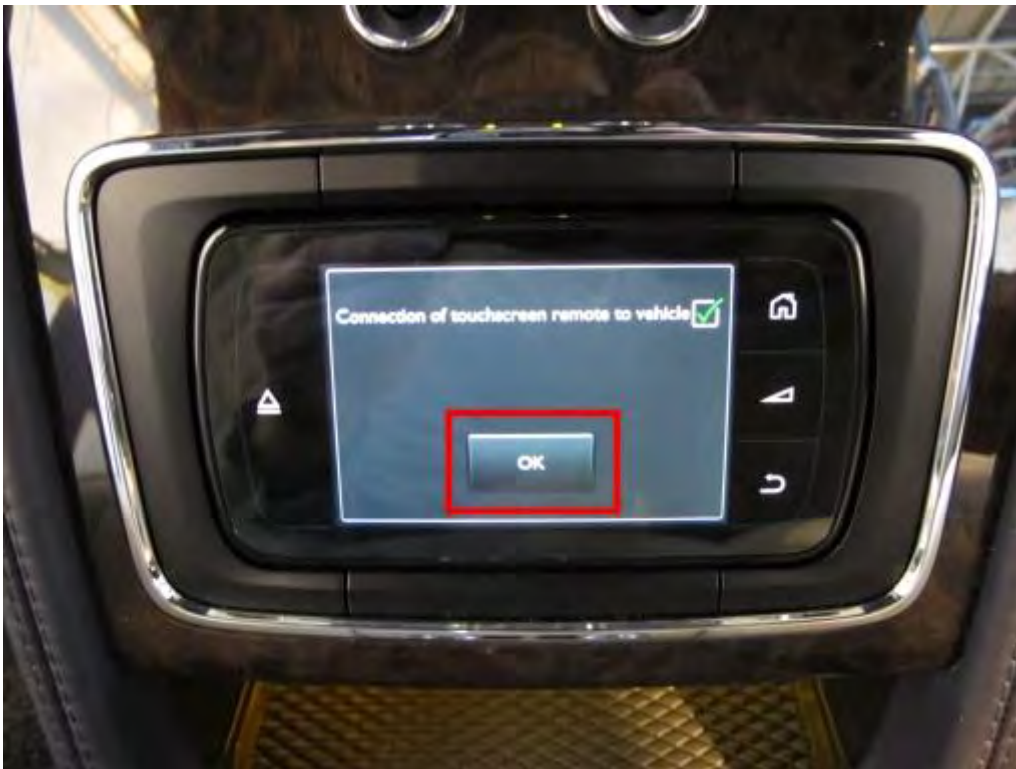
Figure 15

12. On completion the Bentley wings will be displayed for 3 minutes after which the TSR will undock and redock followed by the pairing of the TSR screen. Select *OK* (see Figure 15)

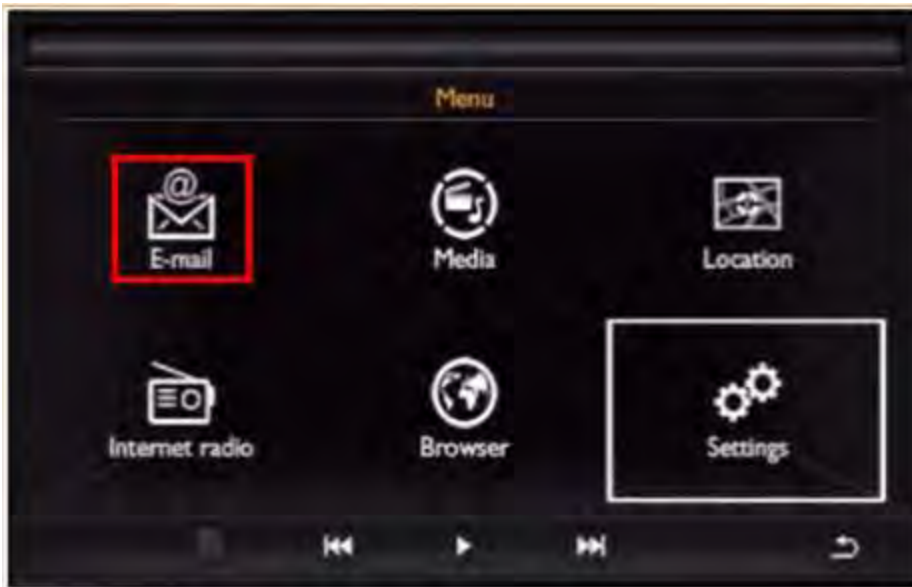
14. Switching on the RSE will now display the additional, online, icons. Figure 16a shows this updated system screen containing amongst others the E-mail icon
