EL18-024

## 2019 QX50; AUDIO SYSTEM WILL NOT TURN ON AND/OR SCREENS FREEZE UP AFTER HANGING UP A PHONE CALL

**APPLIED VEHICLES:** 2019 QX50 (J55)

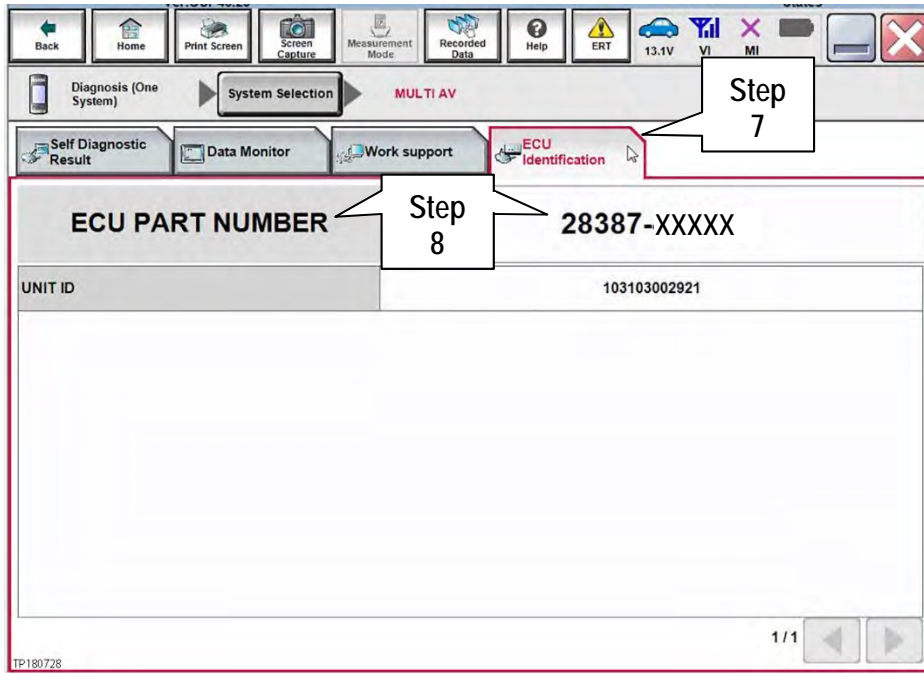
7. Select the **ECU Identification** tab.
8. When the screen in Figure 4 displays, confirm this bulletin applies as follows:
  - a. Write down the **ECU PART NUMBER** on the repair order.

**NOTE:** This is the current DCU part number (P/N).

- b. Compare the P/N you wrote down to the P/Ns in the **CURRENT DCU PART NUMBER** column in **Table A** below.
  - If there is a match, this bulletin applies. Go to the next page, **Update Display Control Unit**.
  - If there is not a match, this bulletin does not apply. Refer to ASIST for further diagnosis.
