EL18-024a

## 2019 QX50; AUDIO SYSTEM WILL NOT TURN ON AND/OR SCREENS FREEZE UP AFTER HANGING UP A PHONE CALL

**APPLIED VEHICLES:** 2019 QX50 (J55)

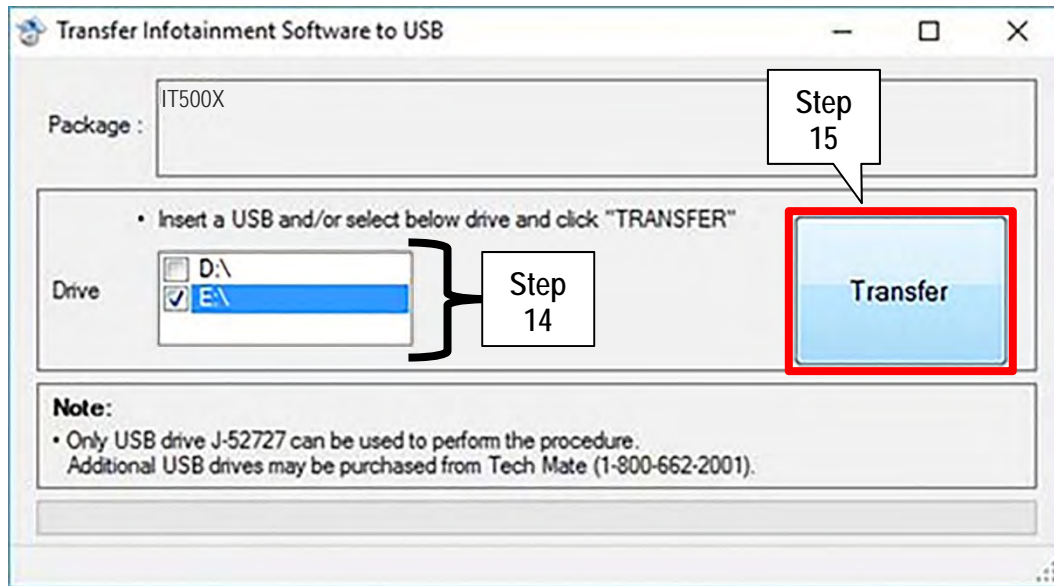
Figure 7

14. Once the download is complete, select the USB drive for update software package transfer.
- See example in Figure 7. The drive selection on your PC may be different.

15. Select **Transfer**, and then wait for the transfer to complete (see Figures 7 and 8).

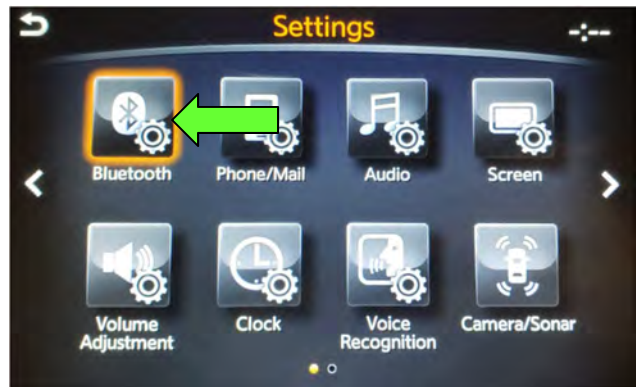
Figure 10

20. Open the Settings Menu and then select **Bluetooth**.

- The settings menu is accessed by selecting the settings app icon on the lower display.

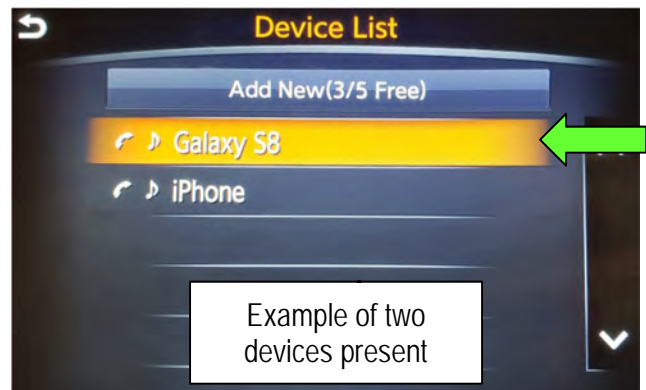
Figure 12

22. Is a device present in the Device List?

- **YES:** Select a device and then proceed to step 23.
- **NO:** Proceed to step 25.

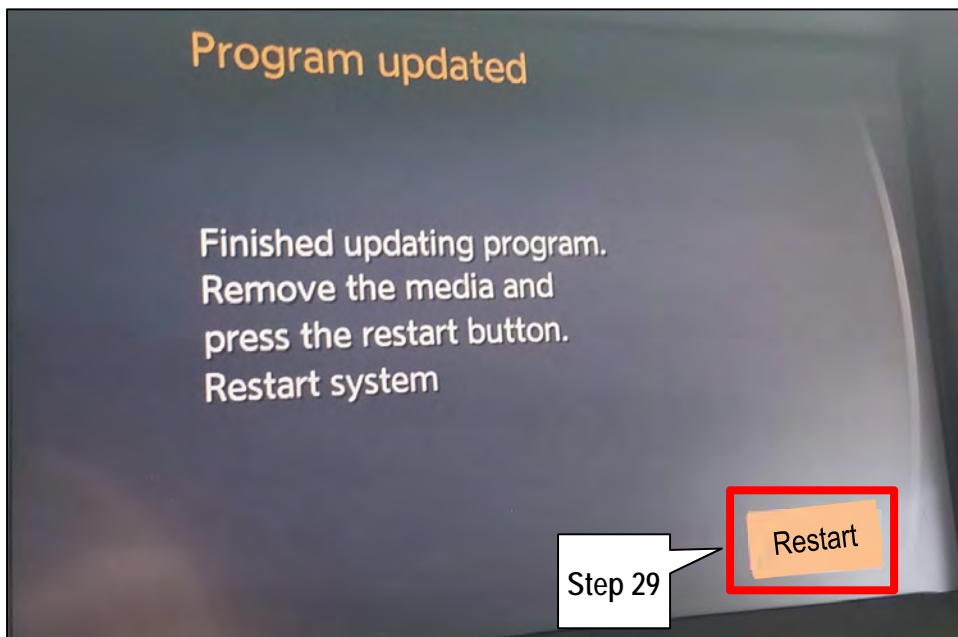
Figure 21

29. Once the update is complete, remove the USB drive, and then select **Restart**.
