TDI / AEM Emissions Service Action – USA ONLY

Code: 23Z3

Repair Available – Emissions Service Action 23Z3 / Improved Post-AEM Engine Control Module Software (AEM-C)

Date: December 20, 2018

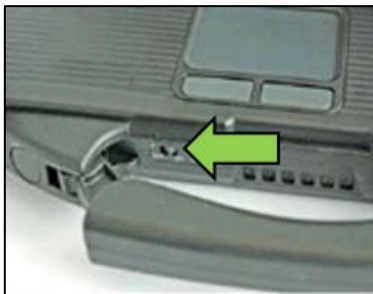
- ✓ **The Bluetooth function of the scan tool is physically switched off <see pictures below>.**

VAS 6150 & VAS 6150A
(Front panel behind handle)

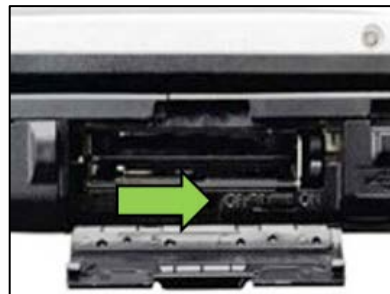
VAS 6150B
(Right side behind WIRELESS door)

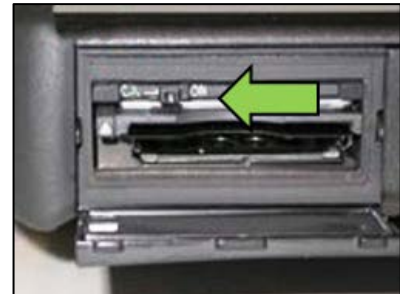
VAS 6150C/D
(Left side behind SC/EX door)

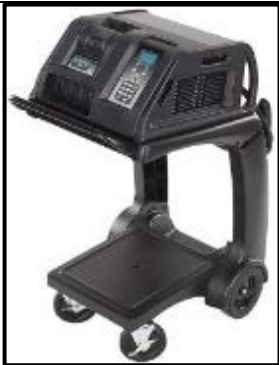
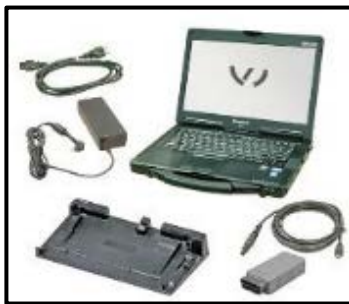
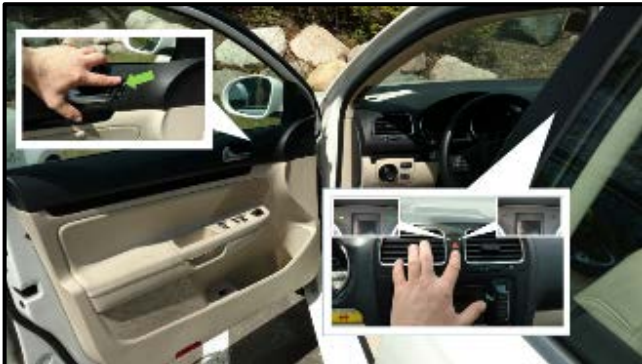
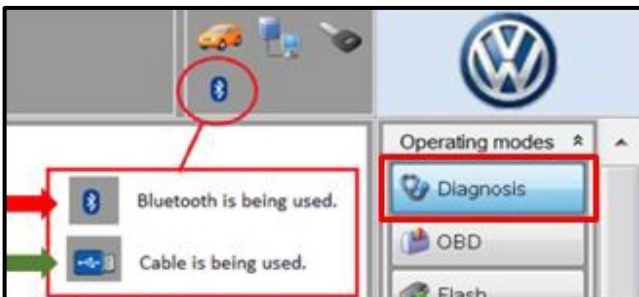
- Open the hood.
- Open the battery cover.
- Switch the ignition on.
- Apply the parking brake.
- Switch off all consumers (headlights, heated seats, climate control, radio, etc.).
- Connect the VAS6150X/VAS6160X Diagnostic Tester to the vehicle.
- Start the ODIS program.
- Attach the GRX3000VAS Tester/Charger (or equivalent) to the vehicle battery.
- Press the unlock door button <arrow>, and turn the hazards on.
