Title: FLR-10 Bendix Wingman Misalignment Issues

Applies To: All Vehicles Built with Wingman FLR-10 Radars Feature Code 0008TKY

DESCRIPTION:

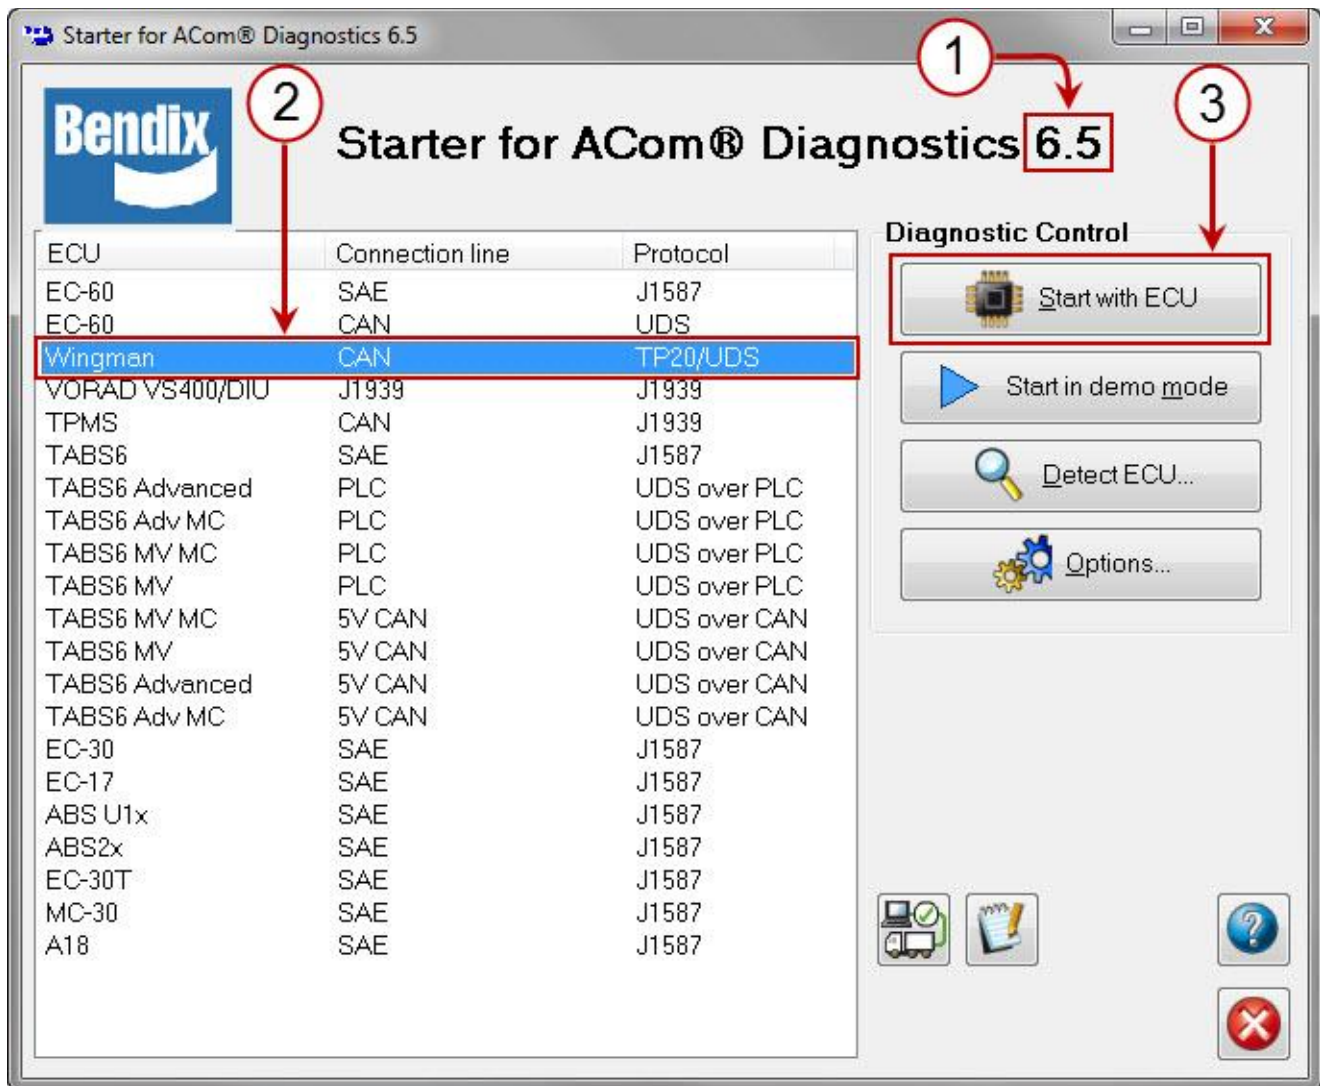
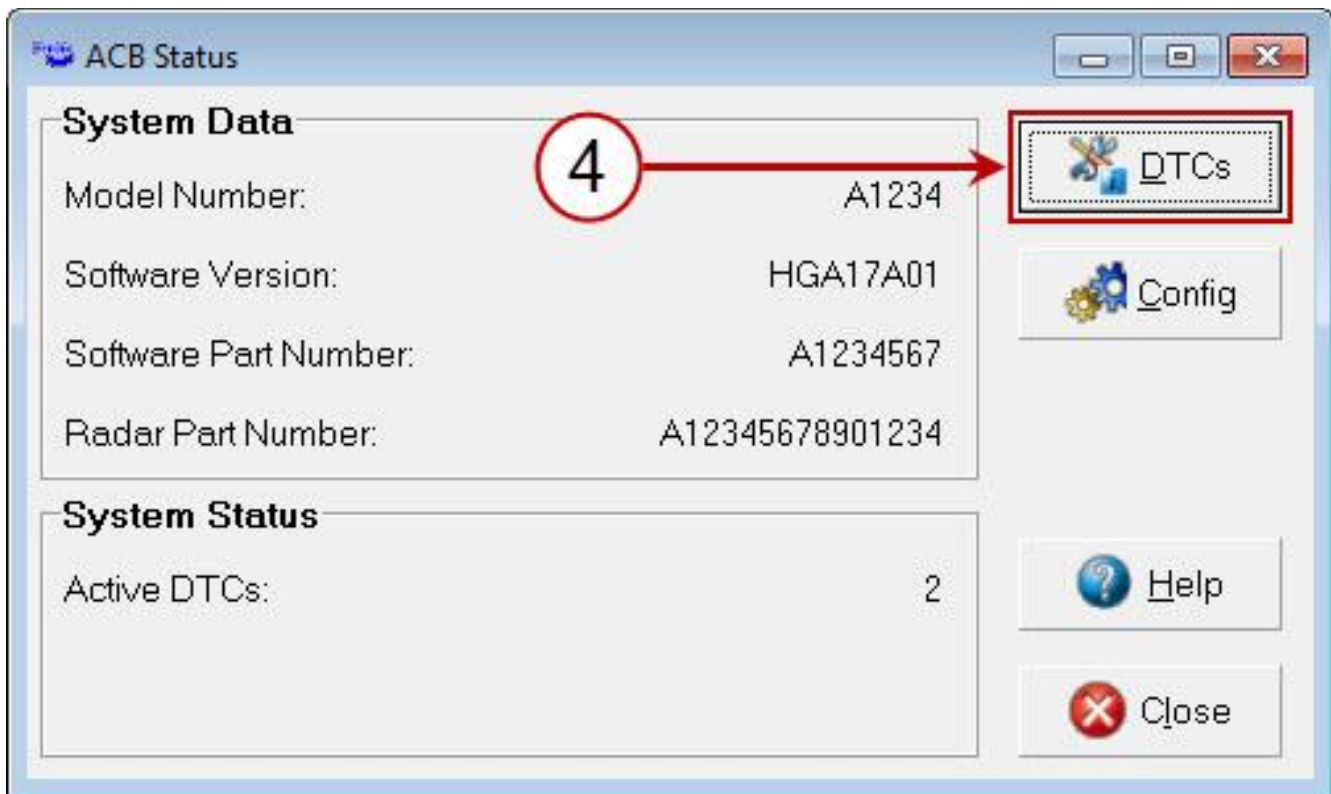
1. ACom Diagnostics software – Version 6.05 or later – is required.
2. Select "Wingman" from the starter screen
3. Select "Start with ECU"
4. Click "DTC" to show the diagnostic trouble codes.
5. If you are unable to connect to Wingman ACB in ACOM, ensure you are using ACOM Version 6.5 or later, and both ECM/TCM fuses are removed to reduce data link traffic.

- When using ACom Diagnostics for the first time, the service technician will be asked to select the communication adapter for both the ACB and Bendix® EC-60™ controllers.
- While both controllers will use the same physical adapter, the technician will need to indicate which communication protocol to use for each.
- Once a successful connection has been made, these steps will no longer be necessary
