UPDATE Technical Bulletin

37L7 UPDATE – Jetta TCM Software (INV_ONLY) (INVENTORY VEHICLES ONLY)

Gearbox may produce a resonance at 450 Hz. Optimized software will reduce the resonance at 450 Hz.

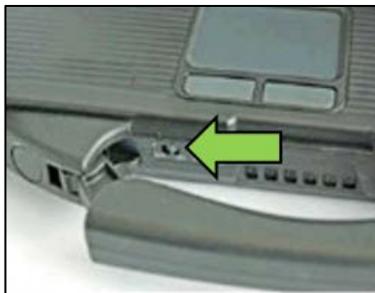
- ✓ **The Bluetooth function of the scan tool is physically switched off <see pictures below>.**

VAS 6150 & VAS 6150A
(Front panel behind handle)

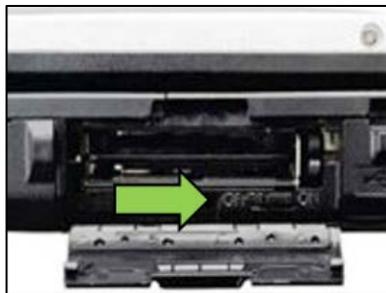
VAS 6150B
(Right side behind WIRELESS door)

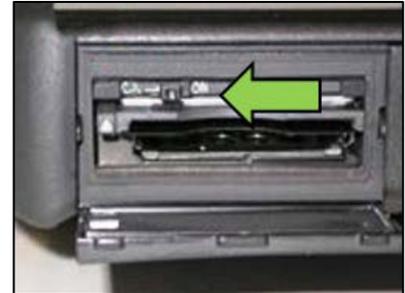
VAS 6150C/D
(Left side behind SC/EX door)

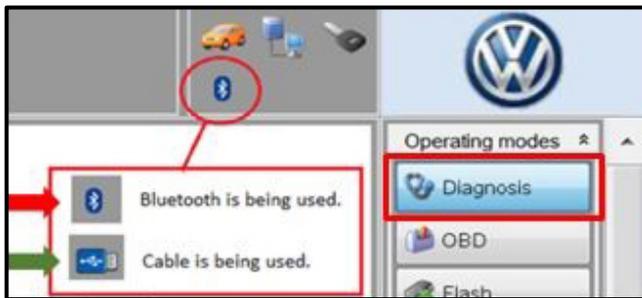
- Confirm that scan tool is communicating with the diagnostic head by USB <Green Arrow>.

1. If the Bluetooth symbol is shown <Red Arrow> then disconnect the diagnostic head from the vehicle and reconnect the USB cable to the diagnostic head and then reattach to the vehicle.

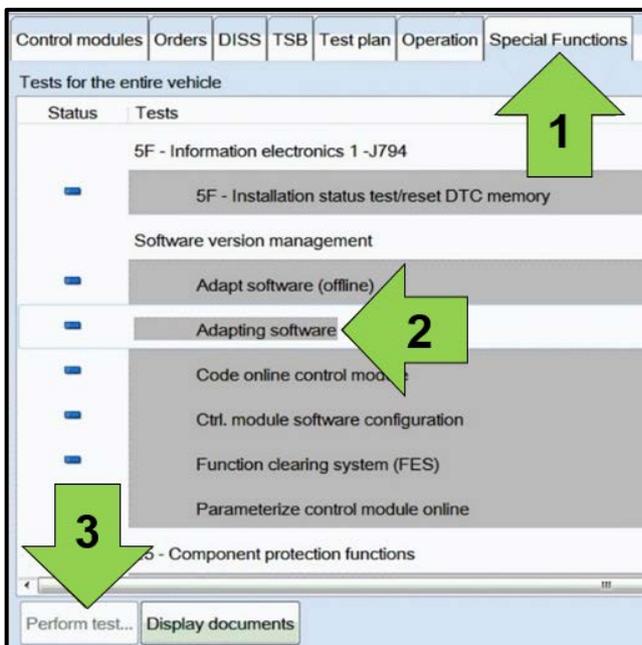
- Upon ODIS startup, verify the "Diagnosis" operating mode is selected <as shown>.

- Once the GFF scan is complete, select "Special functions" <arrow 1>, then "Adapting software" <arrow 2>, then select "Perform test" <arrow 3>.

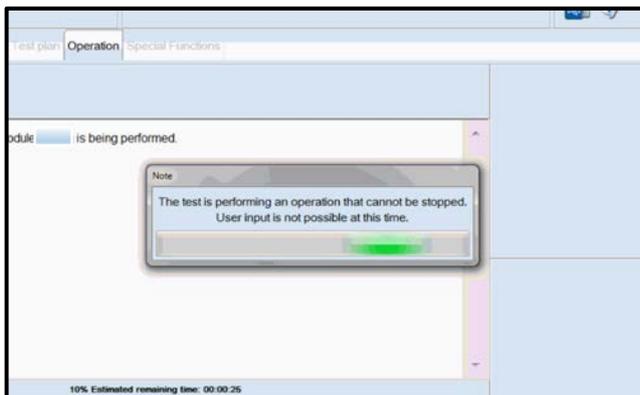
- Select “Accept” <arrow> and follow the on screen prompts.
- During the flash, this screen appears when each of the operations are performed:

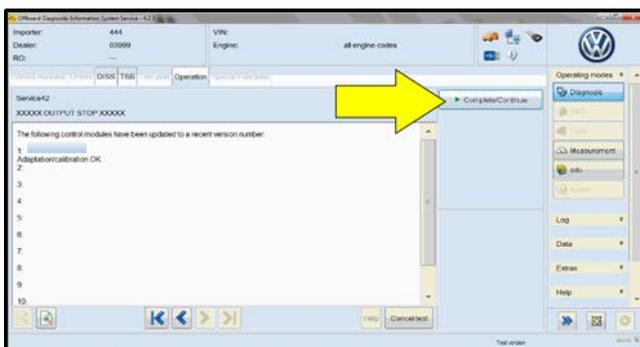
- Select Complete/Continue <arrow> after each operation is completed.

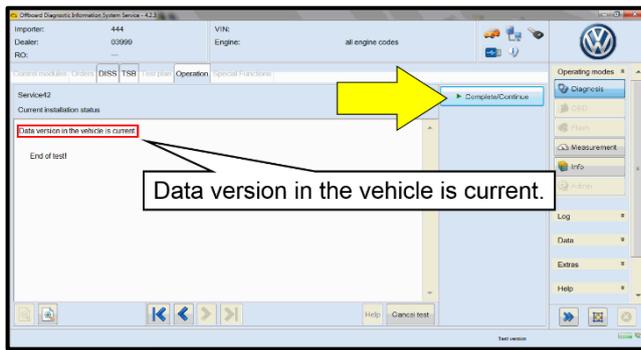
- When the SVM update is complete a confirmation message is displayed <as shown>.
- Select “Complete/Continue” <arrow>.

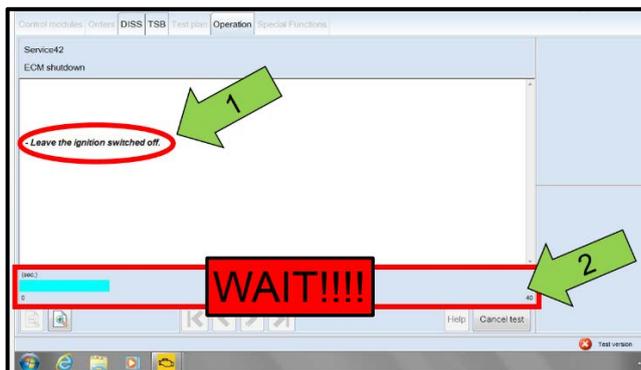
- It is **IMPERATIVE** that **ALL** of the ignition cycle on/off delay requests are fulfilled in their entirety during this flash process <arrow 1>.
- Failing to wait for the ignition on/off timing cycle to complete (progress bar and countdown timer <arrow 2>) before cycling the ignition on/off MAY damage a control module.
- Damage to control modules as a result of failing to wait the specified time displayed by the progress bar and countdown timer <arrow 2> are **NOT** covered under this action.

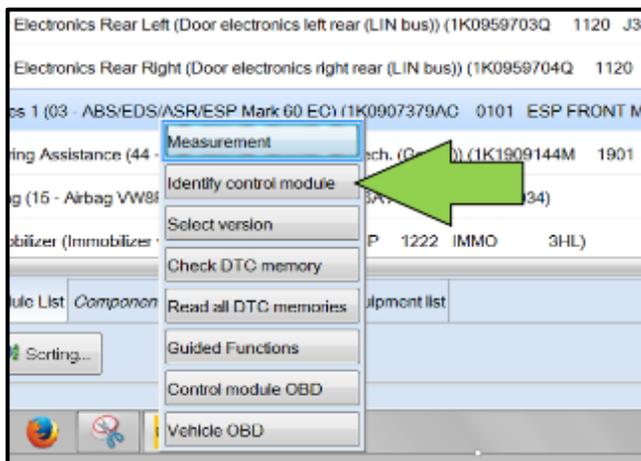
- After the software update is completed and before sending the GFF Log Online:
 - Select the “Control Module” tab.
 - Scroll down and right click on the module that was updated (0002).
 - Select “Identify Control Module” <arrow>.

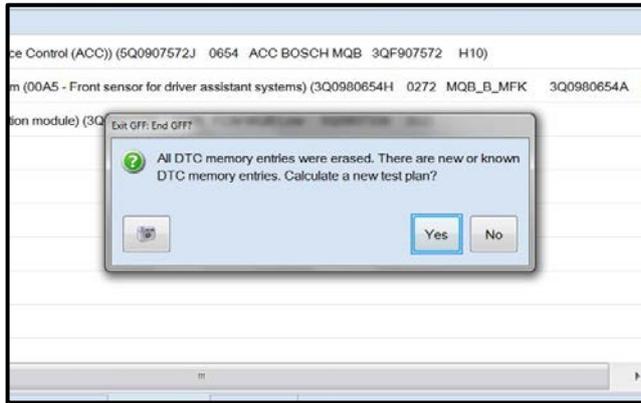
- Exit GFF and send diagnostic protocol online when prompted.
