**Campaign code:**  
L636-A.04.18

**Campaign description:**  
This campaign includes the ECU 5F.

**Model:**  
Urus

As a result of continuous product monitoring, Automobili Lamborghini S.p.A. has released a new software update for entertainment instrument cluster of Urus. This release contains improvement of ECU 5F graphics, 5GHz connection and text tool.

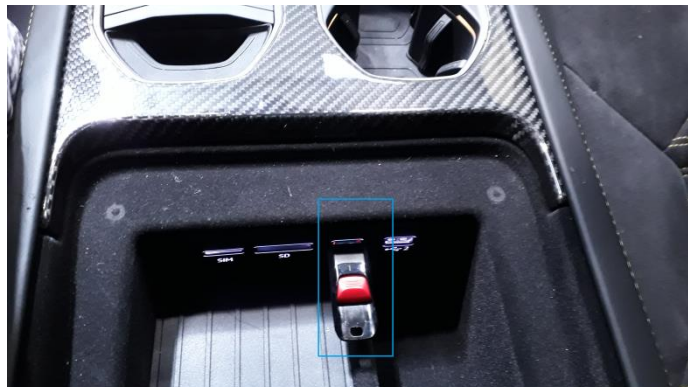
10. Move on the car and insert the USB memory stick containing the downloaded software in one of the USB ports under the armrest in the central tunnel.

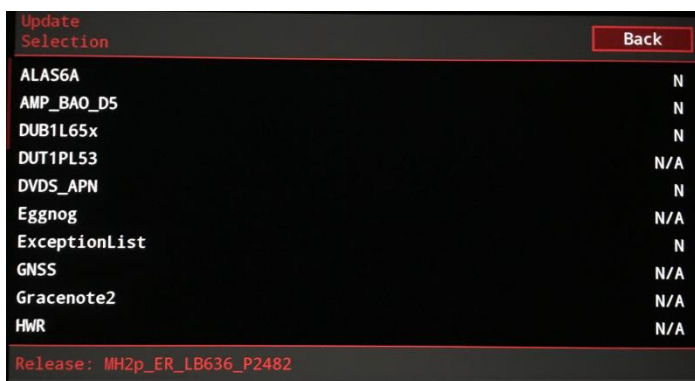
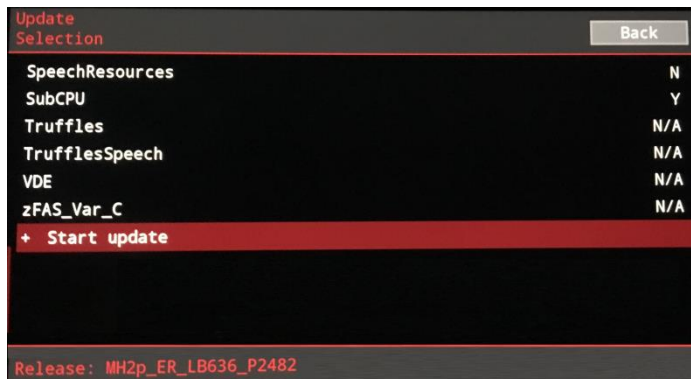
16. The files to be installed will be listed in the screen, scroll with the main knob through the items displayed in the ECU 5F, until you select "Start Update".

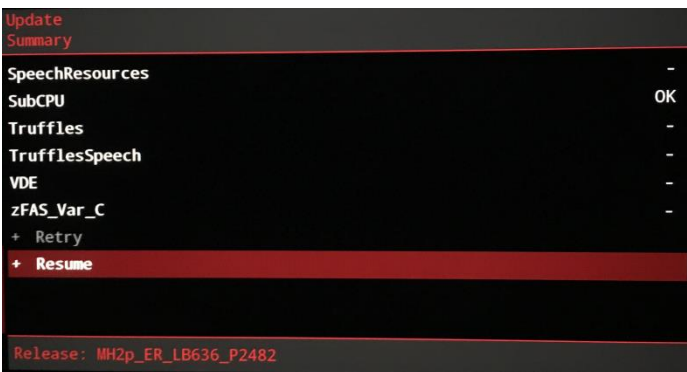
21. When the ECU 5F restarts, the "Update Summary" file will be displayed, scroll down and click "Resume". You can now unplug the USB memory stick.

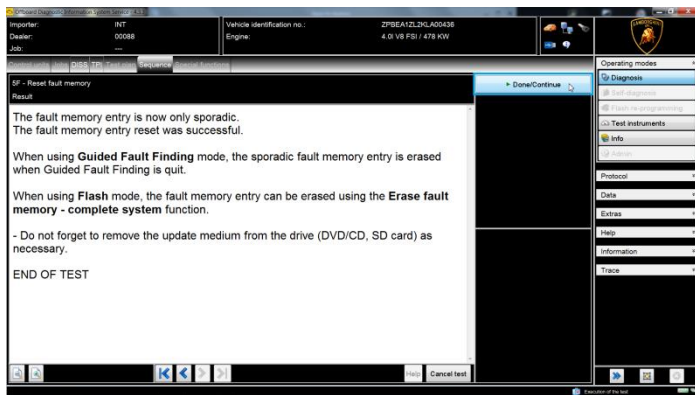
40. Click “Done/Continue” to end the procedure.

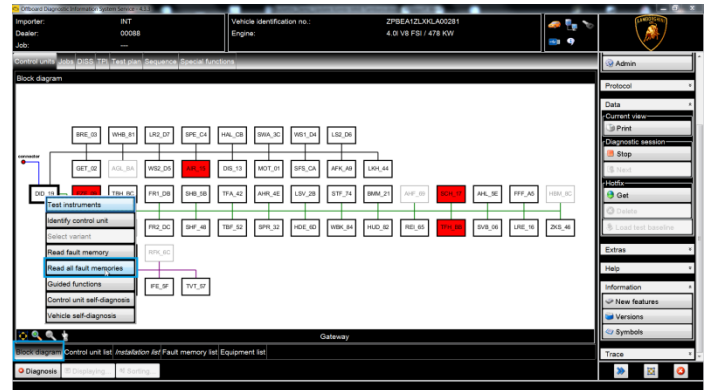
42. Go back to the “Block diagram” tab and select “Read all fault memories” from one of the ECUs of the vehicle.
