675LT Vehicle Software Update to Platform 5.3

Bulletin type: Service Campaign Bulletin
Reference number: 11 M 102
Campaign reference: 04M
Attention: Retailer Service Managers and Retailer Technicians
Affected vehicles: 675LT Coupe & Spider
Situation: McLaren Automotive has released a new software platform for 675LT
Procedure: This software update must be completed on all vehicles at the next Service Centre visit
Date: 10th April 2018

McLaren Automotive has released a new software platform for 675LT. This software update must be completed on all vehicles at the next Service Centre visit.

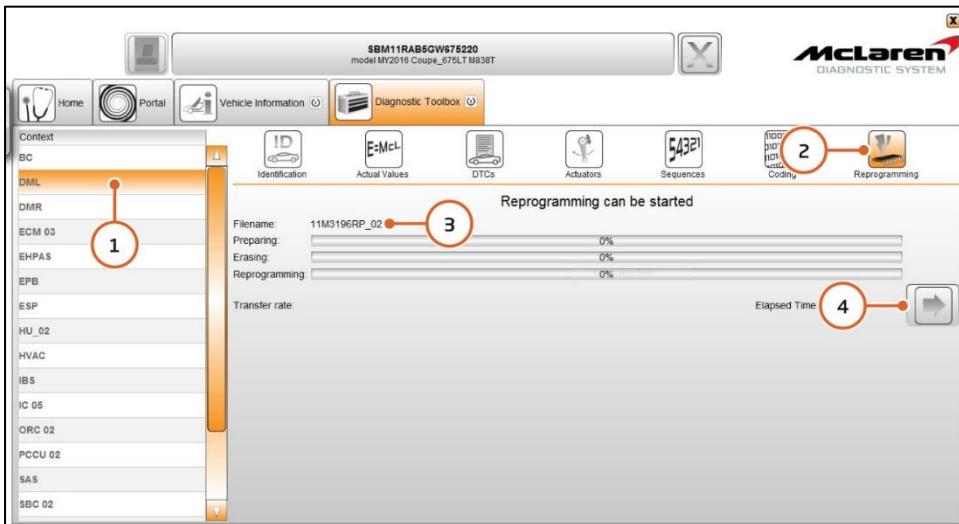
Step 11

Select 'DML' (1), then 'Reprogramming' (2), the software level 11M3196RP.02 will be displayed (3). Proceed to the software download by selecting the arrow button (4)

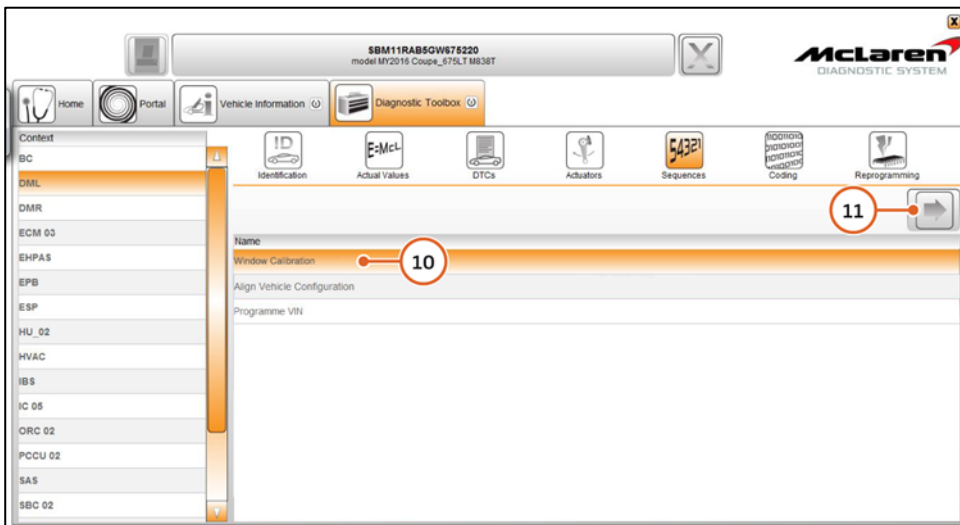
Step 14

Select 'Window Calibration' (10), followed by the arrow key (11)

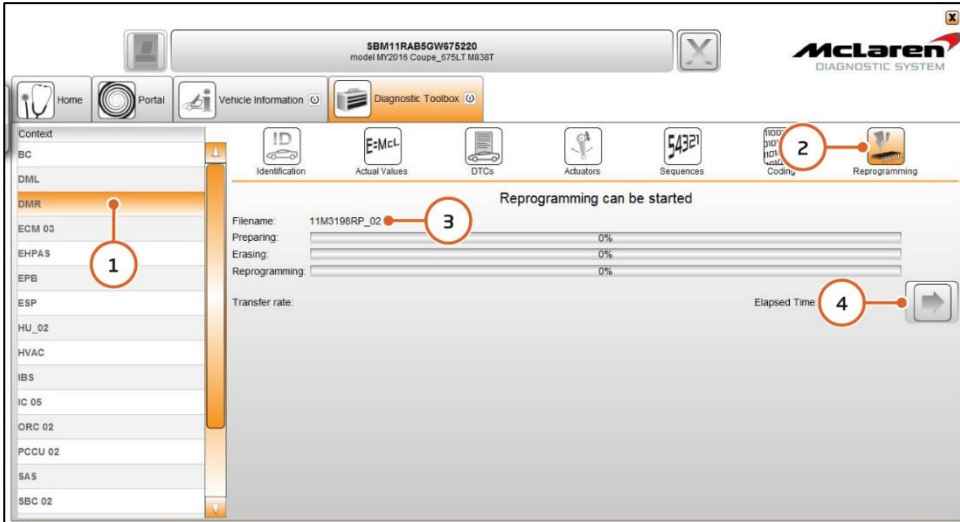
Step 16

Select 'DMR' (1), then 'Reprogramming' (2), the software level 11M3198RP.02 will be displayed (3). Proceed to the software download by selecting the arrow button (4)

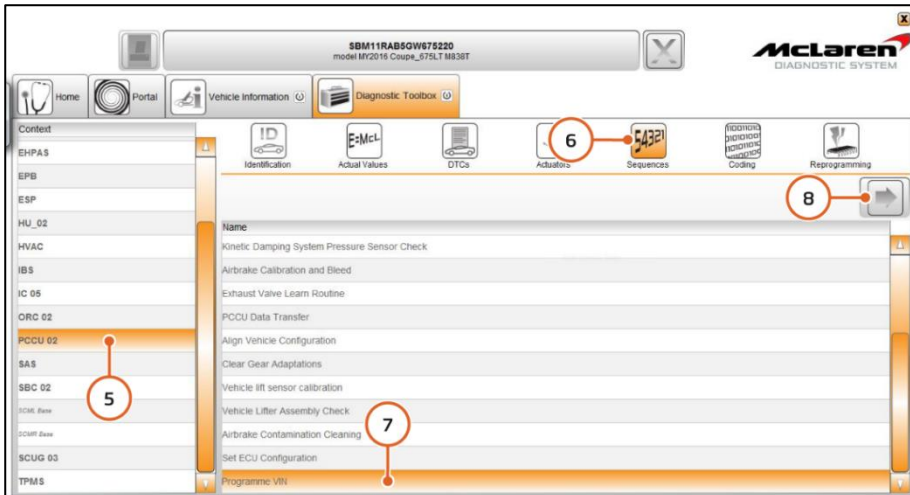
Step 23

Ensure the 'START/STOP' button is flashing and clear any DTC's before continuing with the procedure. Immediately after that, select 'PCCU' (5), then 'Sequences' (6), select 'Programme VIN' (7), followed by the arrow key (8)

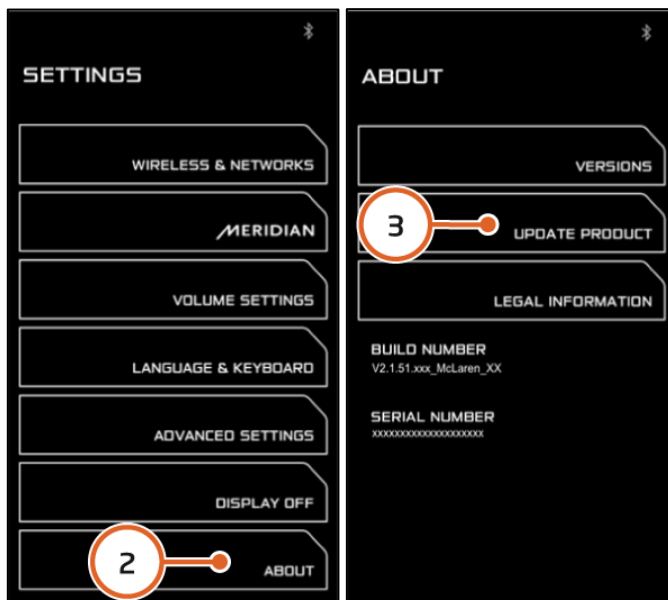
Step 35

Select 'About' (2) and then 'Update Product' (3)

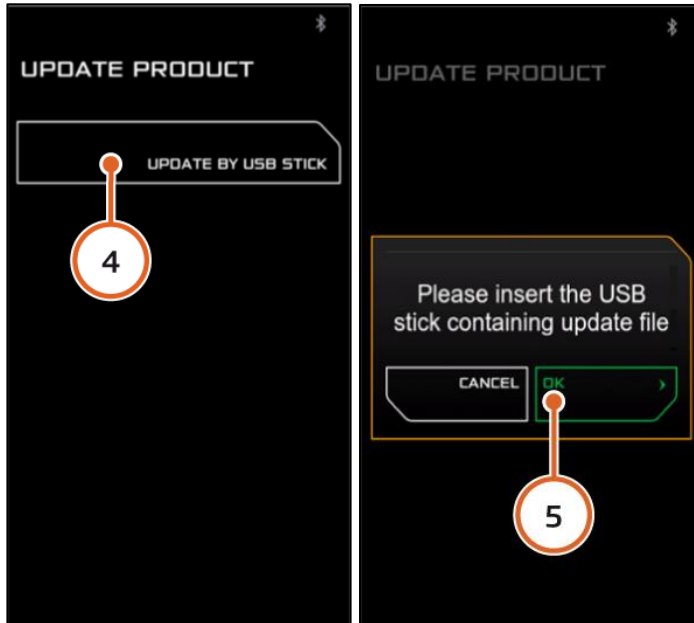
Step 36

On the following screen select 'Update by USB Stick' (4). A pop up message will be displayed. Press 'OK' (5) to start the loading operation

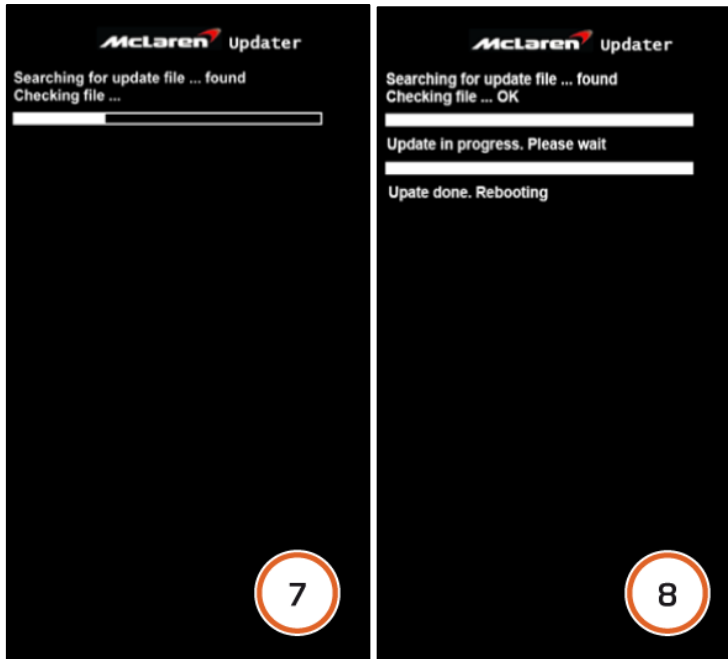
Step 38

After the system has rebooted it will search for and check the update file (7). Once the installation has finished the following screen will be displayed (8) and the system will reboot

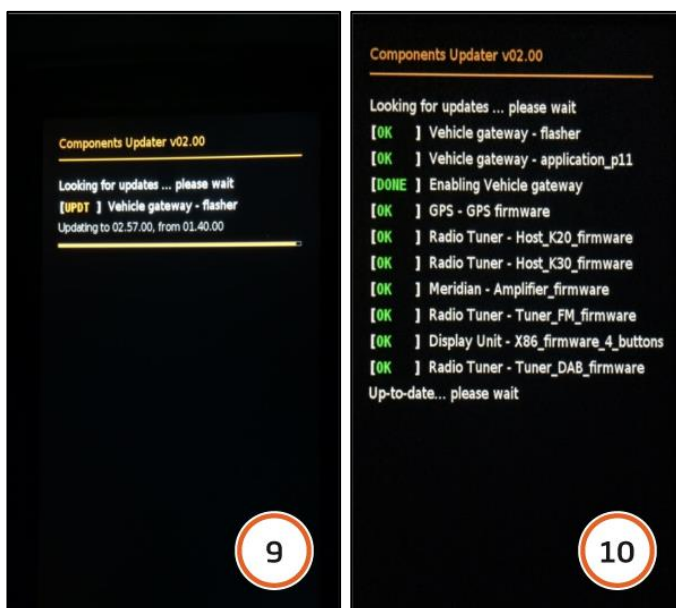
Step 39

Following the reboot, the system will start to update the individual system components (9) and (10). During the update, the system may reboot multiple times. This is normal, do not attempt a manual reset

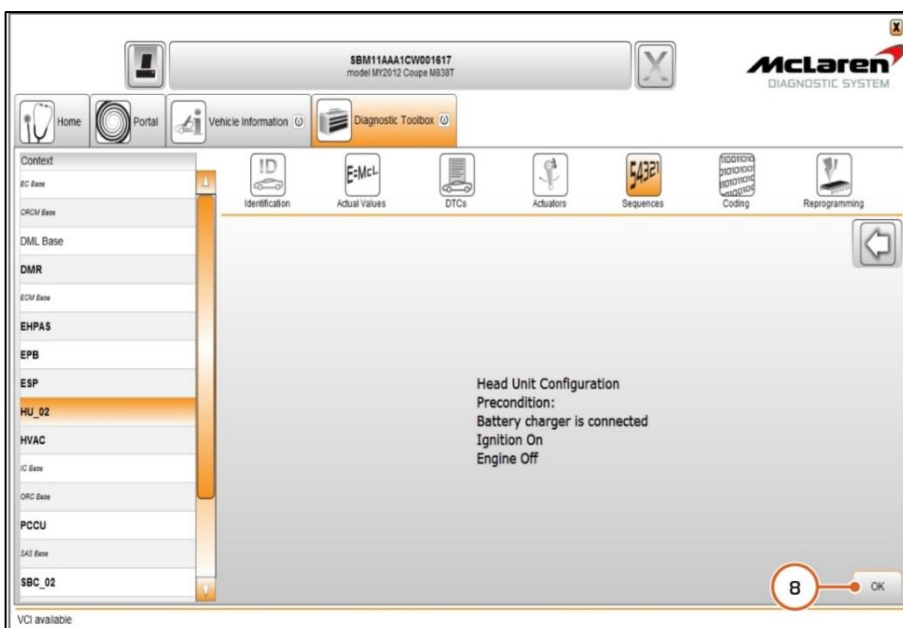
Step 47

The following screen will appear, select 'OK' (8)

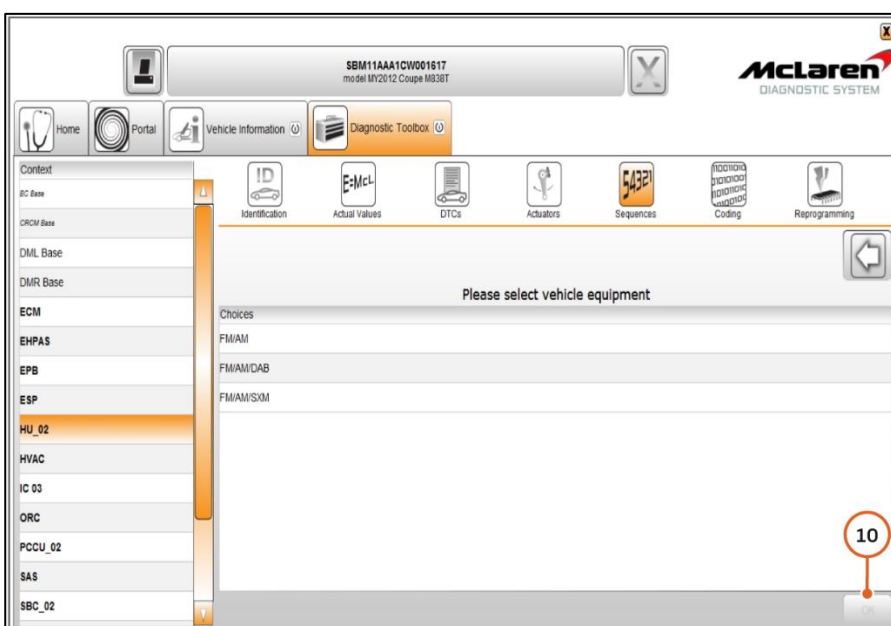
Step 49

Select the relevant radio frequency option, followed by 'OK' (10)

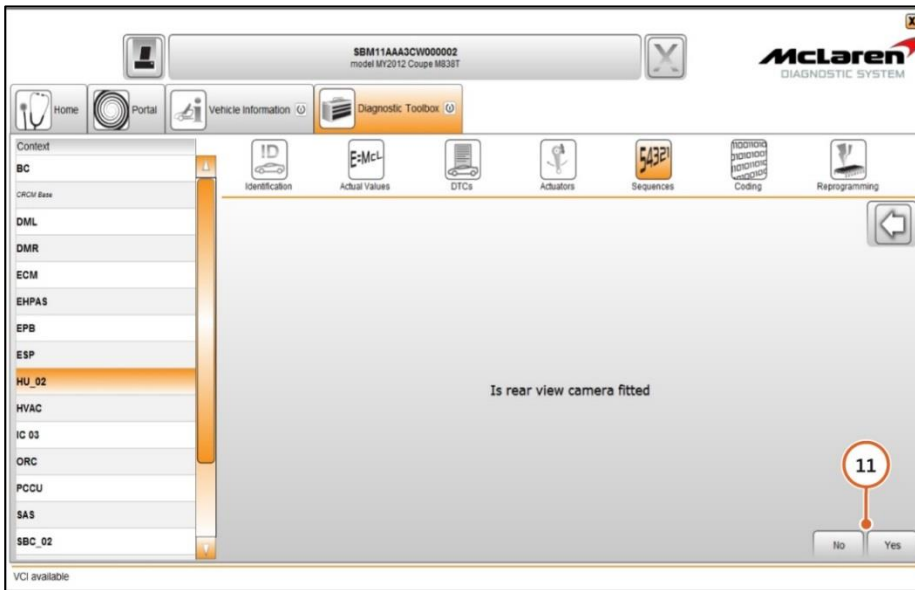
Step 50

Is rear view camera fitted, select 'Yes' or 'No' (11)

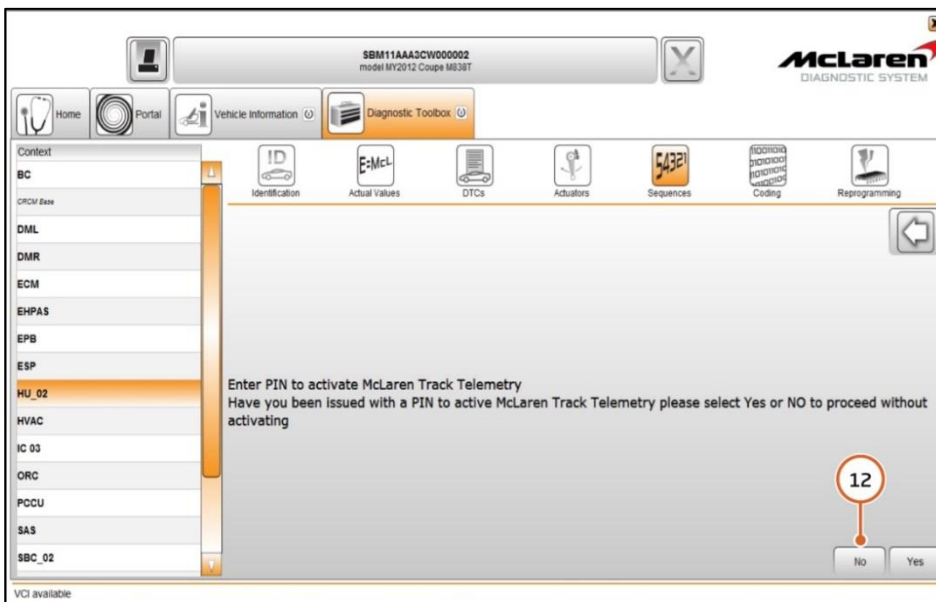
Step 51

- The screenshot below may not appear as the database stored on the MDS may contain the VIN number

Proceed and select 'No' (12)

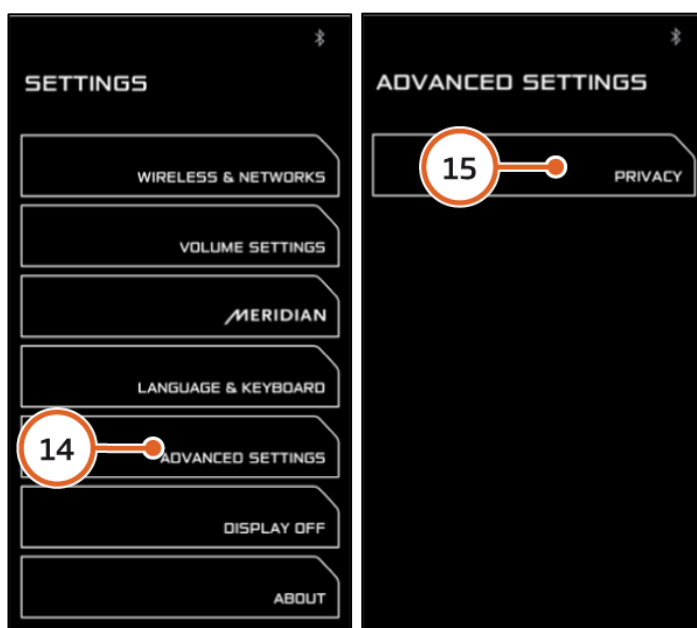
Step 54

Select 'Advanced Settings' (14) and then 'Privacy' (15) to access the Factory Data Reset
