GROUP <b>ENG</b>	MODEL <b>2019MY Optima (JFa) 2.4L GDI</b>
	NUMBER <b>198</b>	DATE <b>January 2019</b>
<b>TECHNICAL SERVICE BULLETIN</b>		
<b>SUBJECT: SERVICE ACTION: 2.4L GDI ENGINE START LOGIC IMPROVEMENT (SA369)</b>

## SERVICE ACTION: 2.4L GDI ENGINE START LOGIC IMPROVEMENT (SA369)

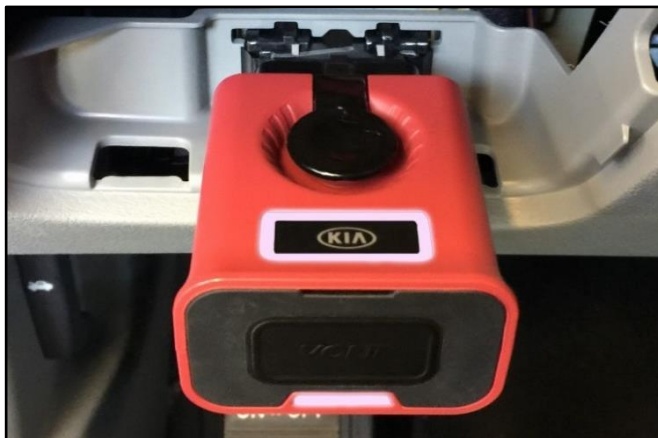
1. Connect the VCI-II to the OBD-II connector, located under the driver's side of the instrument panel.

The ECU upgrade function on KDS operates wirelessly. It is not necessary to perform the upgrade via USB cable.

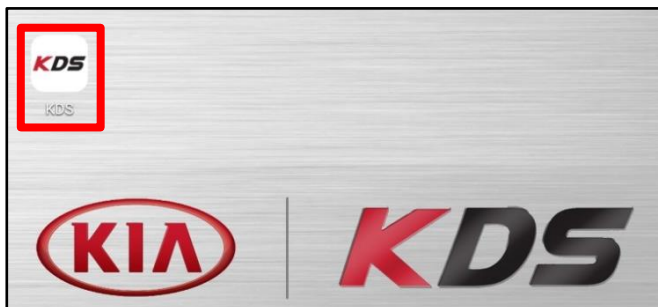
2. With the ignition ON, turn ON the KDS tablet. Select **KDS** from the home screen.

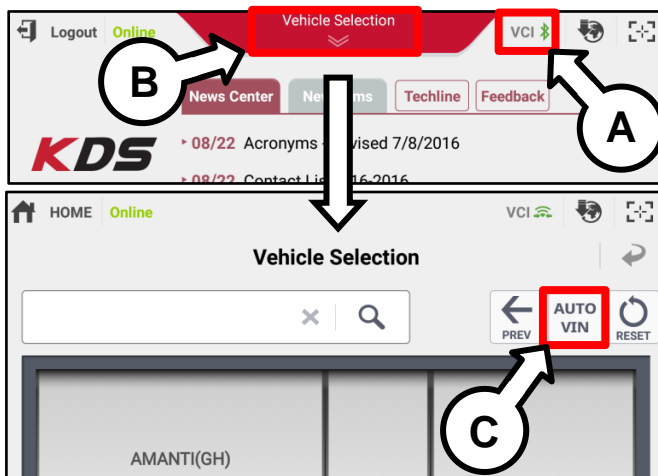
3. Confirm communication with VCI (A) and then configure the vehicle (B) using the **AUTO VIN** (C) feature.

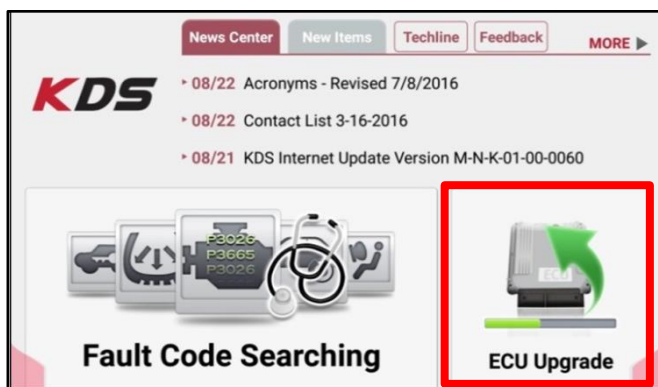
4. Select **ECU Upgrade**.

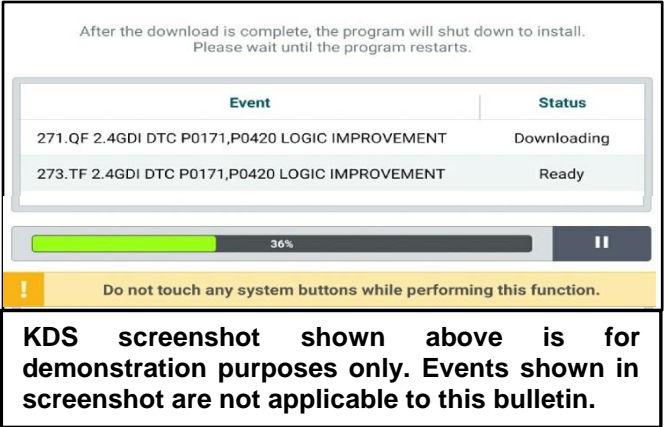
- The KDS will check the server for recently uploaded Events and then automatically download **Upgrade Event #405**.

**\* NOTICE**  
 The vehicle must be identified in Vehicle Selection to download an Event for that vehicle.

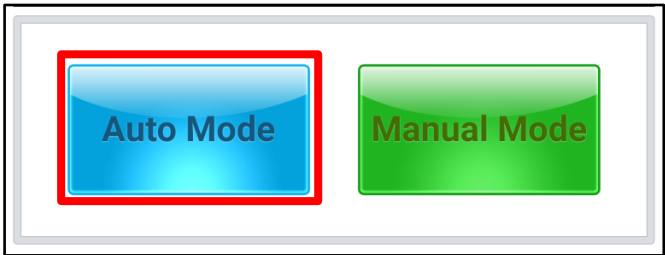
- Select **Auto Mode**.

**CAUTION**  
 Do NOT attempt to perform a Manual Mode upgrade UNLESS Auto Mode fails. Always follow the instructions given on the KDS in either Auto or Manual mode.

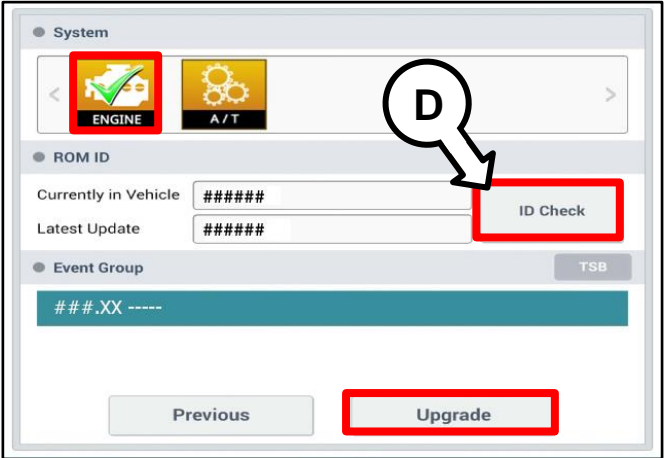
- Select the **Engine** system under the System selection menu.

Touch **ID Check** (D) and confirm that the latest update is available.

Select **Upgrade Event #405** and select **Upgrade** to continue.

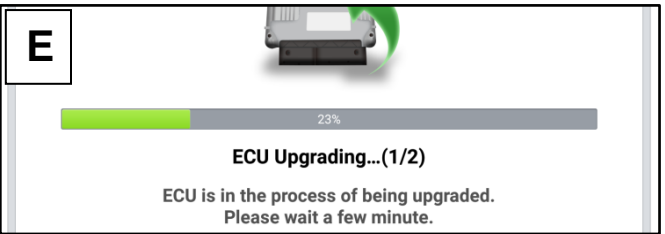
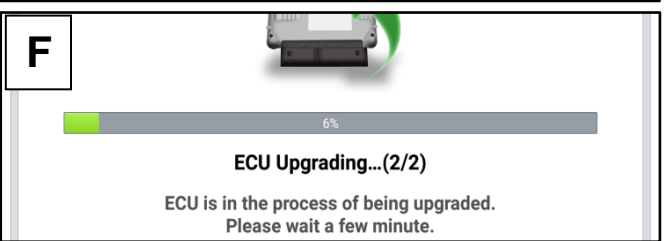
- The ECU upgrade will begin and the progress of the upgrade will appear on the bar graph. Upgrade part (1/2) (E) will download the upgrade event to the VCI-II. Upgrade part (2/2) (F) will upgrade the ECU.

**CAUTION**  
 Do not touch the system buttons (like 'Back', 'Home', 'etc.') while performing ECU Upgrade.

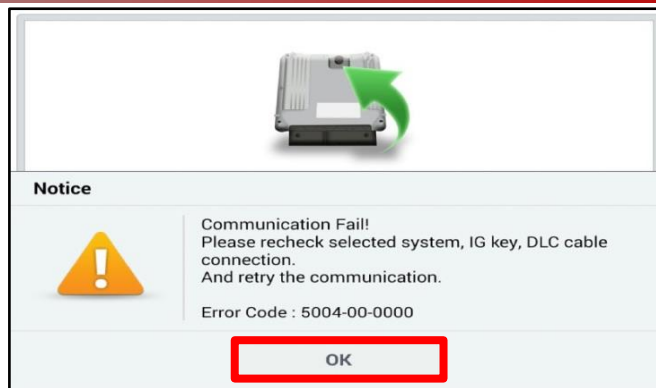
9. If a “Communication Fail” screen appears, verify that the VCI-II and KDS are communicating properly. Touch **OK** and restart the procedure from step 4.

**If an error notice continues to appear or if the upgrade cannot be performed, DO NOT disconnect the KDS/VCI-II. Contact GIT America Help Desk at (888) 542-4371 or Techline.**

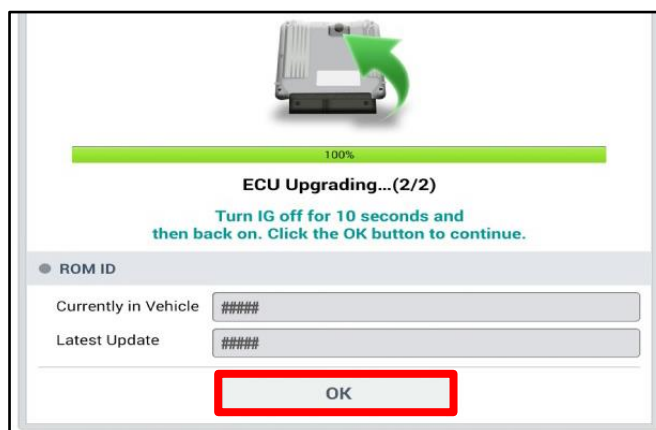
10. When instructed on the KDS, turn the ignition **OFF** for ten (10) seconds then back on. Touch **OK** to continue.

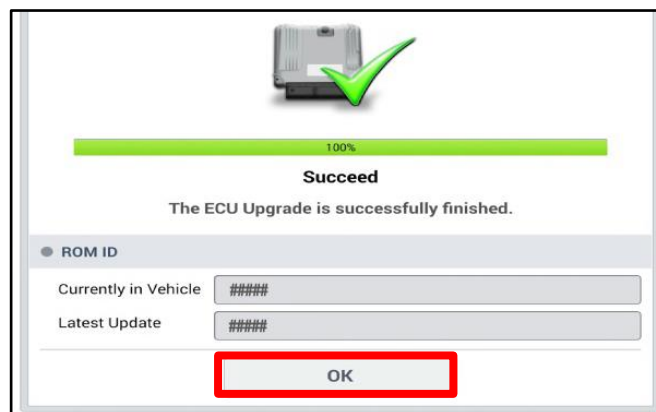
11. Once the upgrade is complete, touch **OK** to finalize the procedure.

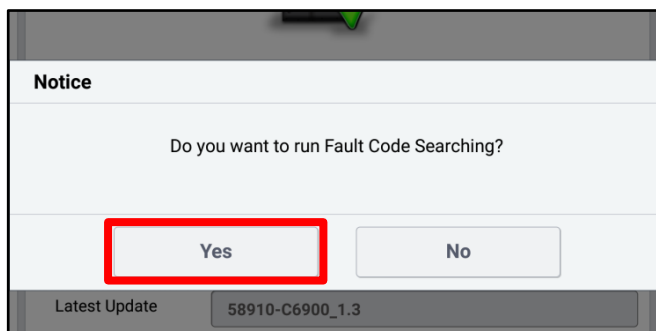
12. When prompted, select **YES** to check for Diagnostic Trouble Codes (DTC) and erase any DTCs stored such as EPS, ESC, and TPMS that may have been set during the upgrade.
