Entune Audio Head Unit Software Update (Fujitsu Ten)

Service Category Audio/Visual/Telematics

Section Navigation/Multi Info Display

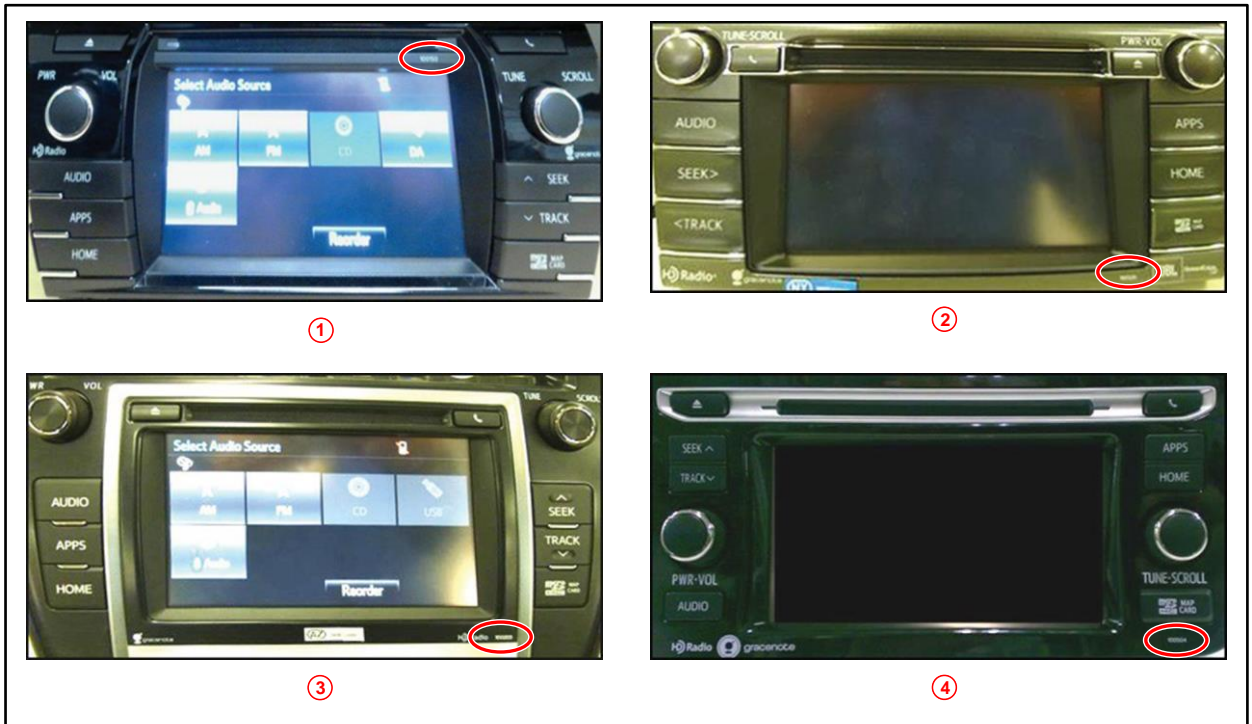
Figure 1.

1. Confirm the audio system type by checking the panel ID printed above the top right or bottom right of the display.

1	Corolla
2	RAV4, RAV4 HV

3	Camry, Camry HV
4	Prius C

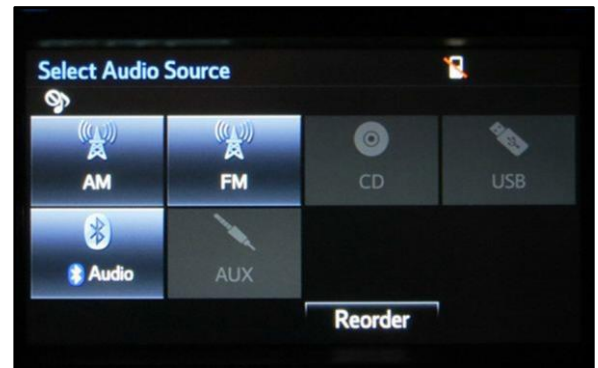
Figure 2.

2. Perform steps 7 – 11 and verify the latest software needs to be installed.
Is the software up to date?
 - **YES** — This bulletin does NOT apply. Continue diagnosis using the applicable Repair Manual.
 - **NO** — Continue to step 3.
3. Insert the USB flash drive into the vehicle USB port.
4. Start the engine.
5. When the Select Audio Source screen displays, continue to the next step.
6. When the USB source icon highlights and displays the USB name with the icon, continue to the next step.

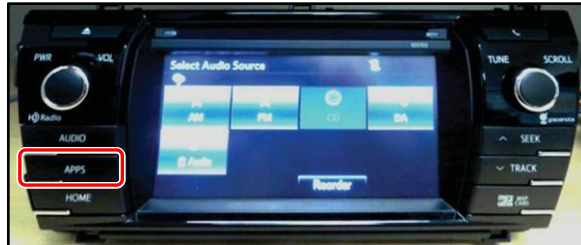
(1) Press the Apps button on the left or right of the panel.

Figure 5. Camry, Camry HV, Corolla, RAV4, RAV4 HV

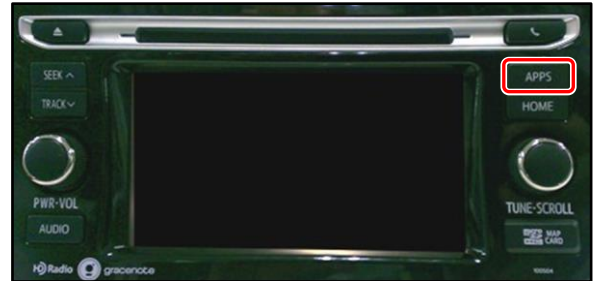
Figure 6. Prius C

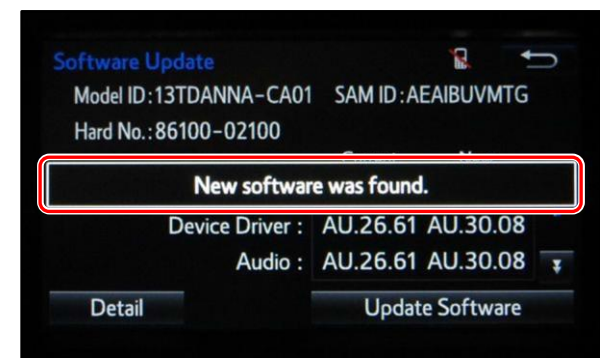
Figure 12.

If software is detected properly, a "New Software was found." pop-up will display.

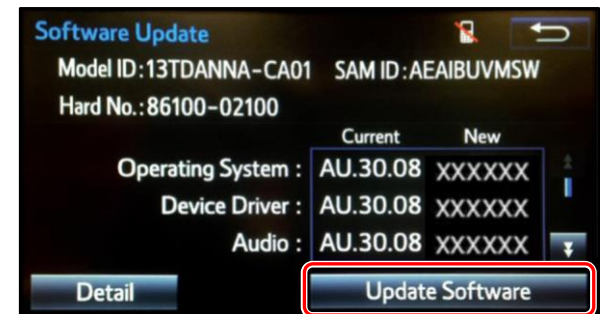
Figure 14.

- Select Update Software on the Software Update screen.

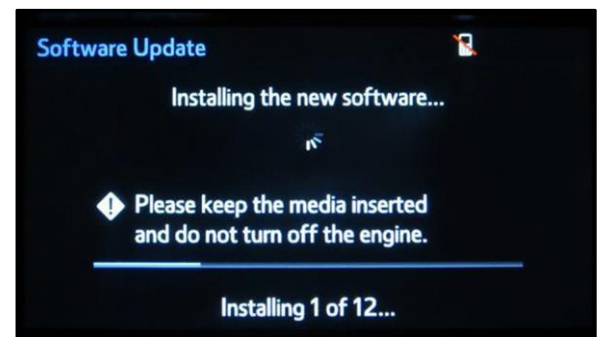
Figure 17.

14. This unit will begin installation.

Do NOT turn off ACC before the software is ready for updating.

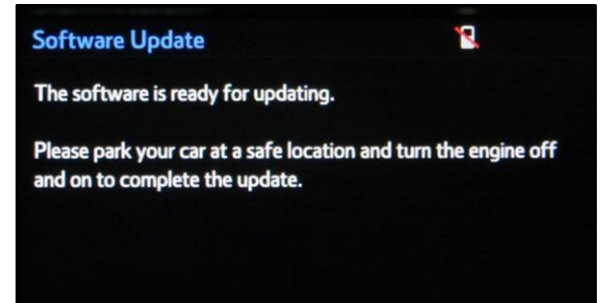
Figure 18.

15. When “The software is ready for updating” displays, cycle the ignition OFF, wait 30 seconds, then cycle the ignition ON again.

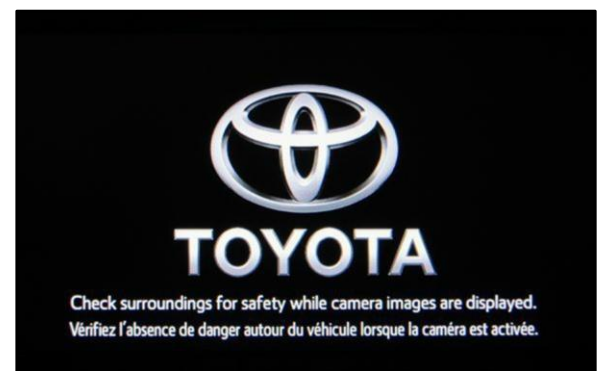
Figure 20.

When the Toyota logo screen displays, the update is complete.

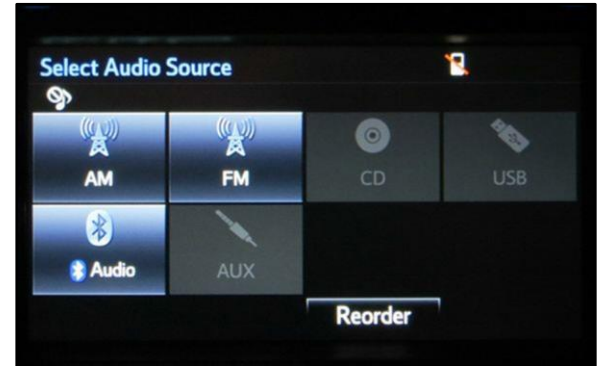
Figure 21.

18. When the the Select Audio Source screen displays, continue to the next step.
