SERVICE PROGRAM BULLETIN

APPLICABILITY: 2018 MY Legacy
 2018 MY Outback
 2017-2018 MY Impreza
 2018 MY Crosstrek
 2018 MY BRZ*

NUMBER: WUA-86R

SUBJECT: Harman Kardon Head Unit Reprogramming

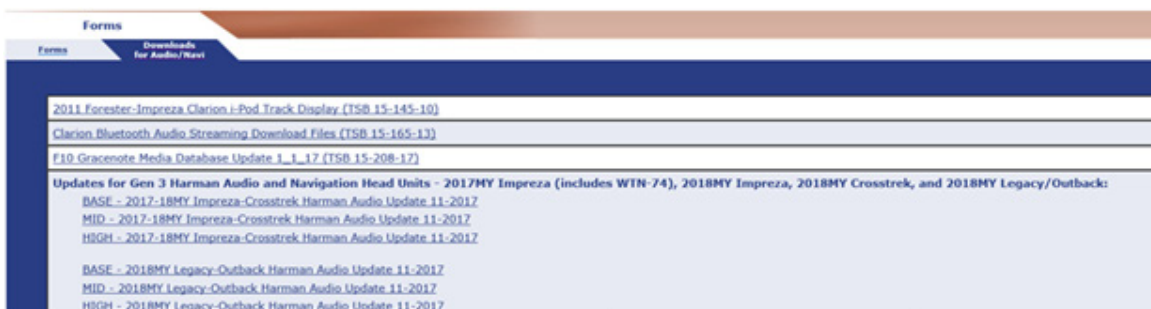
- If the files are being **downloaded from Subarunet**, they will be .zip files and must be unzipped before they can be used. An EXAMPLE image of the Subarunet links page is provided below.

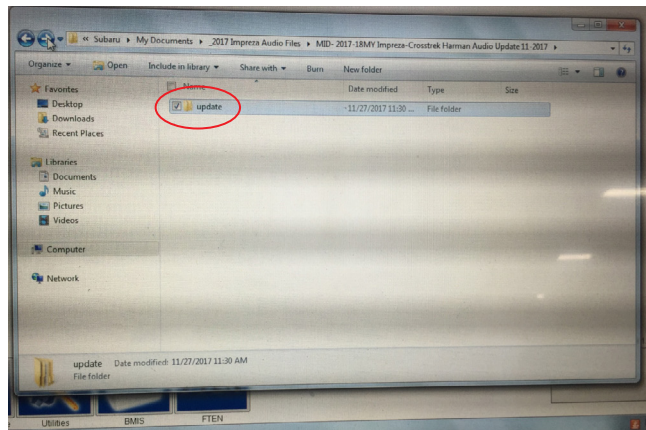
- Double-click on the required file (for this example, select the file entitled “BASE-17-18 Impreza-18 Crosstrek-18-Legacy-Outback-18-BRZ-HARMAN AUDIO UPDATE-NOVEMBER 2018”) and the Update file will display as shown.

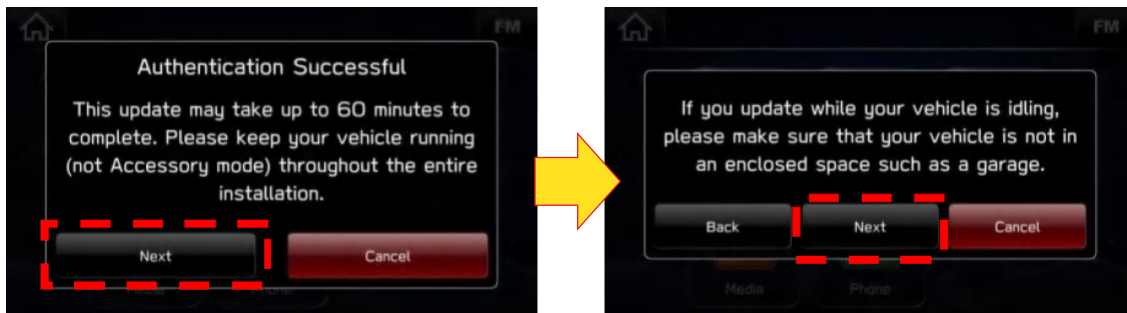
- After the unit “authenticates” the USB flash drive, press “Next” and after the second screen is displayed, press “Next” again.

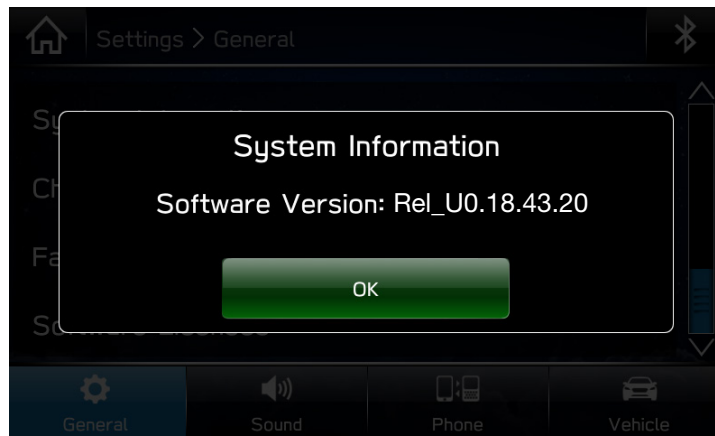
- Confirm Software Version is now “Rel_UO.18.43.20”.
