Quick tip

Title: Remote start with extended range

(Only applies to 2019 Tiguan LWB, Jetta, GLI built after CW36/18, Atlas built after CW42/2018)

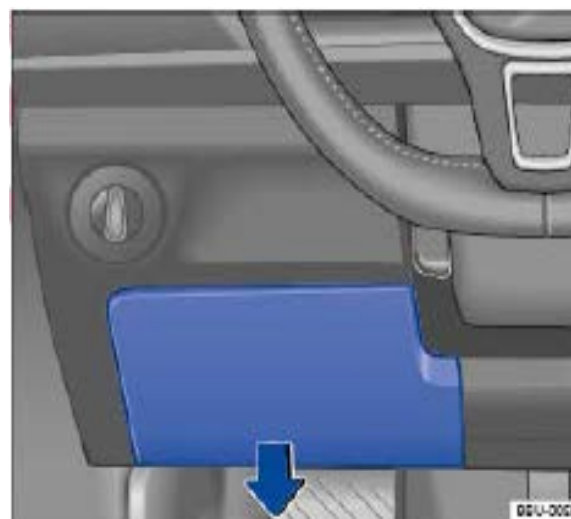
Step 4:

- Remove fuse panel cover.

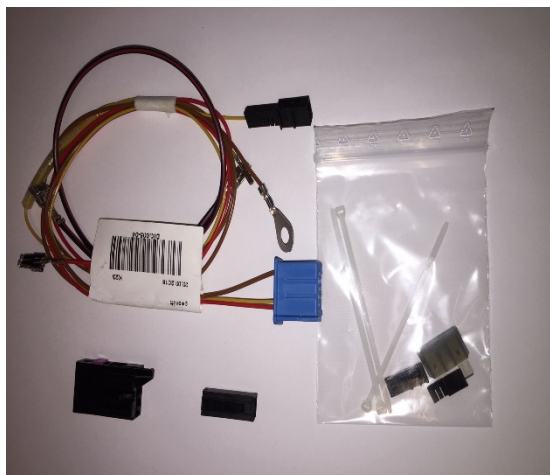
Step 7:

- Insert red wire into the fuse holder.
- Insert black/red wire into fuse holder.
- Insert the 2-amp fuse into the fuse holder.
- Insert the red/black wire into the connector.

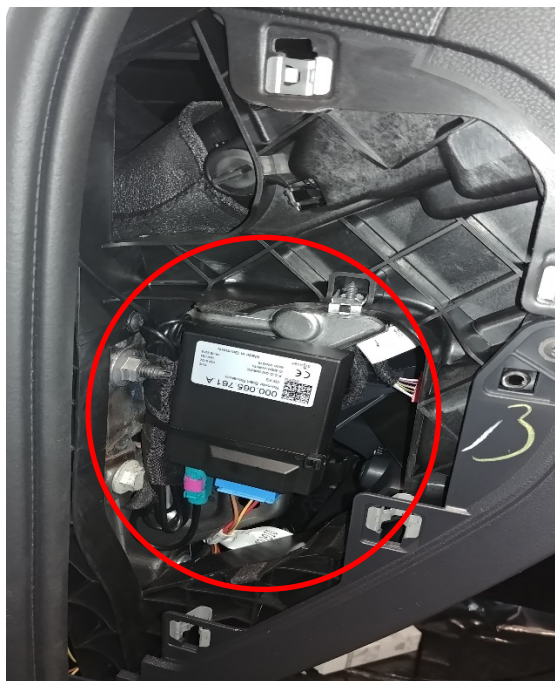
Step 8:

- Use a cable tie and secure the module at the base of A-pillar.

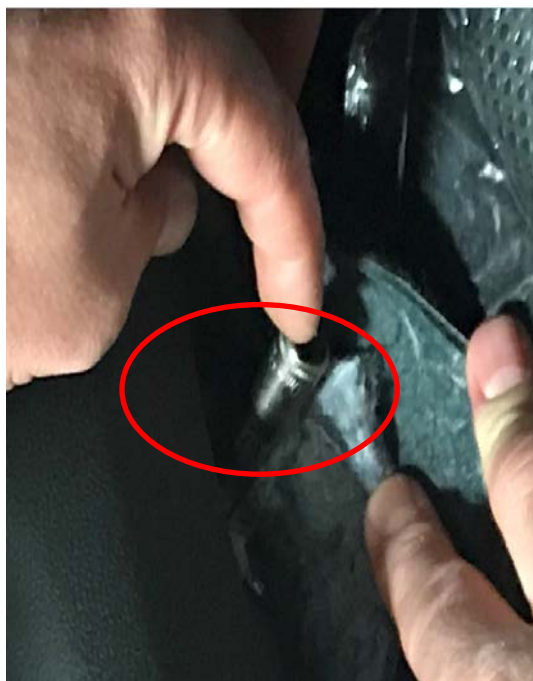
Step 9:

- Route ground wire behind lower A-pillar trim and connect to the chassis ground location under the carpet near the base of A-pillar.
- Torque nut to 9Nm.

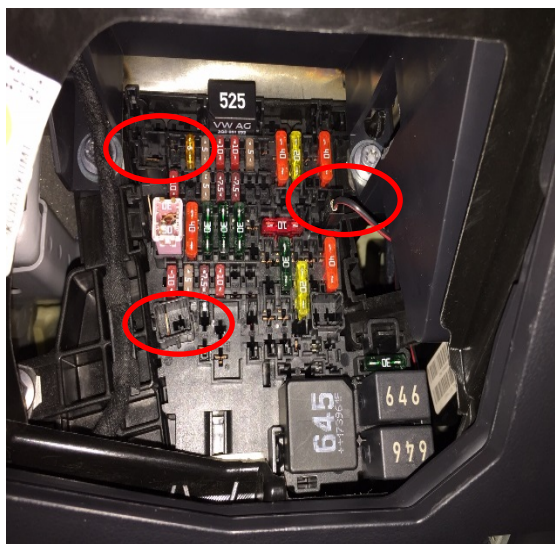
Step 10:

- Insert the power wire in any open location shown above.
