## **EMISSIONS RECALL**

**CAB OVER ENGINE (COE) ECU AND DCU  
SOFTWARE UPDATE**

**CAMPAIGN NO: AACR0  
DATE: 2-14-2019  
REFERENCE: QA-190212-N1**

**SUBJECT VEHICLES:** 18MY-20MY COE trucks equipped with a J05 engine

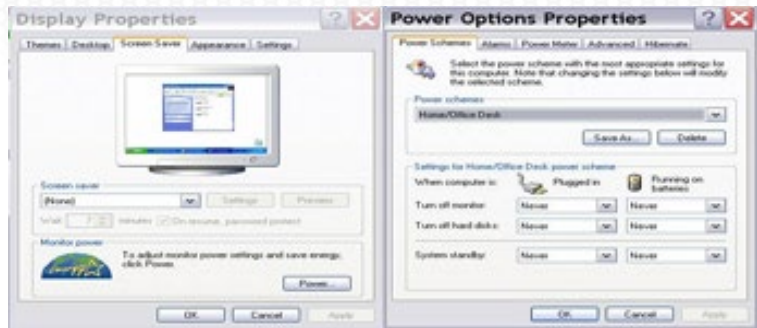
1. Screen saver
2. Energy saving features
  - a. Monitor
  - b. Hard disks
  - c. System standby

**NOTICE:** The illustrations above depict what you will see on your computer screen with regard to the features which must be disabled. The location on the screen of the features to be disabled will vary, however, based upon the operating software. Consult your IT (Information Technology) department as required.

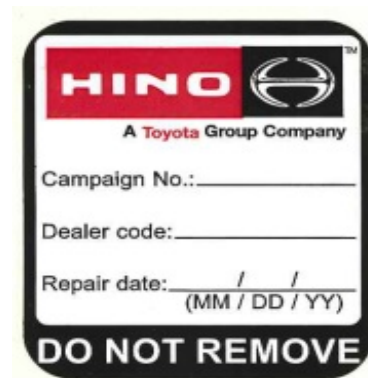
Once all above steps in this recall procedure have been completed, apply a recall label to the left door jamb above the VIN label. Fill in the Campaign No, Dealer code, and Repair date. Proceed to the Final Inspection Procedure, below.
